# MONTANA DEPARTMENT OF TRANSPORTATION STREAM MITIGATION MONITORING REPORT

*Year Project Completed: 2011  
Monitoring Report #5: December, 2017*

## **STREAM MITIGATION MONITORING REPORT #5**

MDT Project Number: NH 7-1(114)59  
Control Number: CN 2015004

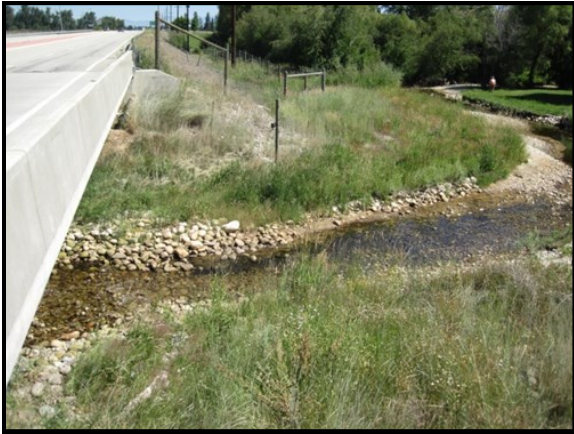
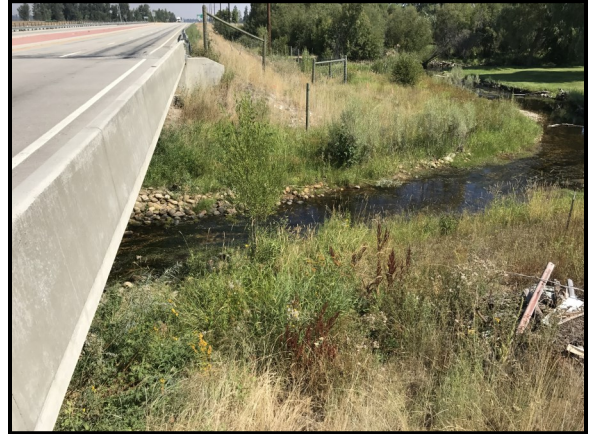
**2013**  
**Photo Point 1.1:** View of north bank from bridge abutment. **Compass:** 45 (Northeast)

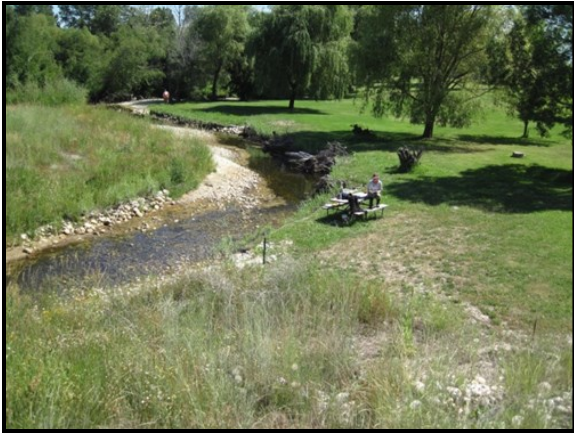
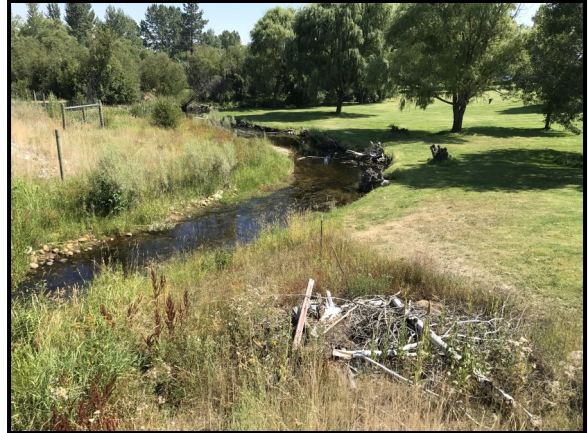
**2013**  
**Photo Point 1.2:** View of both banks looking downstream from bridge abutment. **Compass:** 68 (East-Northeast)

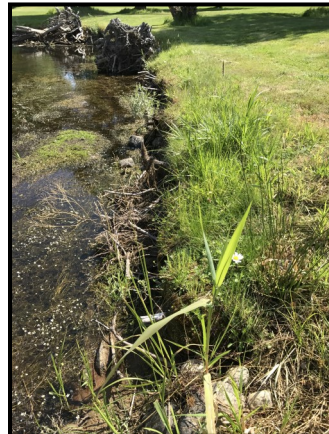
An erosion inventory conducted along both stream banks revealed no newly eroding banks in 2017. In 2014, erosion at EBR1 was noted along a 15' segment of the right (south) bank where one of the coir logs separated from the bank and washed downstream. The location of this erosion is noted on Figure 2 in Appendix A. This bank has become undercut and laterally migrated an additional 1 foot in the past year as a result of hydraulics in the vicinity of the root wad installed to provide bank protection (see Additional Photos 4 and 5 in Appendix C). All but a couple of willow sprigs installed along this 15-foot bank segment have eroded into the stream. The lack of woody vegetation establishment along the bank, presence of the large root wad, and decomposition of coir materials used to construct the bank factor into the potential that erosion may continue along this short bank segment.

The 15-foot section of eroding bank along Sweathouse Creek identified in 2014 showed no signs of migrating further in 2015 or 2016; however it appears to have undercut and laterally eroded approximately 1 foot southward in the past year. Erosion along this bank is resulting from the hydraulics generated by the adjacent rootwad, lack of woody vegetation establishment along the bank, and degradation of the coir fabric used to originally construct the bank. This erosion is relatively short in length, is not currently threatening any infrastructure and is migrating at a rate of less than 1 foot per year. As a result of these factors, corrective actions do not appear warranted.

**2013**  
**Photo Point 2:** View of un-keyed coir log on south bank. **Compass:** 90 (East)

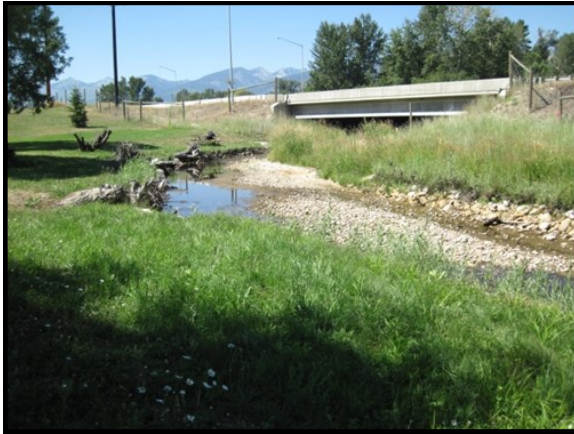
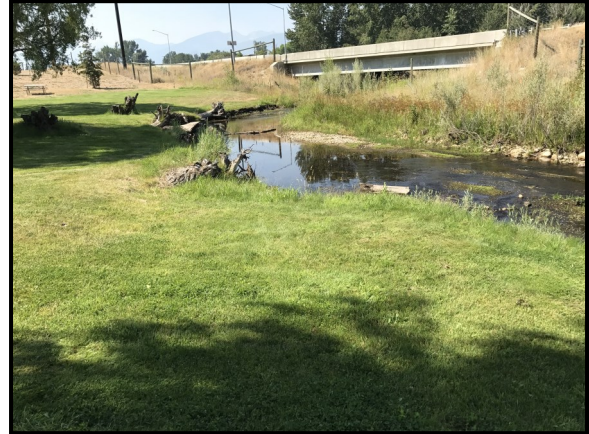
**Photo Point 3.1:** Looking upstream from downstream end of project reach. **Compass:** 225 (Southwest)

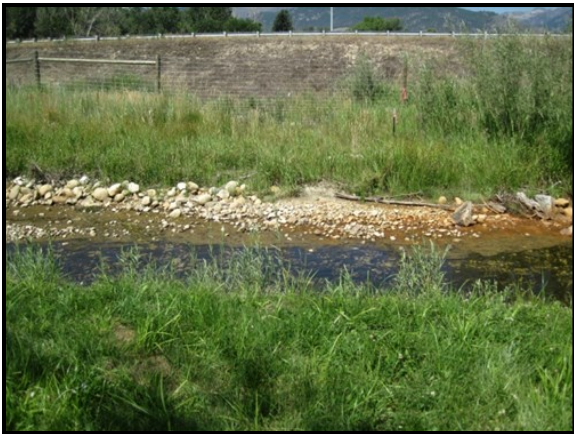
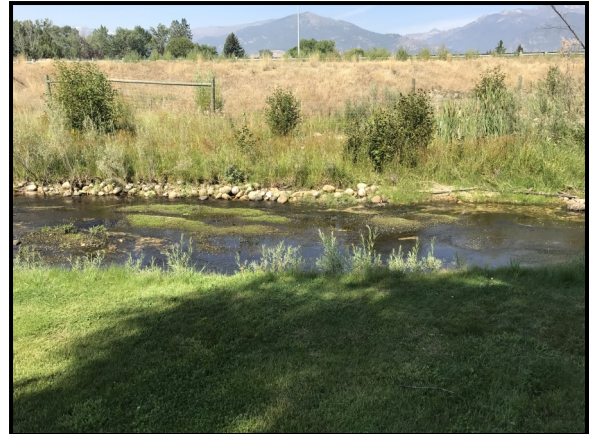
**Photo Point 3.2:** View of the north bank looking across channel. **Compass:** 315 (Northwest)

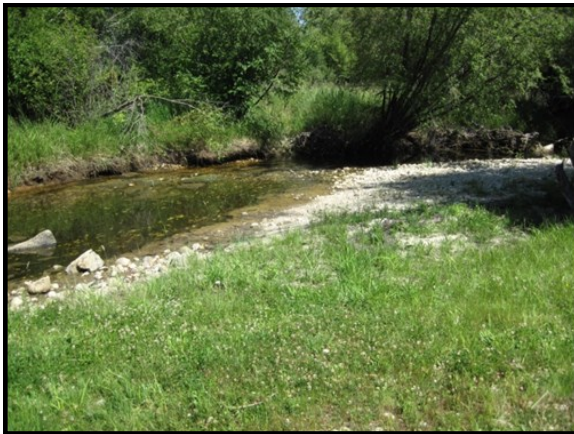
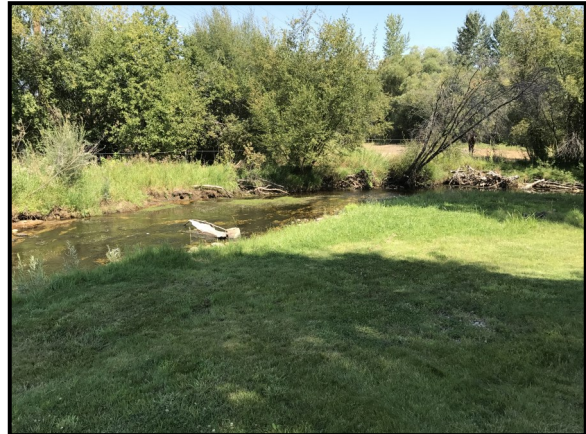
**Photo Point 3.3:** View of downstream extent of project area. **Compass:** 45 (Northeast)

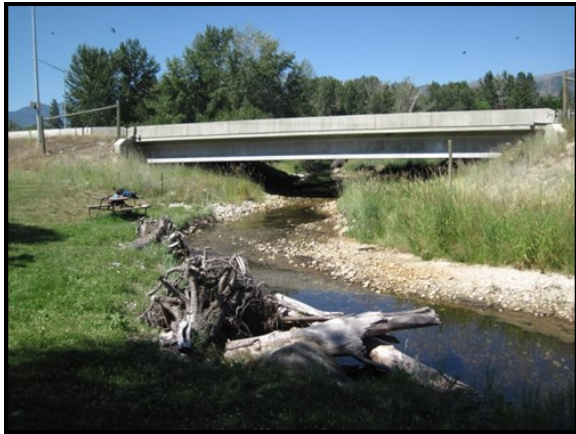
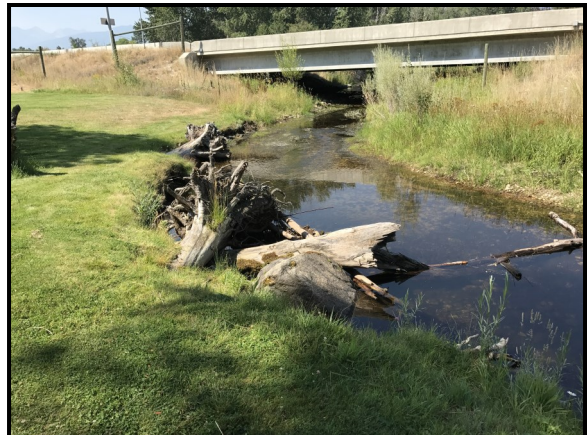
**2013** **2017**  
**Photo Point 4.1:** View of both banks looking upstream. **Compass:** 45 (Northeast)

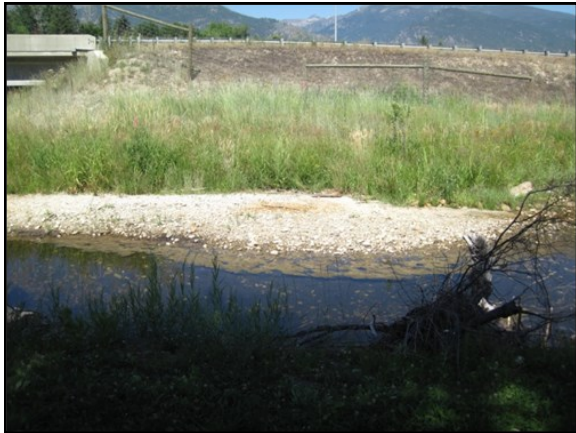
**2013** **2017**  
**Photo Point 4.2:** View of north bank and point bar development. **Compass:** 315 (Northwest)

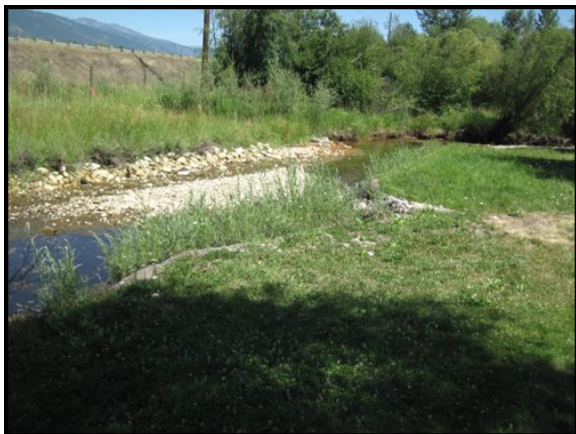
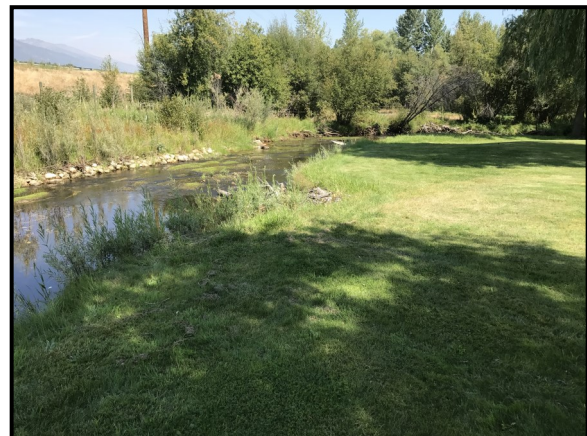
**2013** **2017**  
**Photo Point 4.3:** View of both banks looking downstream. **Compass:** 225 (Southwest)

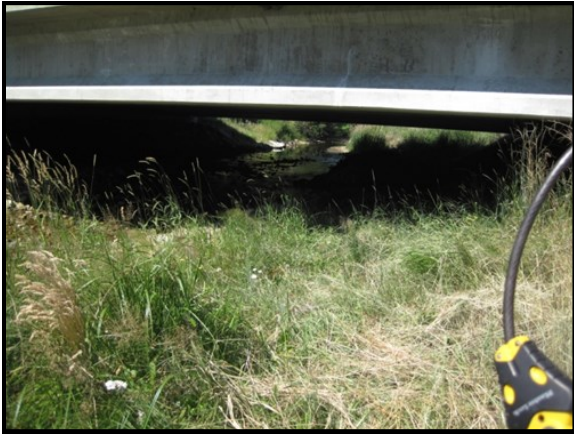
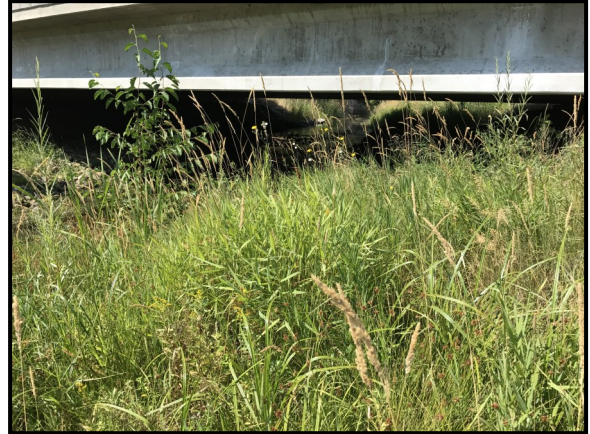
**Photo Point 5.1:** View from north bank looking upstream underneath bridge. **Compass:** 270 (West)

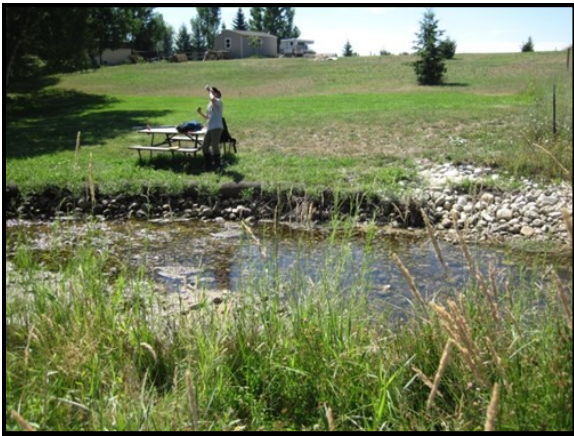
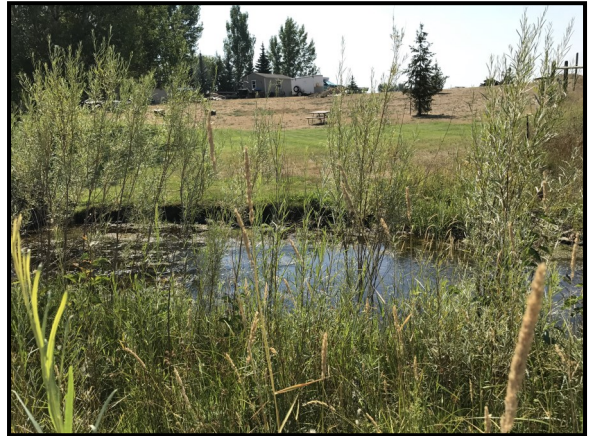
**Photo Point 5.2:** View of south bank. **Compass:** 180 (South)

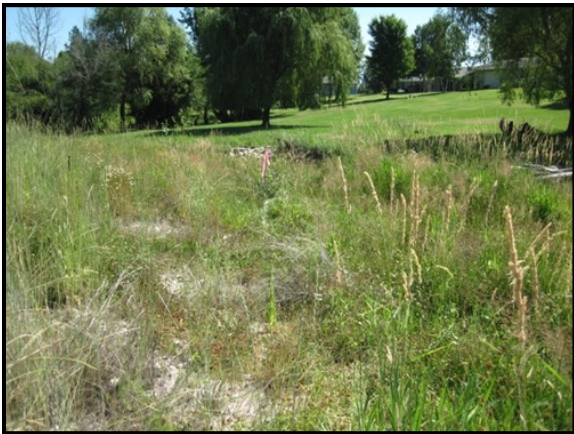
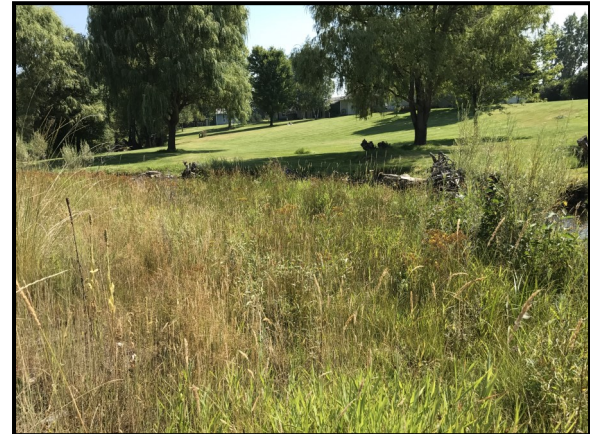
**Photo Point 5.3:** View of vegetation on north bank. **Compass:** 90 (East)

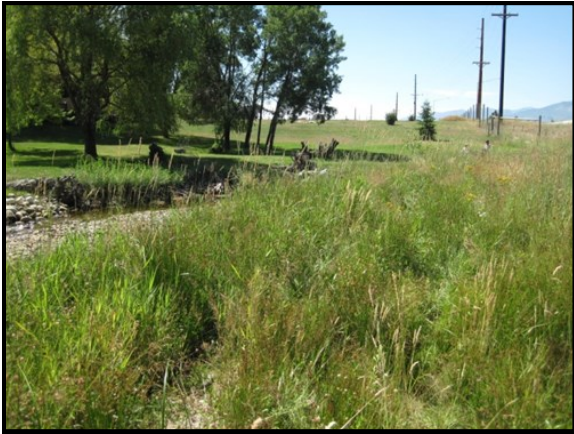
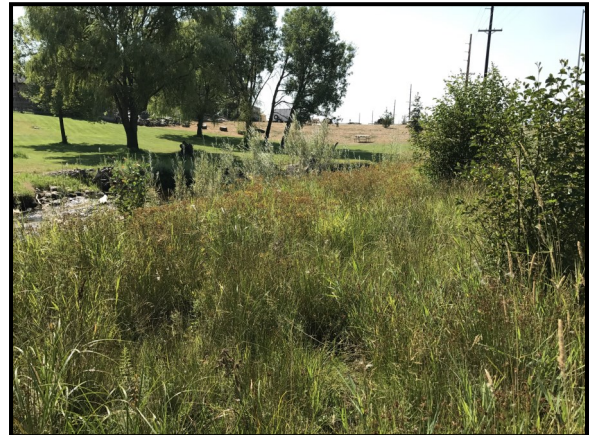
**2013**  
**Photo Point 6.1:** View of north bank vegetation. **Compass:** 225 (Southwest)

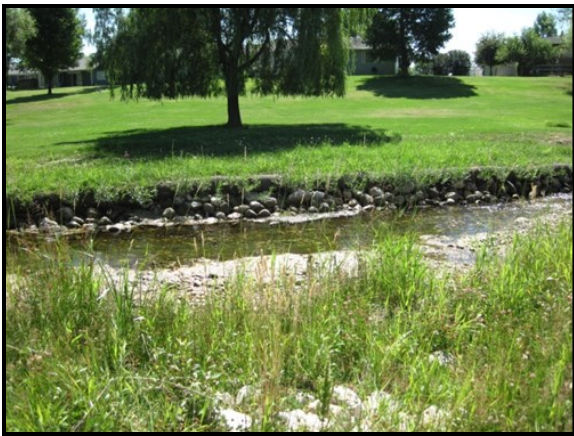
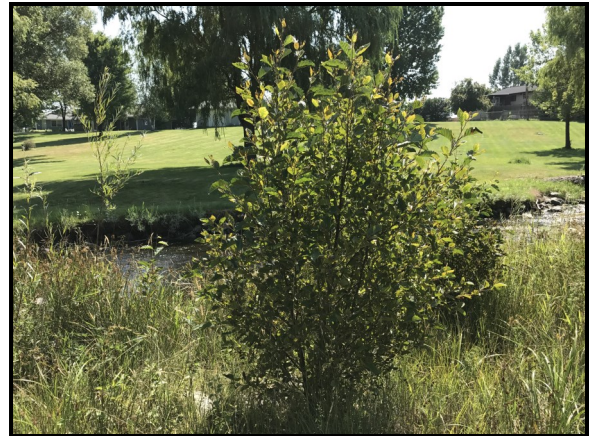
**2013**  
**Photo Point 6.2:** View of south bank looking across channel. **Compass:** 135 (Southeast)

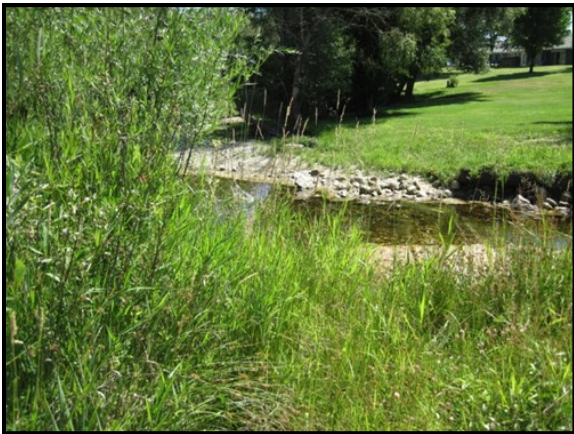
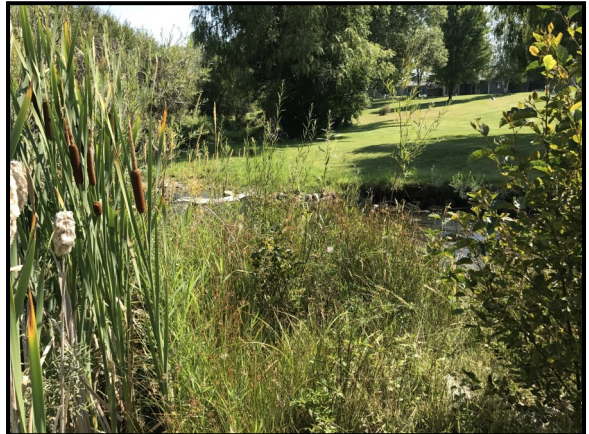
**2013**  
**Photo Point 6.3:** View looking across channel from north bank. **Compass:** 90 (East)

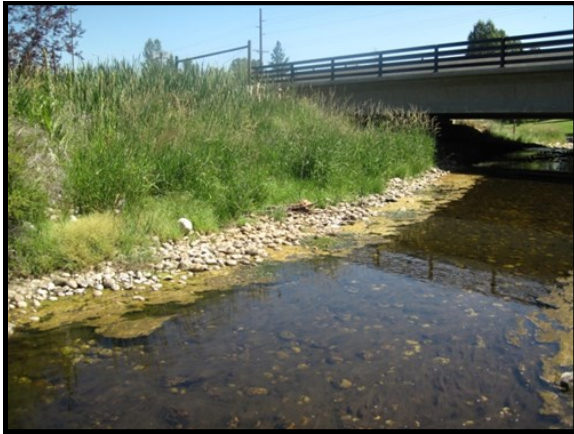
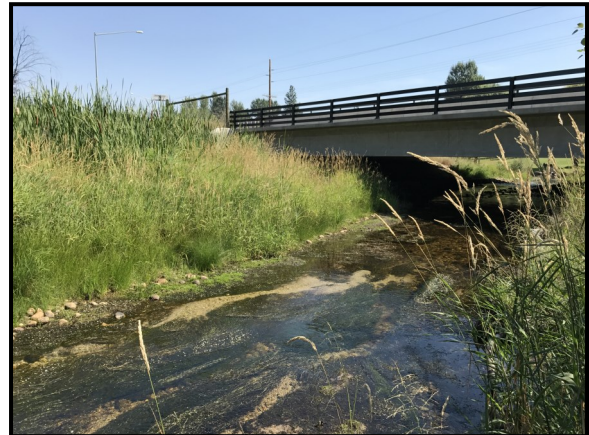
**Photo Point 7.1:** View of north streambank upstream of bridge. **Compass:** 68 (East-Northeast)

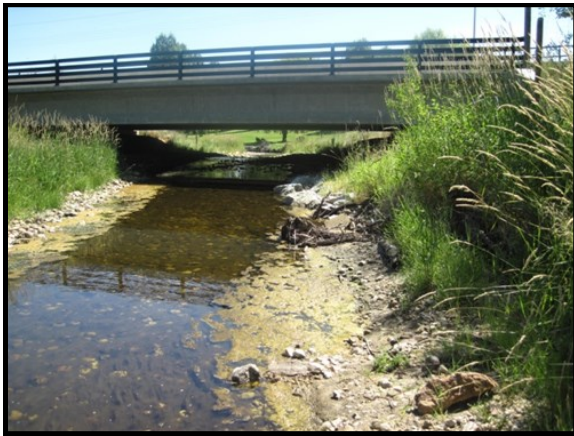
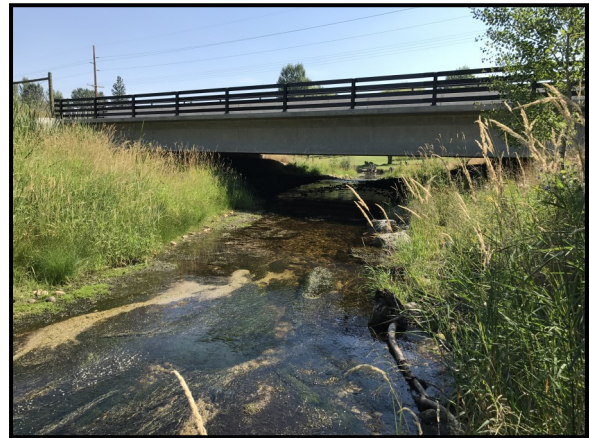
**Photo Point 7.2:** View looking downstream beneath bridge. **Compass:** 90 (East)

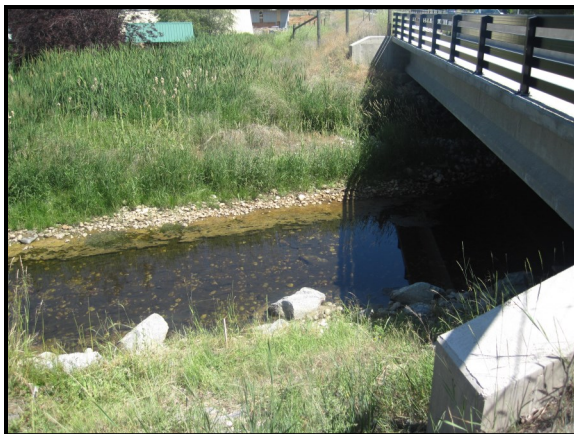
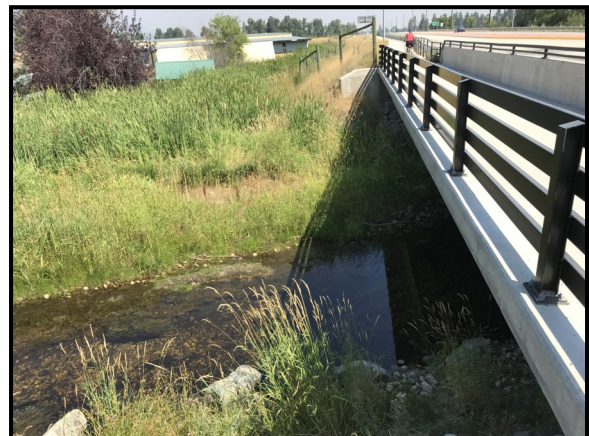
**Photo Point 7.3:** View of north bank looking across stream channel. **Compass:** 0 (North)

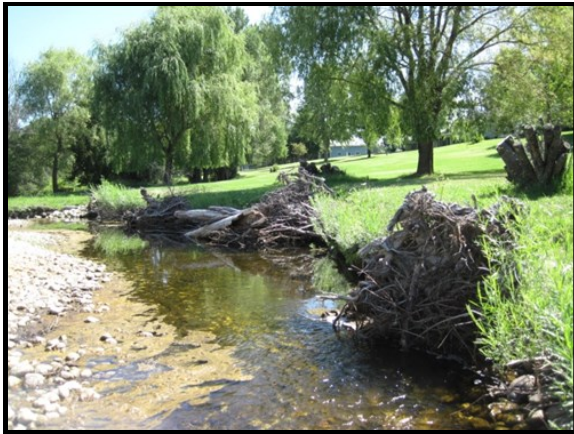
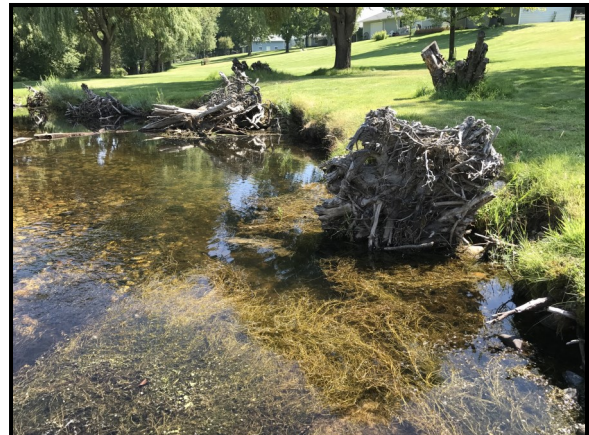
**Additional Photo 1: Root wads along south streambank. Compass: 45 (Northeast)**

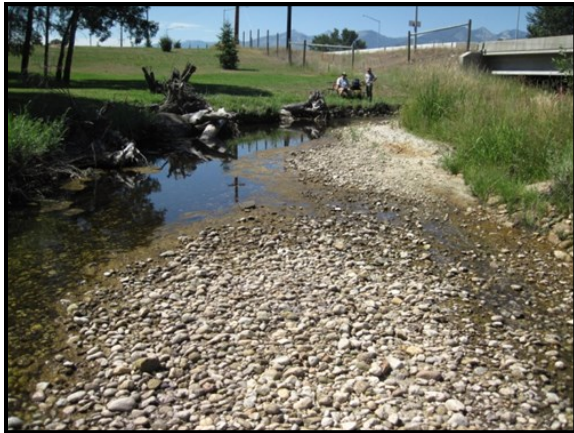
**Additional Photo 2: Point bar formation on north side of channel. Compass: 250 (West-Southwest)**

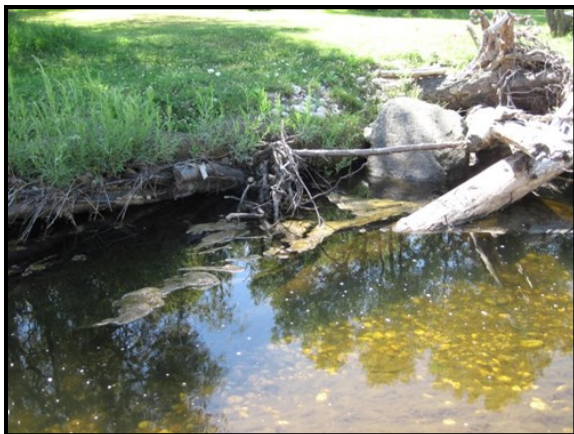
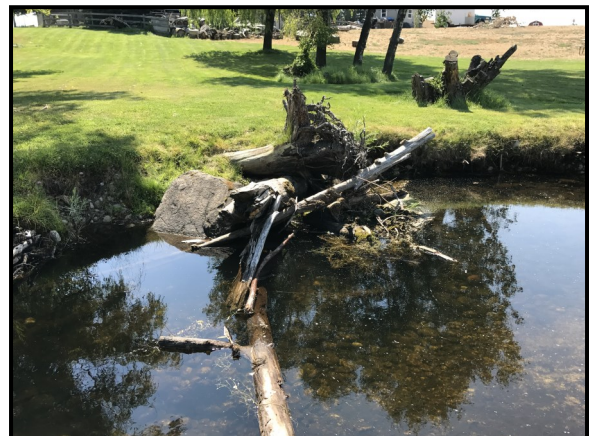
**Additional Photo 3: Log structure along south streambank. Compass: 110 (East-Southeast)**

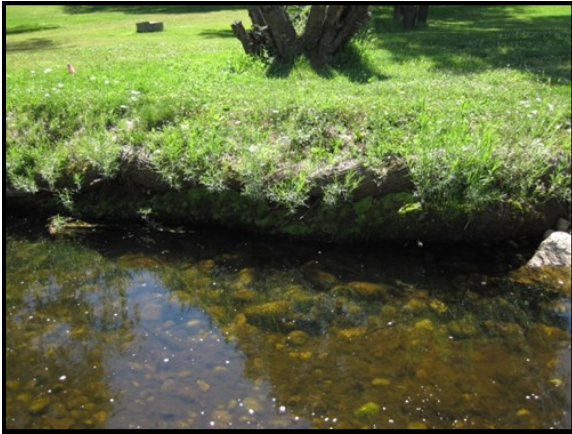
**2013**  
**Additional Photo 4: Eroding Bank EBR1 prior to bank collapse** **Compass: 90 (East)**

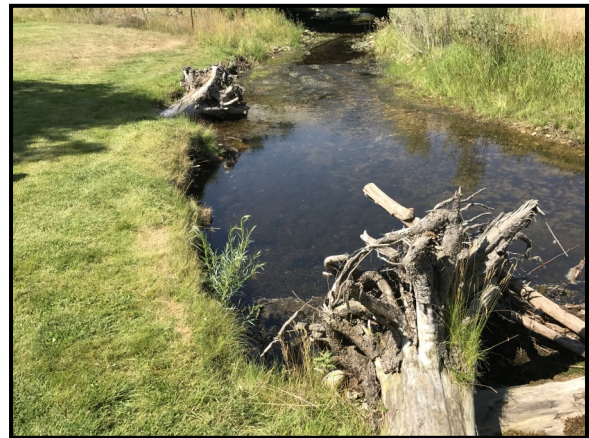
**2013**  
**Additional Photo 5: Looking upstream toward Highway 93 bridge from south bank.**

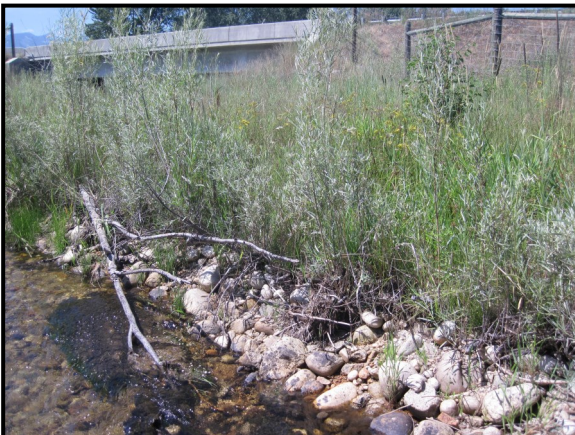
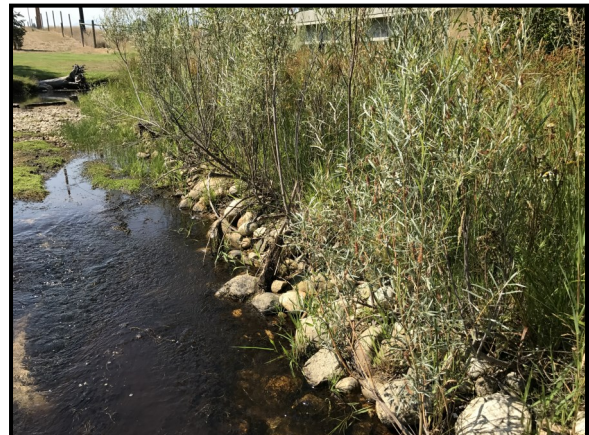
In 2017, percent cover of woody vegetation within the riparian corridor remained at 11%, and is below the performance standard of 50% cover by the end of the third growing season. The willows planted beneath the coir logs along the right bank are in poor condition. Monitoring of the woody vegetation along this bank indicates the young willows are no longer thriving and mortality is increasing due to continued trimming of the willows by the adjacent landowner. No additional woody vegetation is establishing within the remainder of the 25-foot wide riparian zone along the right bank due to mowing activities. It is unlikely the mitigation site will achieve the performance criteria for woody vegetation composition until the riparian areas along the right bank are replanted with woody shrubs and measures are taken to protect these species from removal. MDT biologists previously installed approximately 150 red-osier dogwood (*Cornus alba*), Woods' rose (*Rosa woodsii*), and willows (*Salix* spp.) within the riparian zone in an attempt to establish woody species composition; however, with the exception of willow stems installed in the stream banks, all woody vegetation installed in the riparian corridor has been removed from the south side of the project reach, presumably by frequent mowing by adjacent landowner.

**2013**  
**Additional Photo 6: Willow cutting growth along north bank** **Compass: 270 (West)**
