MONTANA DEPARTMENT OF TRANSPORTATION STREAM MITIGATION MONITORING REPORT

*Mill Creek
Ravalli County, Montana*

*Project Constructed: 2011
Monitoring Report #6: December, 2018*

MDT Project Number: NH7-(114)59
Control Number: 2015004

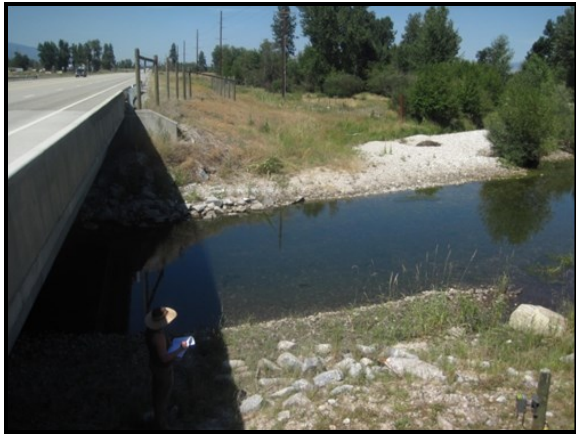
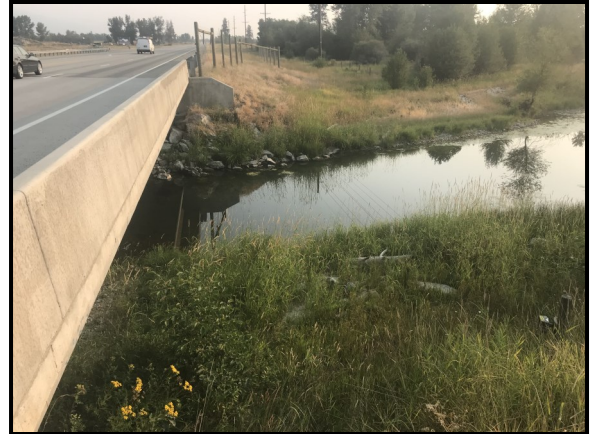
2013

Photo Point 1.1: View east (downstream) of Hwy 93 Bridge. **Compass:** 45 (Northeast)

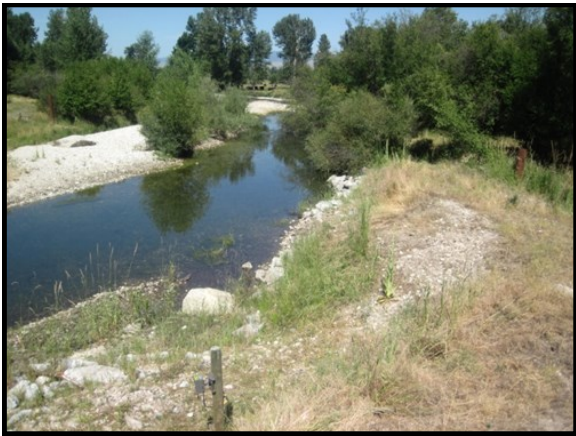
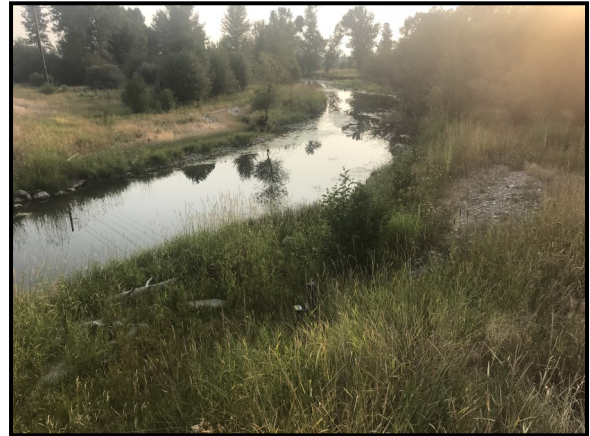
Photo Point 1.2: View from southeast corner of bridge looking downstream. **Compass:** 45 (Northeast)

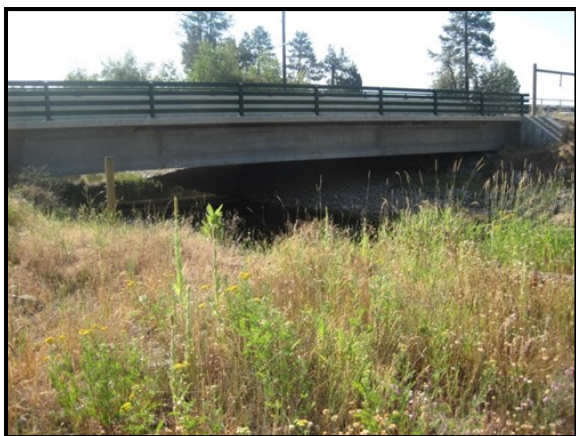
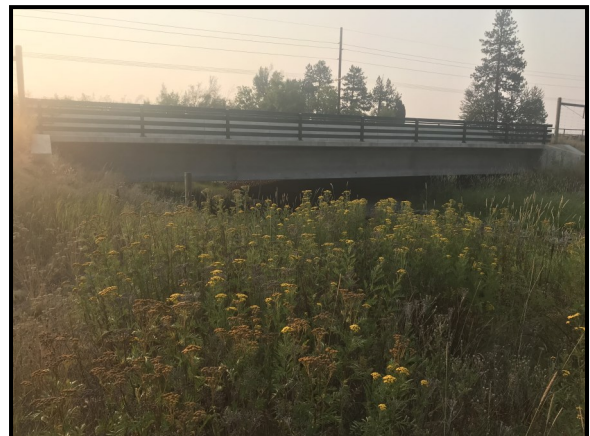
Photo Point 2.1: View across channel from west side of bridge. **Compass:** 113 (East-Southeast)

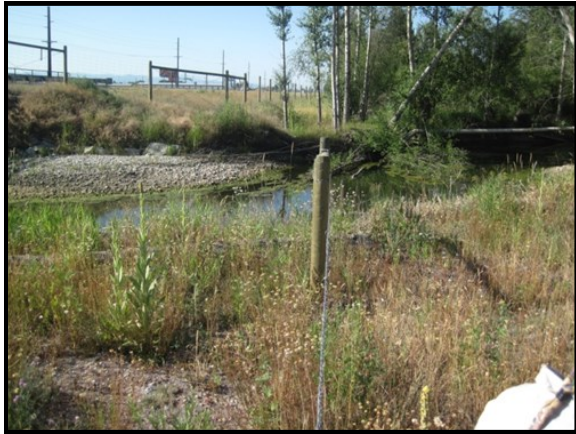
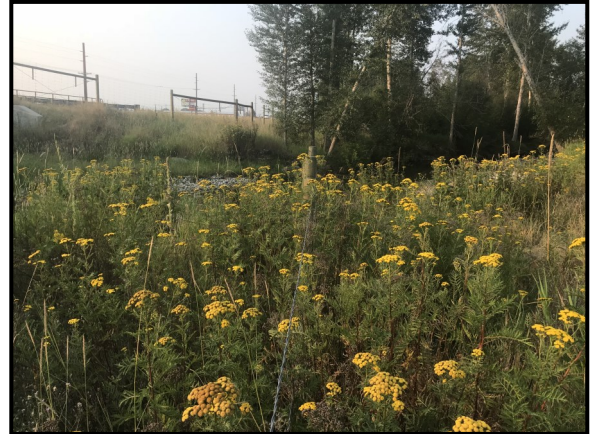
Photo Point 2.2: View from west side of bridge looking across stream channel. **Compass:** 225 (Southwest)

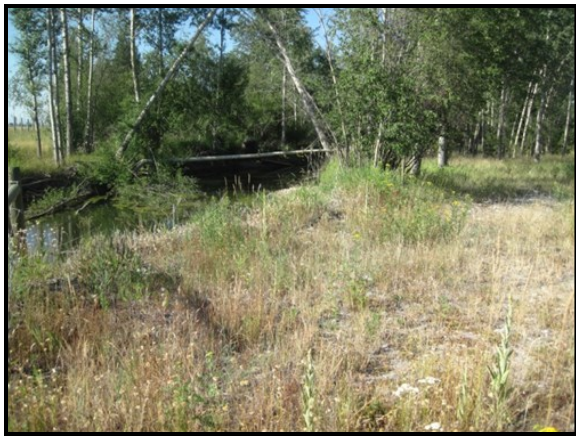
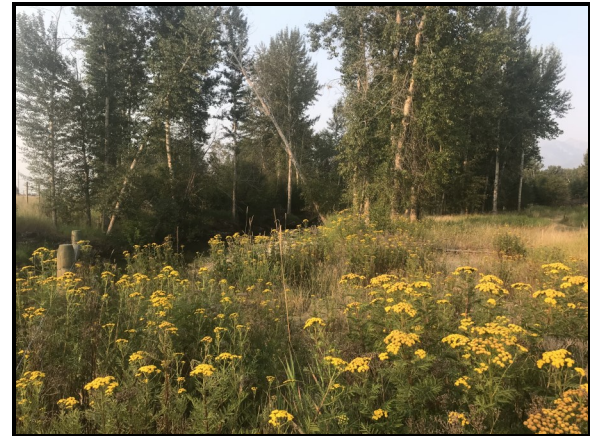
Photo Point 2.3: View from Photo Point 2 looking upstream. **Compass:** 248 (West-Southwest)

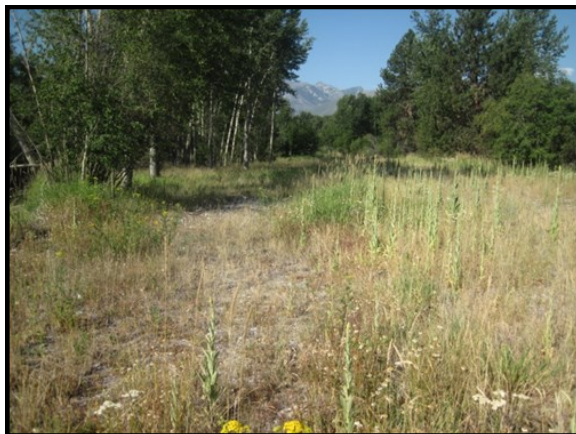
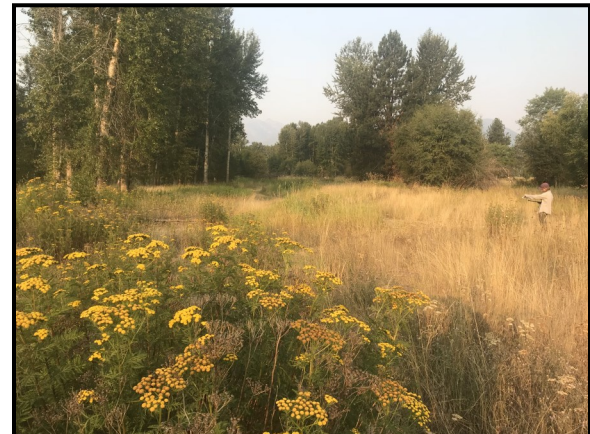
Photo Point 2.4: View of deactivated channel alignment **Compass:** 270 (West)

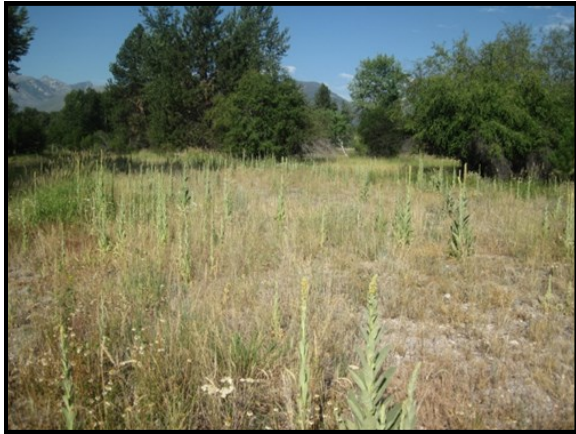
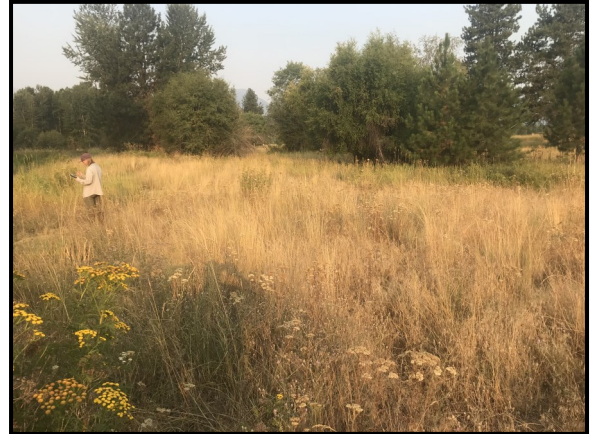
Photo Point 2.5: View of deactivated channel alignment. **Compass:** 248 (West-Southwest)

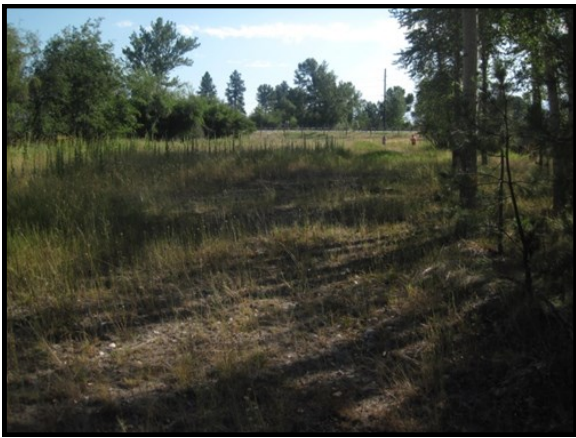
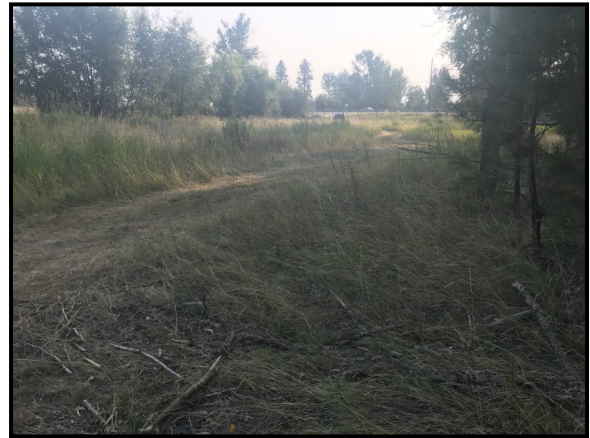
Photo Point 3.1: View of deactivated channel segment from Photo point 3. **Compass:** 68 (East-Northeast)

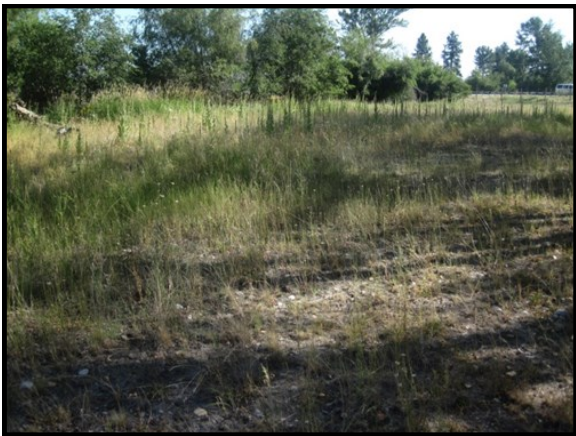
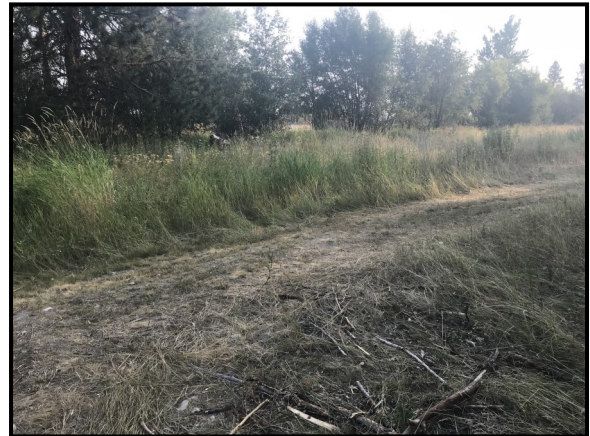
Photo Point 3.2: View of deactivated channel plug. **Compass:** 45 (East)

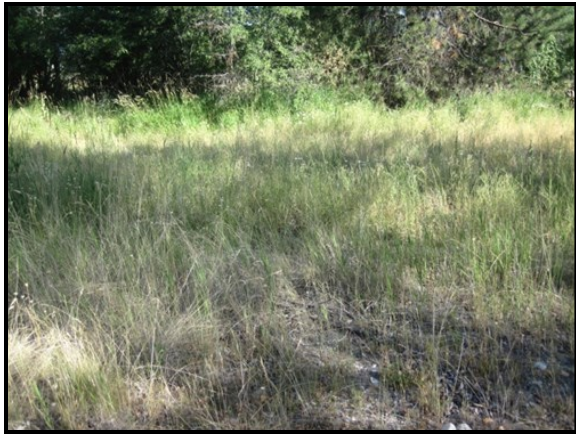
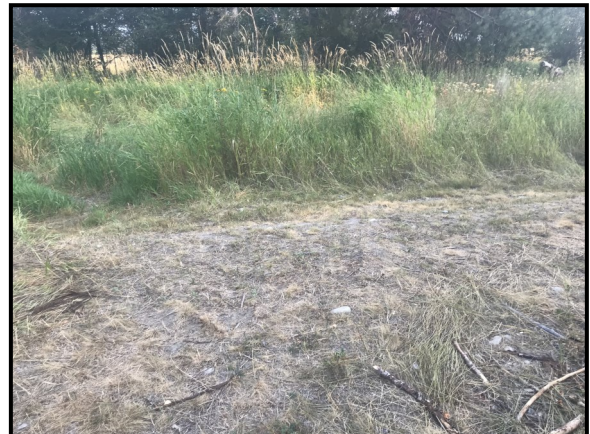
Photo Point 3.3: View of deactivated channel plug from Photo Point 3. **Compass:** 0 (North)

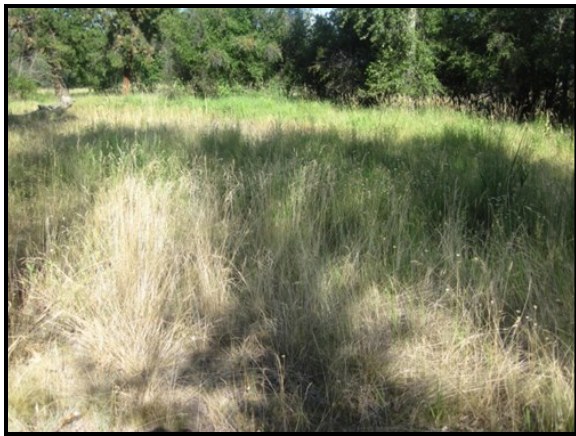
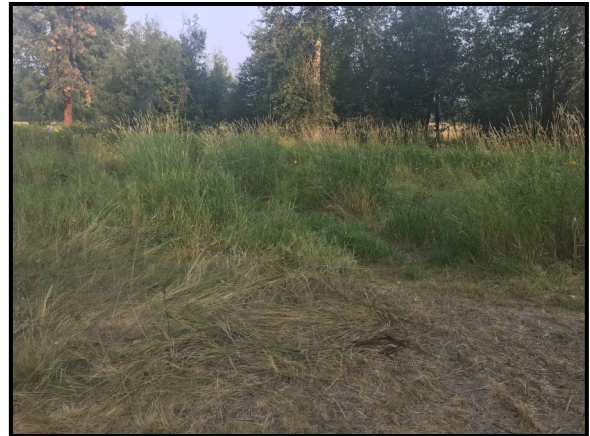
Photo Point 3.4: View of deactivated channel plug from Photo Point 3. **Compass:** 315 (Northwest)

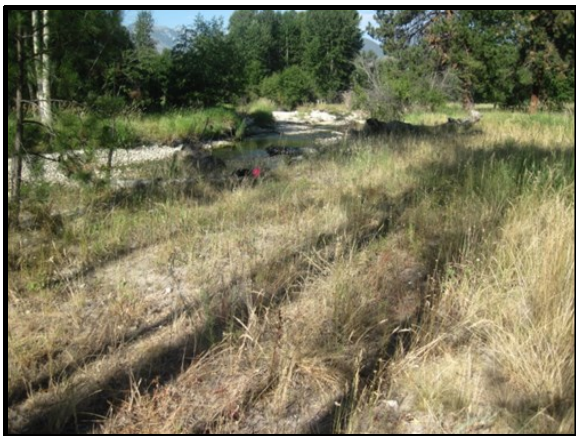
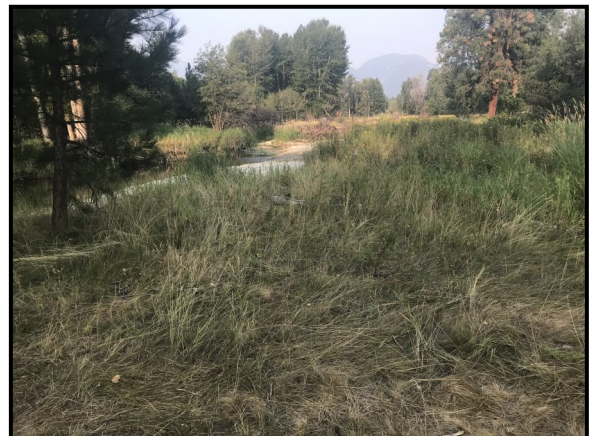
Photo Point 3.5: View of upstream extent of deactivated channel segment **Compass:** 270 (West)

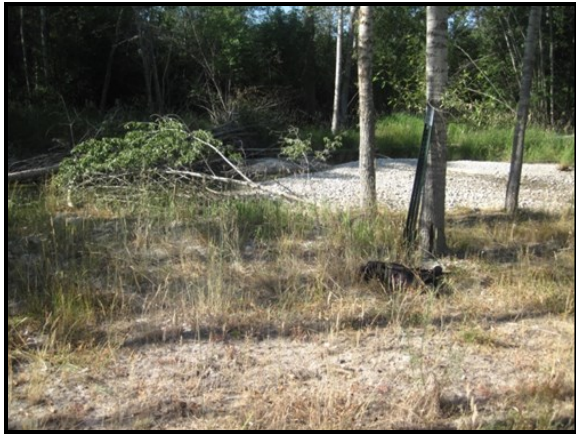
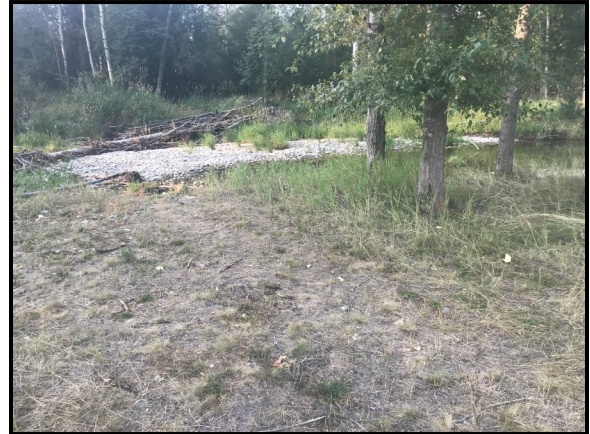
Photo Point 3.6: View of north bank (foreground) and woody debris in the channel. **Compass:** 248 (WSW)

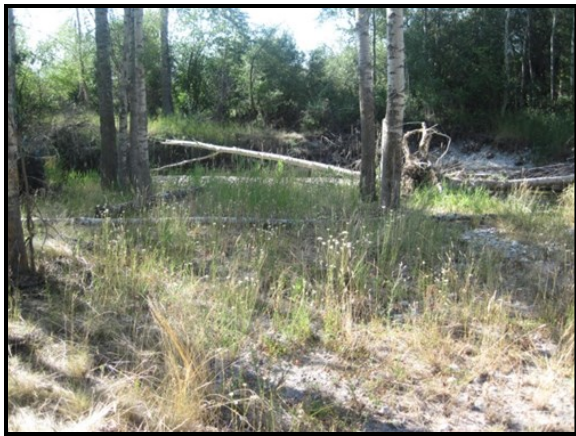
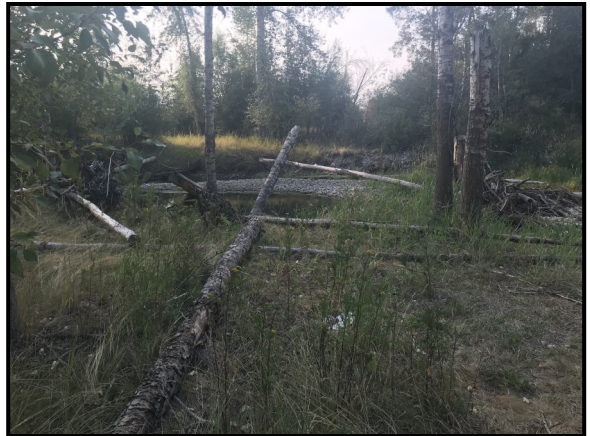
Photo Point 3.7: View of north bank (foreground) and woody debris in the channel. **Compass:** 180 (South)

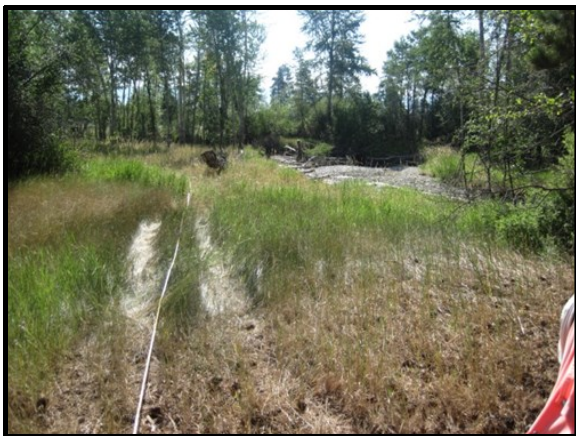
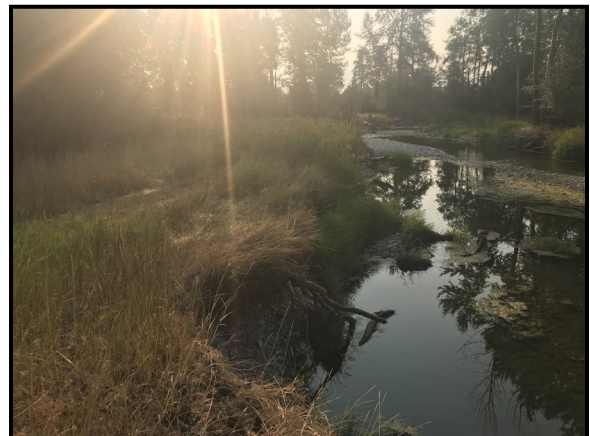
Photo Point 3.8: View looking across deactivated channel segment. **Compass:** 90 (East)

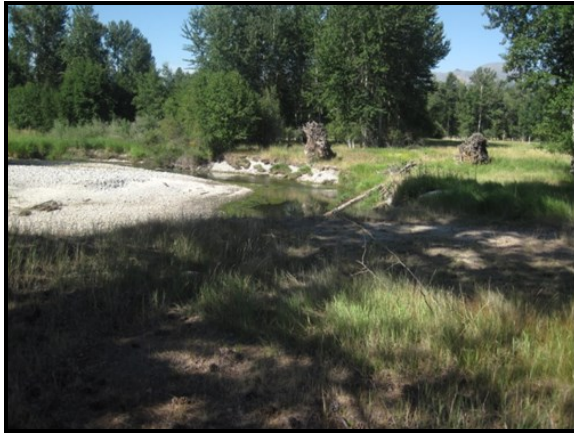
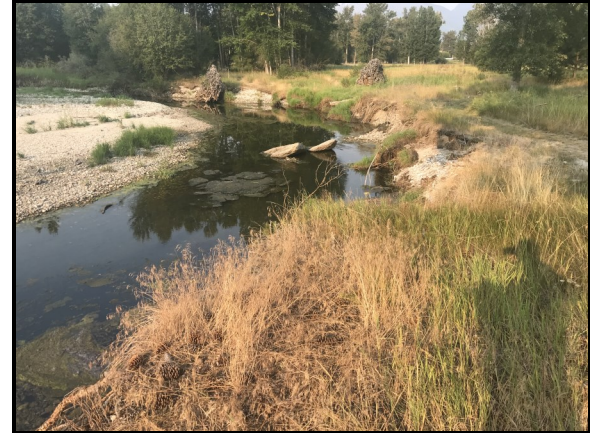
Photo Point 4.3: View of point bar formation from Photo Point 4. **Compass:** 225 (Southwest)

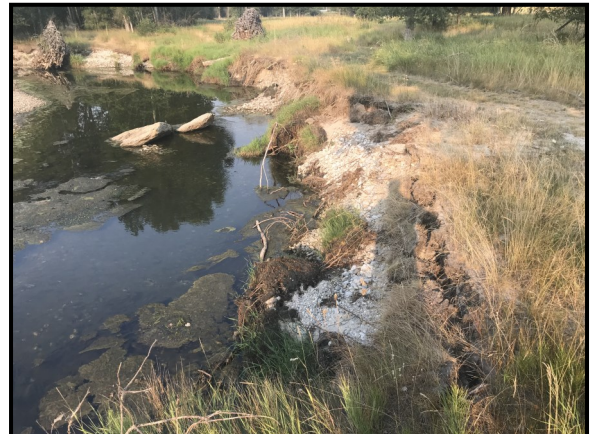
Photo Point 4.4: View of boulders, logs, and root wads placed on bank. **Compass:** 248 (West-Southwest)

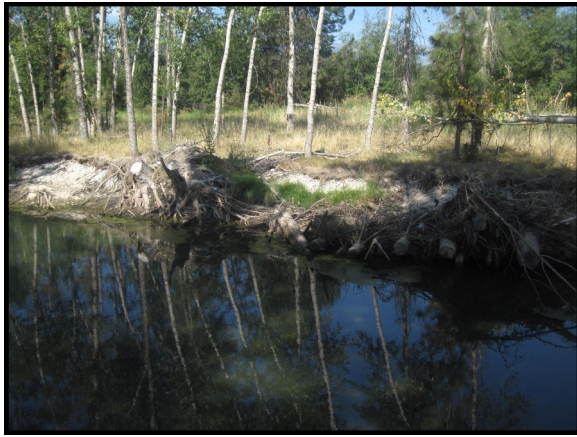
Additional Photo 5: Eroding streambank EBL4

Lateral erosion at bank EBL4 has continued the past three years, as evidenced by a log jam forming adjacent to the bank causing localized scour (see Additional Photo 5 in Appendix C). The bank has retreated approximately two feet in the past year and 8-10 feet in the past six years, although the eroding bank length has not increased. Bank instability at this location was potentially caused by removal of the trees for use in log revetment construction, or by natural channel adjustments and debris jams forming following construction. These debris jams are considered beneficial to the restored channel alignment, as they improve habitat complexity and generate pool scour features to the benefit of fish. The dominant vegetation along the bank includes reed canary grass and smooth brome, the former of which offers dense roots capable of withstanding erosion more effectively than most species. Erosion severity along this bank is considered low, as it does not jeopardize any infrastructure elements or the newly installed bridge downstream. As a result of the erosion occurring from natural channel adjustments, no corrective actions are warranted at this location.

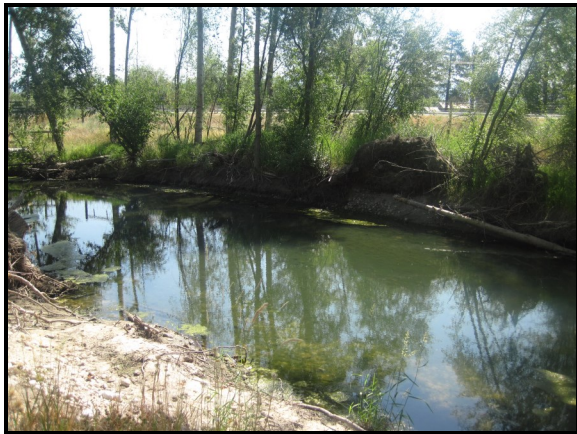
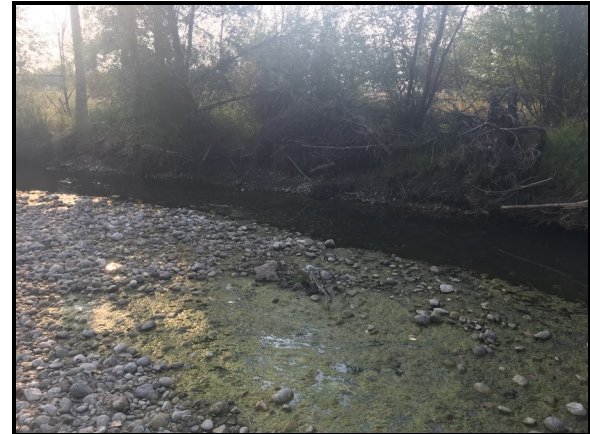
Additional Photo 6: Eroding streambank EBR1

Eroding bank EBR1 occurs directly across the channel from EBL4. Previous monitoring efforts documented fallen trees both into the channel and away from the channel along this bank. Continued erosion was not observed along the bank between 2015 and 2017, however erosion along the toe of the bank was noted in 2018 (See Additional Photo 6 in Appendix C). As such, it has been added back to the actively eroding bank inventory. This bank's slow erosion rate and protection by numerous rooted trees and shrubs classifies it as low erosion severity.

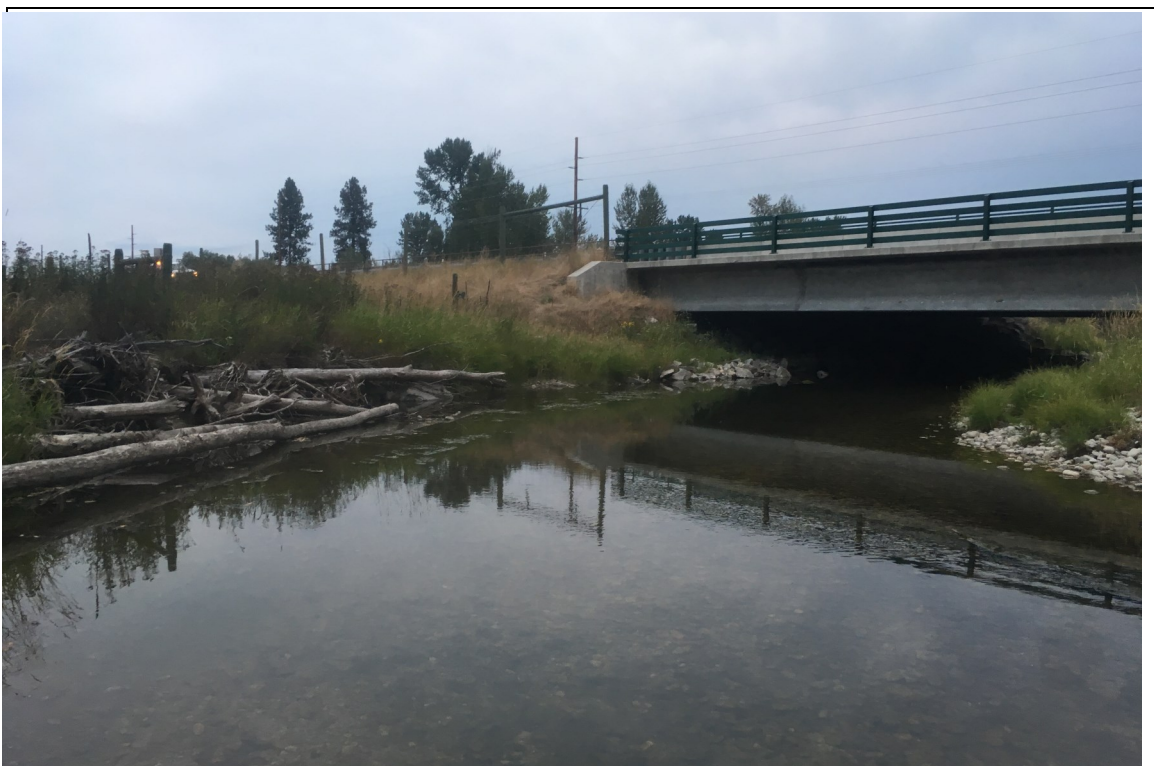
T4 LOOKING EAST DOWNSTREAM FROM MIDDLE CREEK

Transect #4 was originally positioned at a riffle just above the last meander bend upstream of the U.S. Highway 93 Bridge. Repeated surveys in 2018 reveal a developing point bar on the left bank and deeper thalweg along the right bank. Although the stream bed at this transect aggraded between 3 and 4 inches between 2016 and 2017; the channel did not continue to aggrade in 2018. Bar development along the left bank may eventually result in erosion along the right bank; however no erosion has been observed in the vicinity of transect #4 to date.
