MONTANA DEPARTMENT OF TRANSPORTATION STREAM MITIGATION MONITORING REPORT

*Mill Creek
Ravalli County, Montana*

*Project Constructed: 2011
Monitoring Report #7: December, 2019*

MDT Project Number: NH7-(114)59
Control Number: 2015004

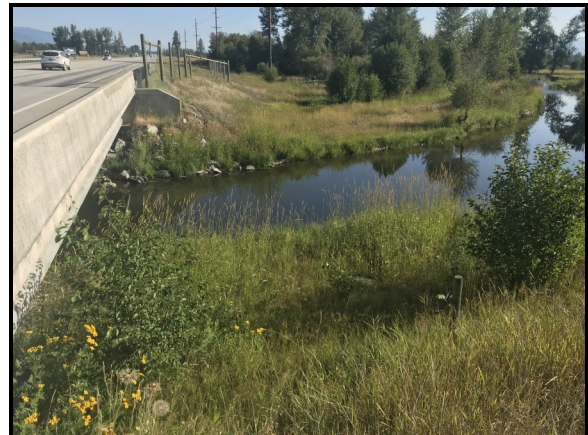
Photo Point 1.1: View east (downstream) of Hwy 93 Bridge. **Compass:** 45 (Northeast)

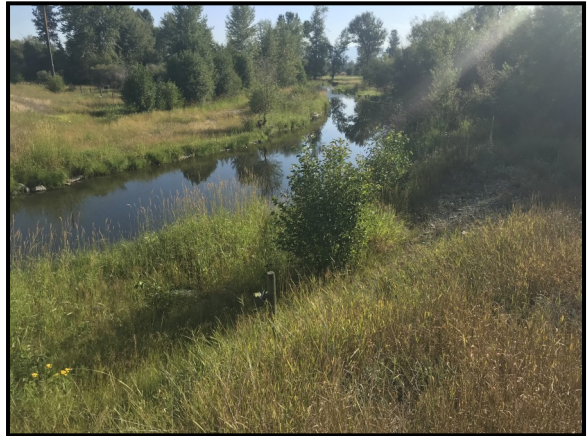
Photo Point 1.2: View from southeast corner of bridge looking downstream. **Compass:** 45 (Northeast)

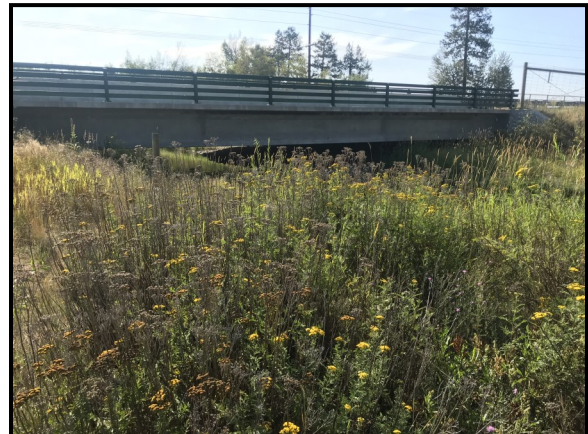
Photo Point 2.1: View across channel from west side of bridge. **Compass:** 113 (East-Southeast)

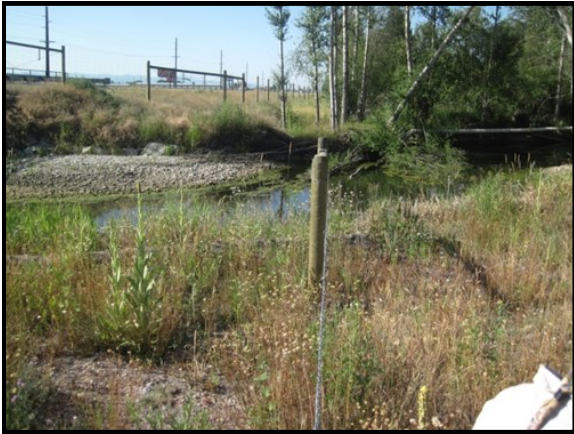
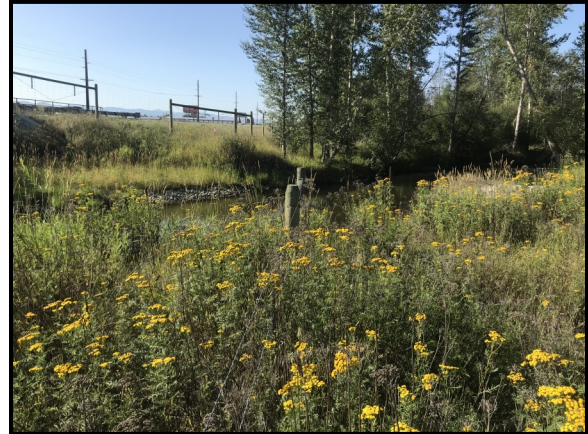
Photo Point 2.2: View from west side of bridge looking across stream channel. **Compass:** 225 (Southwest)

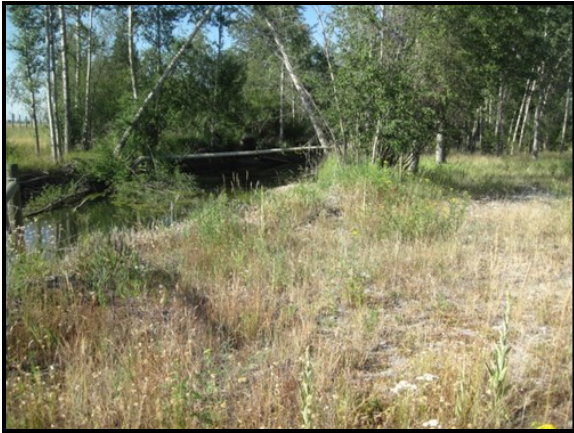
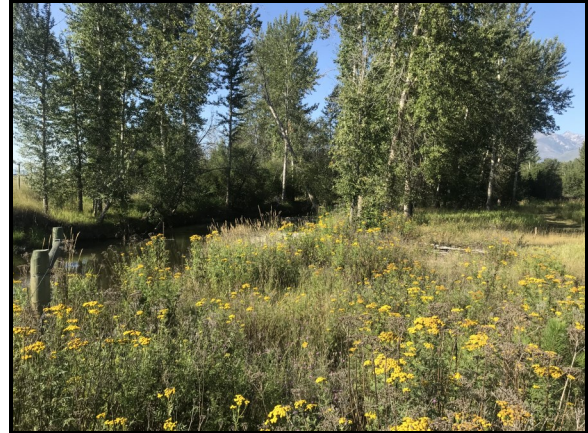
Photo Point 2.3: View from Photo Point 2 looking upstream. **Compass:** 248 (West-Southwest)

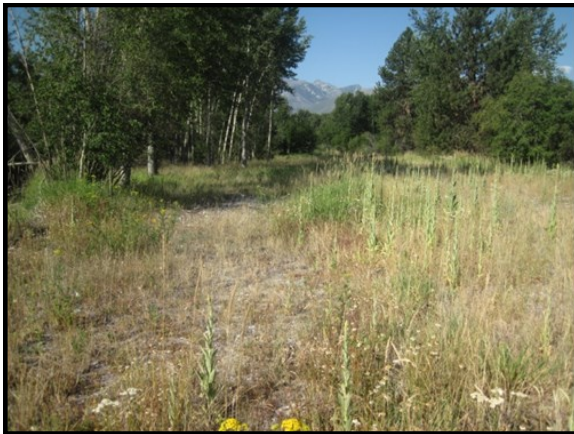
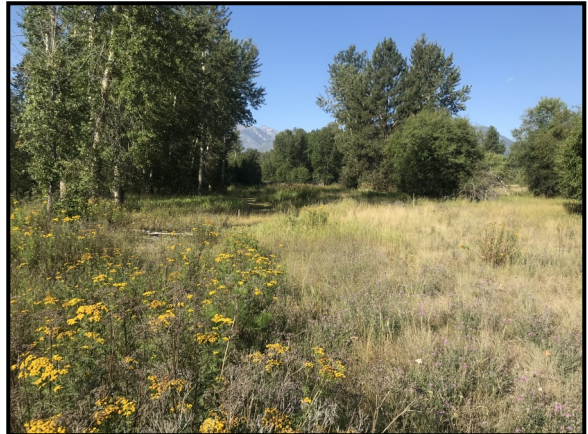
Photo Point 2.4: View of deactivated channel alignment **Compass:** 270 (West)

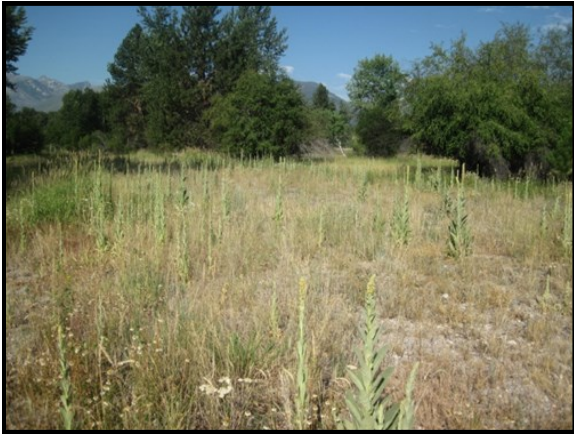
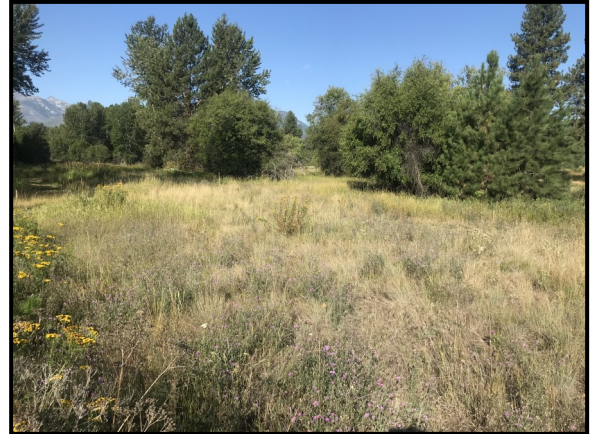
Photo Point 2.5: View of deactivated channel alignment. **Compass:** 248 (West-Southwest)

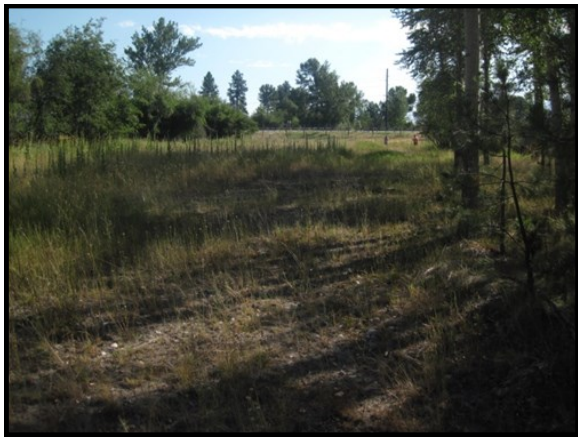
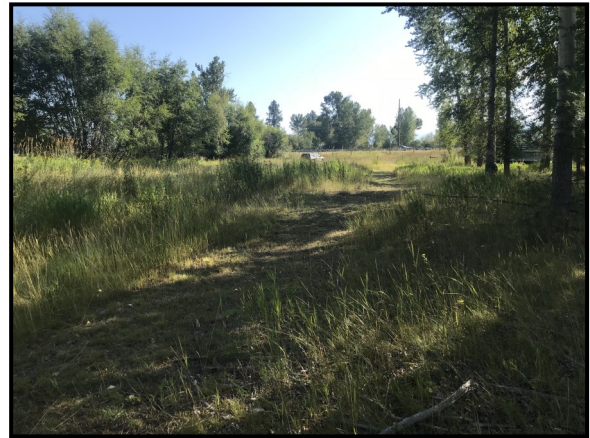
Photo Point 3.1: View of deactivated channel segment from Photo point 3. **Compass:** 68 (East-Northeast)

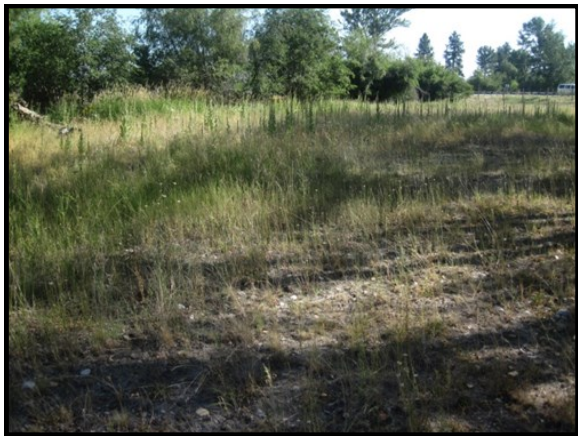
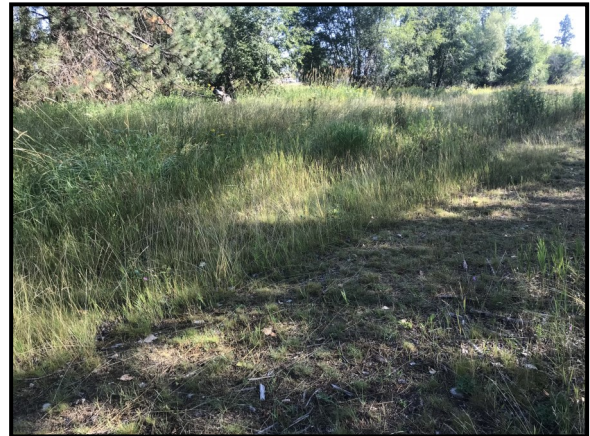
Photo Point 3.2: View of deactivated channel plug. **Compass:** 45 (East)

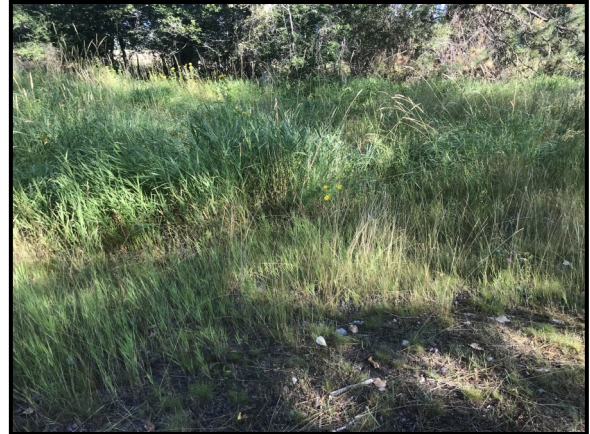
Photo Point 3.3: View of deactivated channel plug from Photo Point 3. **Compass:** 0 (North)

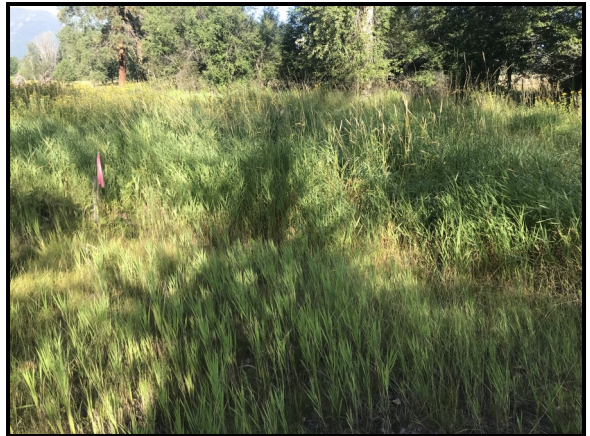
Photo Point 3.4: View of deactivated channel plug from Photo Point 3. **Compass:** 315 (Northwest)

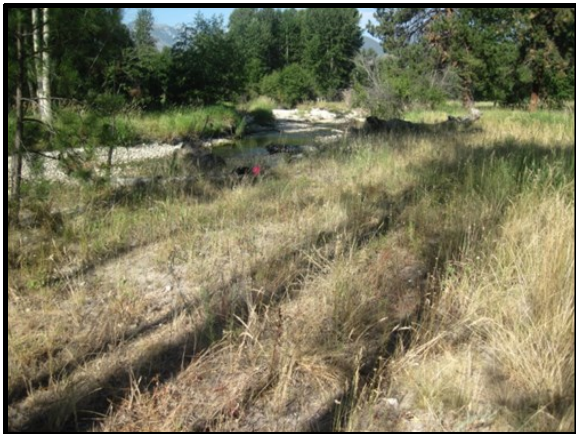
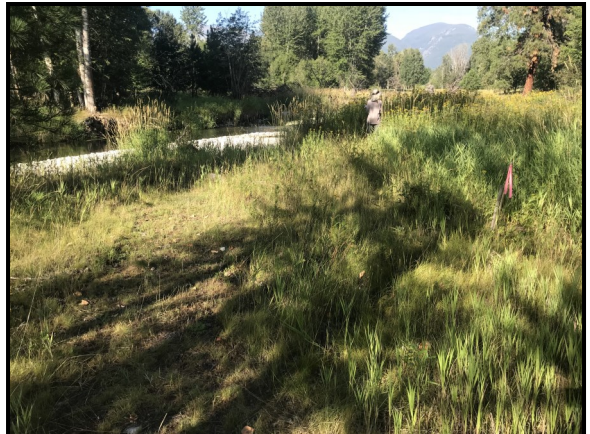
Photo Point 3.5: View of upstream extent of deactivated channel segment **Compass:** 270 (West)

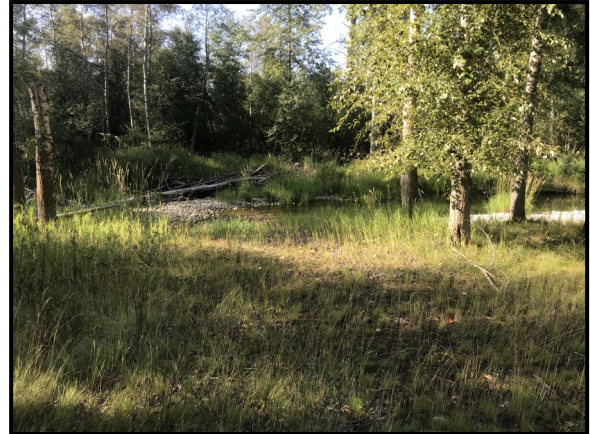
Photo Point 3.6: View of north bank (foreground) and woody debris in the channel. **Compass:** 248 (WSW)

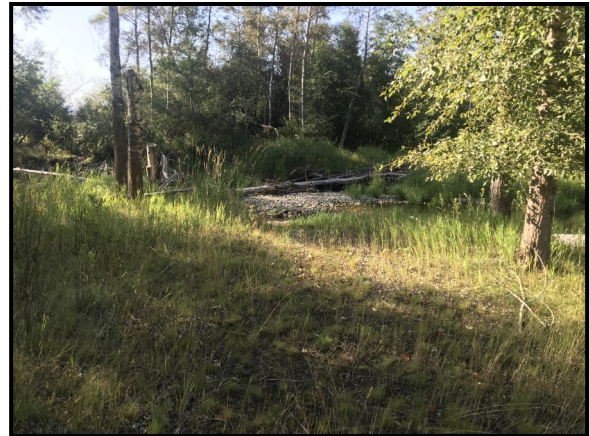
Photo Point 3.7: View of north bank (foreground) and woody debris in the channel. **Compass:** 180 (South)

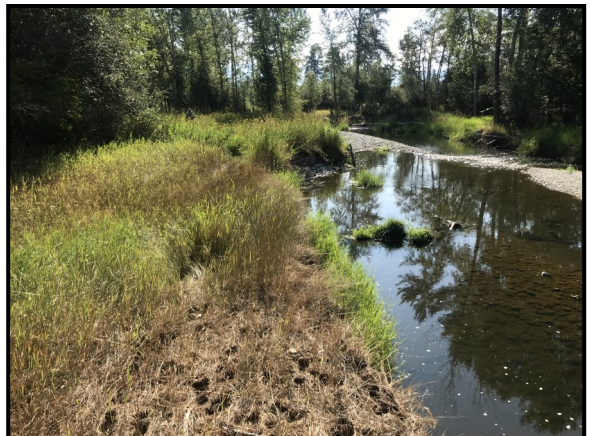
Photo Point 3.8: View looking across deactivated channel segment. **Compass:** 90 (East)

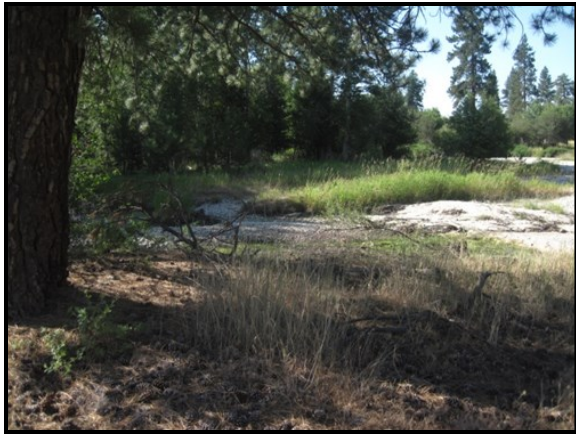
Photo Point 4.2: View across stream channel toward south bank. **Compass:** 180 (South)
Note: toppled Ponderosa pine tree obscures view on left side of photo

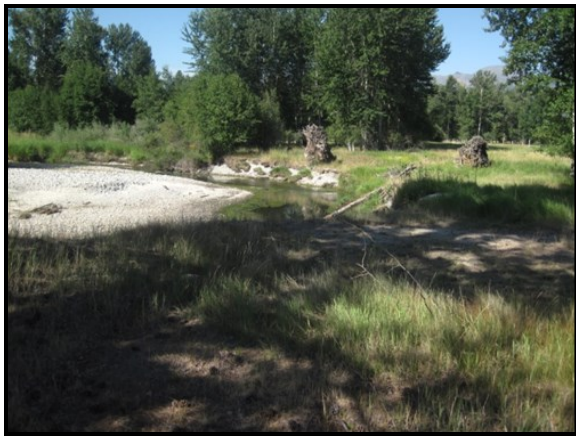
Photo Point 4.3: View of point bar formation from Photo Point 4. **Compass:** 225 (Southwest)

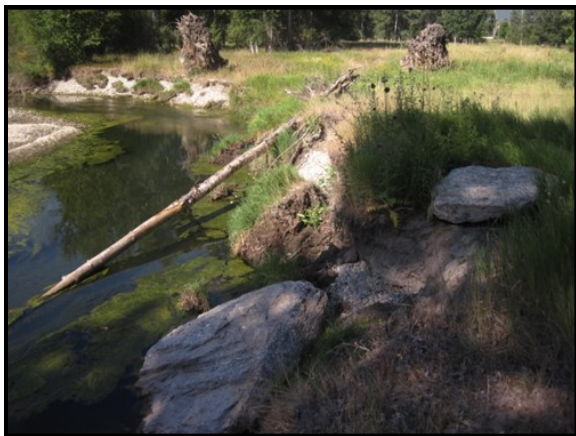
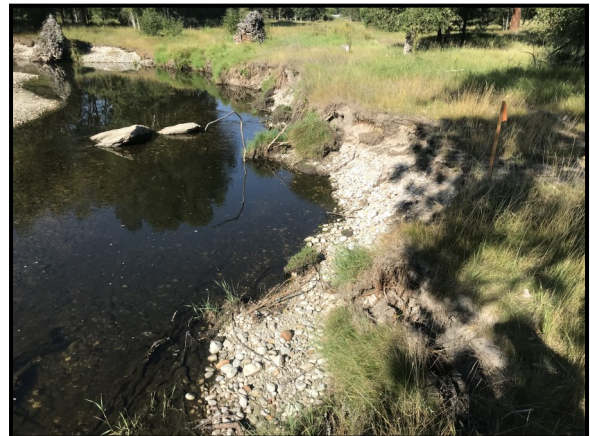
Photo Point 4.4: View of boulders, logs, and root wads placed on bank. **Compass:** 248 (West-Southwest)

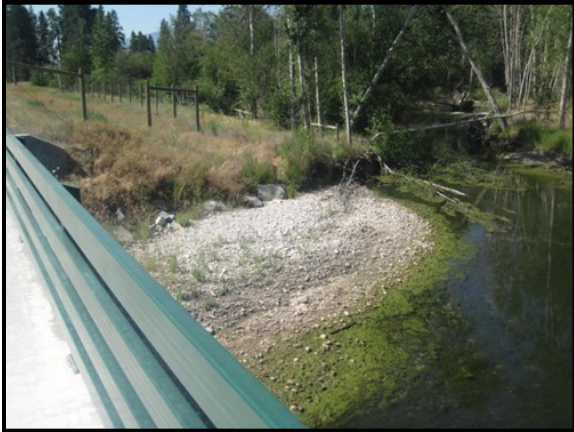
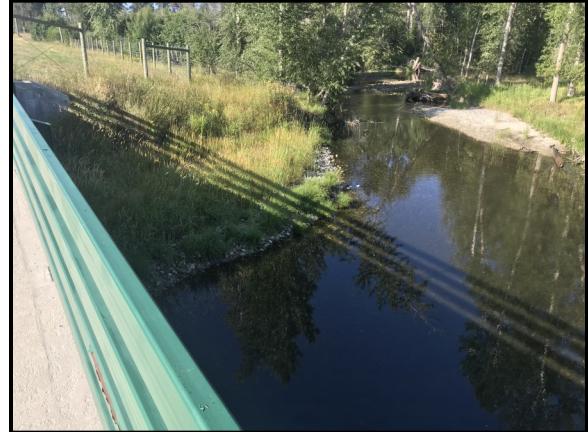
Photo Point 5.1: View looking upstream of south bank taken from bridge. **Compass:** 248 (West-Southwest)

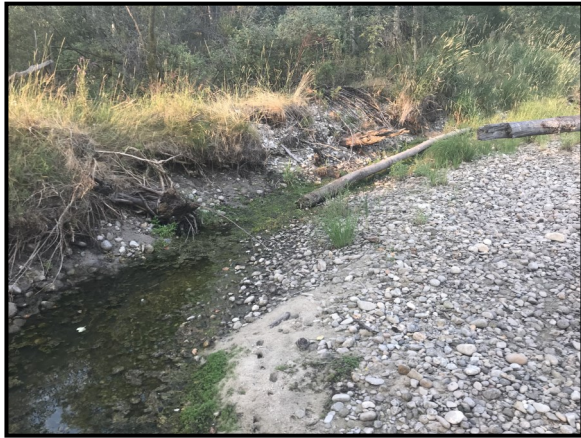
Additional Photo 8: Eroding Bank EBR3

Eroding bank EBR3 was observed in 2017 adjacent to a woody debris jam and was characterized by upper bank sloughing and toe scour. Vegetation along the upper bank includes reed canary grass, oxeye daisy, woods rose, wheatgrass, brome, small cottonwood saplings, and young willows. The bank appeared to retreat by approximately 1 foot or less during high flows in 2018 or 2019, as the adjacent debris jam broke up and a gravel bar has developed adjacent to the bank (Additional Photo 8 in Appendix C). Given the bank's relatively slow retreat rate and the lack of adjacent infrastructure or fencing, corrective actions are not warranted along this bank at this time.
