# STRUCTURE INSPECTION REPORT

Structure # 03719  
BITTERROOT RIVER 010 - W MISSOULA

## Bridge Inspection Date: 06/21/2021

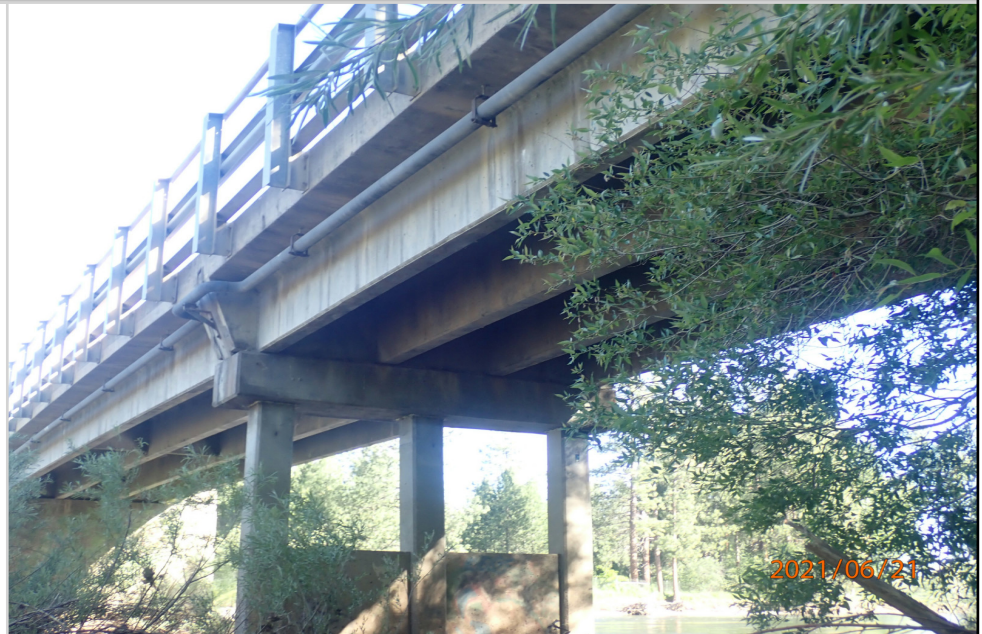
**Photo #:**Underside of Spans 3 and 4, Looking NW Location: ,  
Comments:

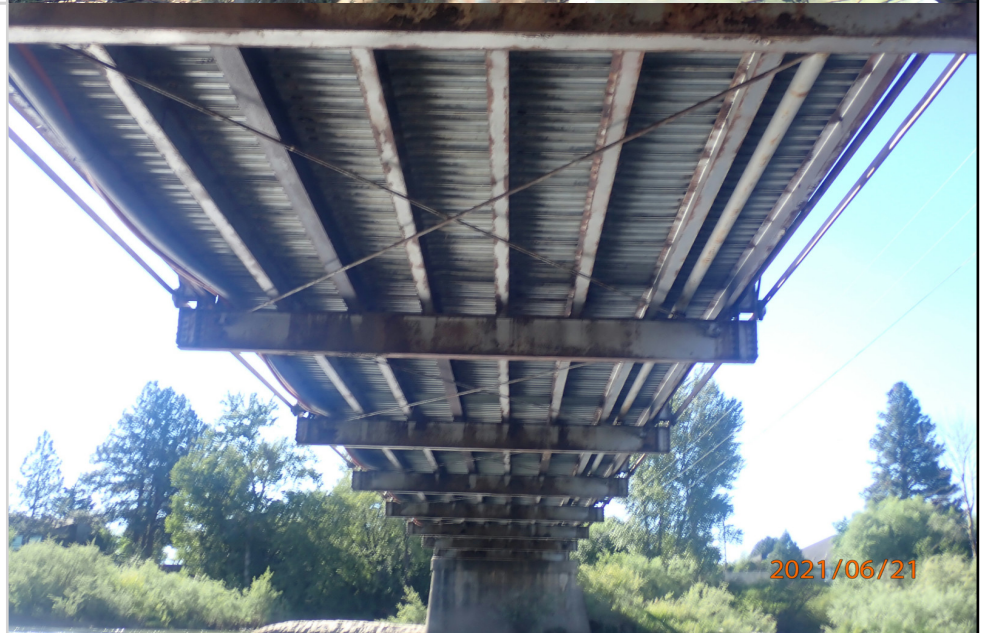
**Photo #:**Underside of Span 1, Looking E Location: ,  
Comments:

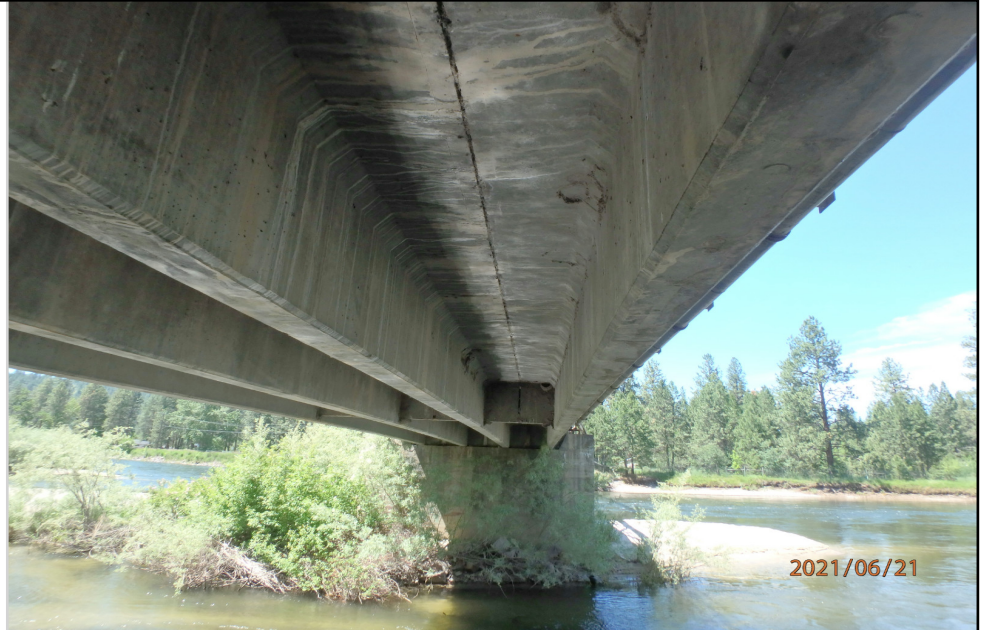
**Photo #:** Span 3 Typical  
Underside, Looking West  
Location: , Comments:

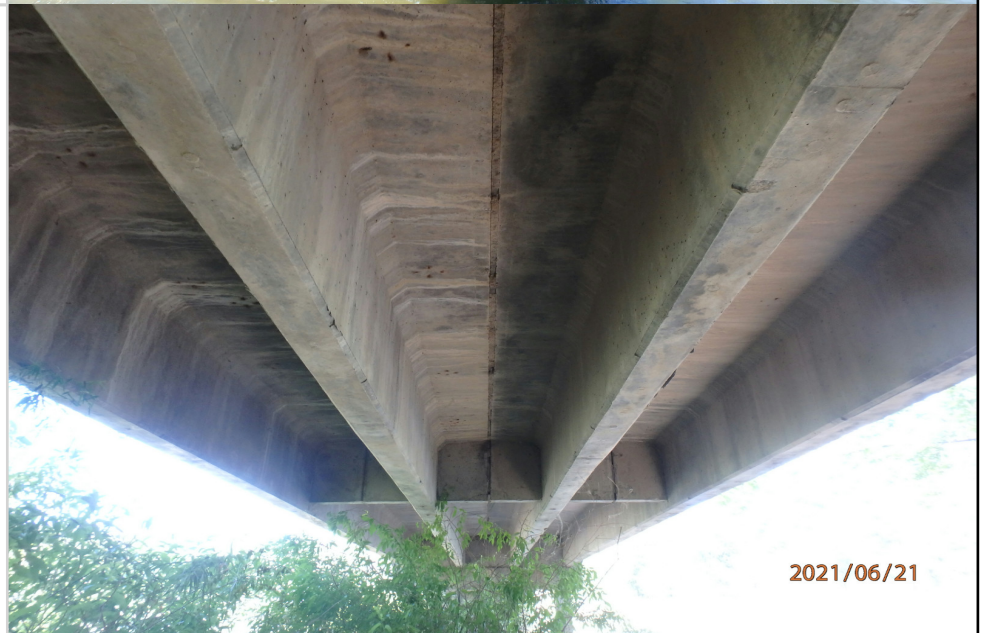
**Photo #:** Typ. Underside Span 4,  
Looking West Location: ,  
Comments:

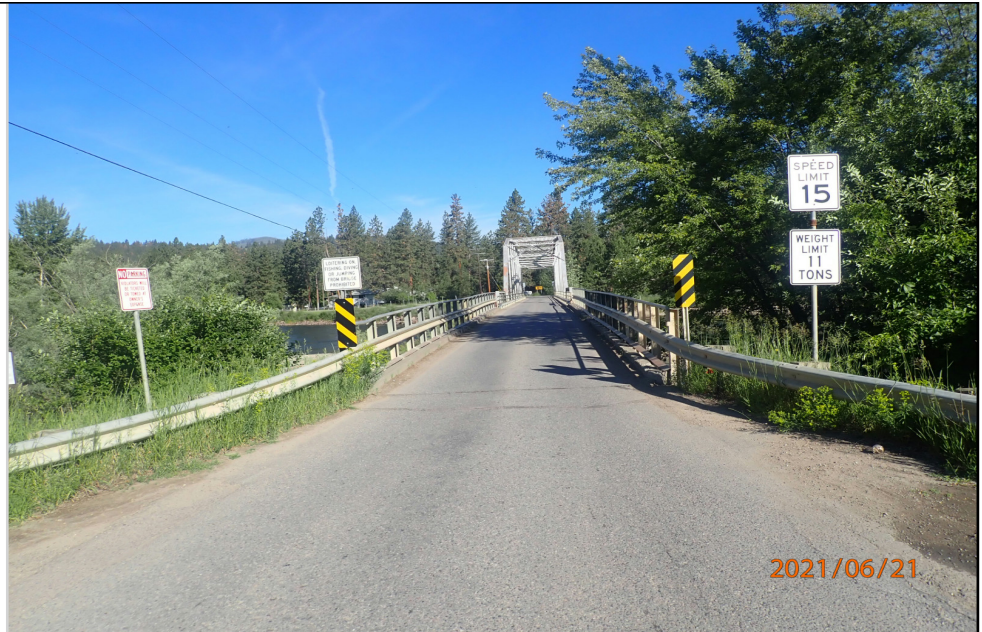
**Photo #:** Roadway, Looking W  
**Location:** , **Comments:**

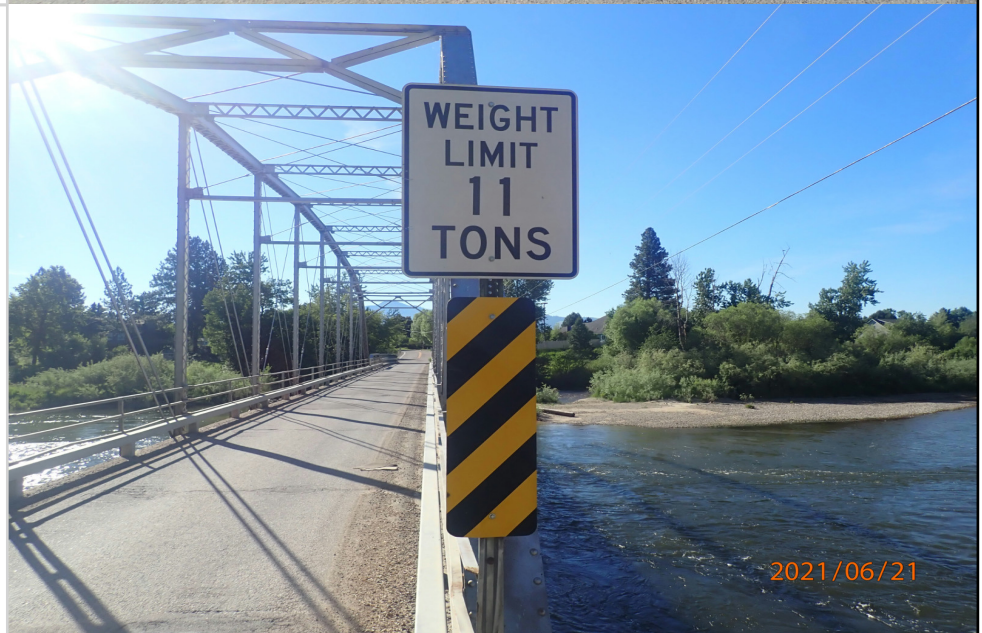
**Photo #:** West Load Posting,  
Looking E **Location:** , **Comments:**

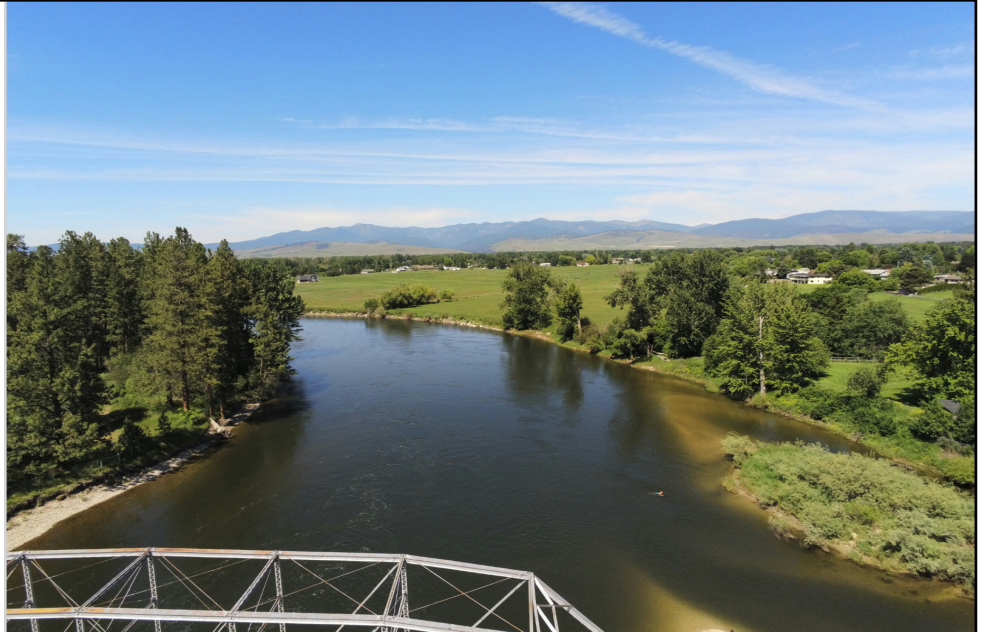
**Photo #:**Downstream Channel,  
Looking N Location: ,  
Comments:

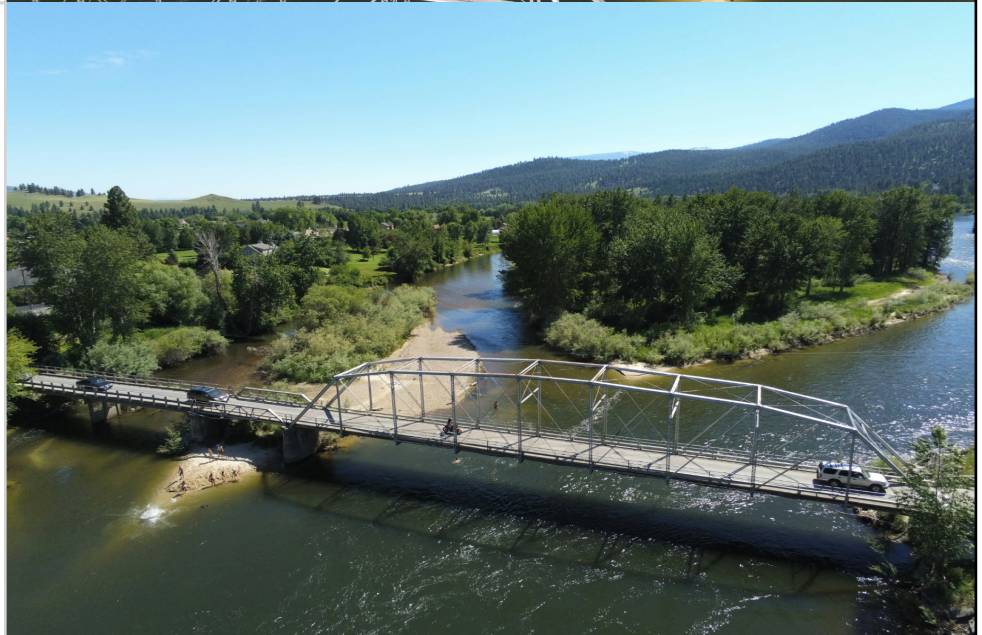
**Photo #:**Elevation, Looking S  
Location: , Comments:

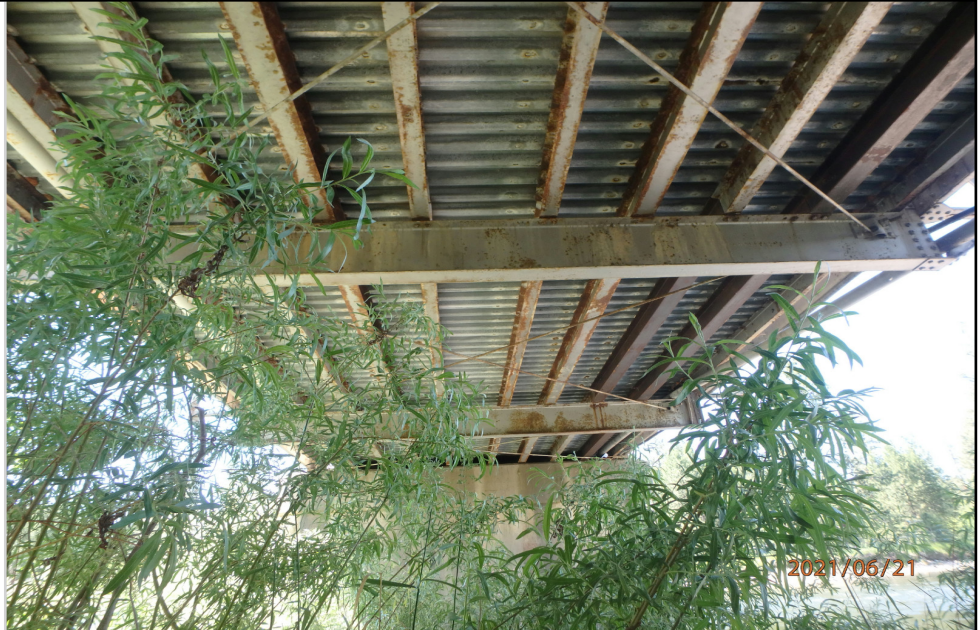
**Photo #:** Typical Underside Span  
2, Looking W Location: ,  
Comments:

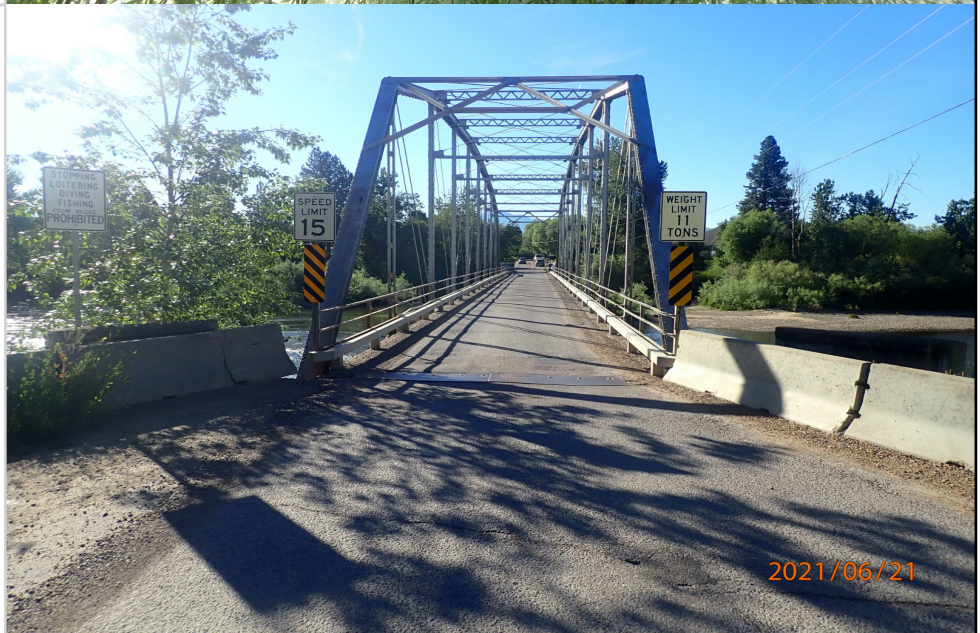
**Photo #:** Roadway, Looking E  
Location: , Comments:

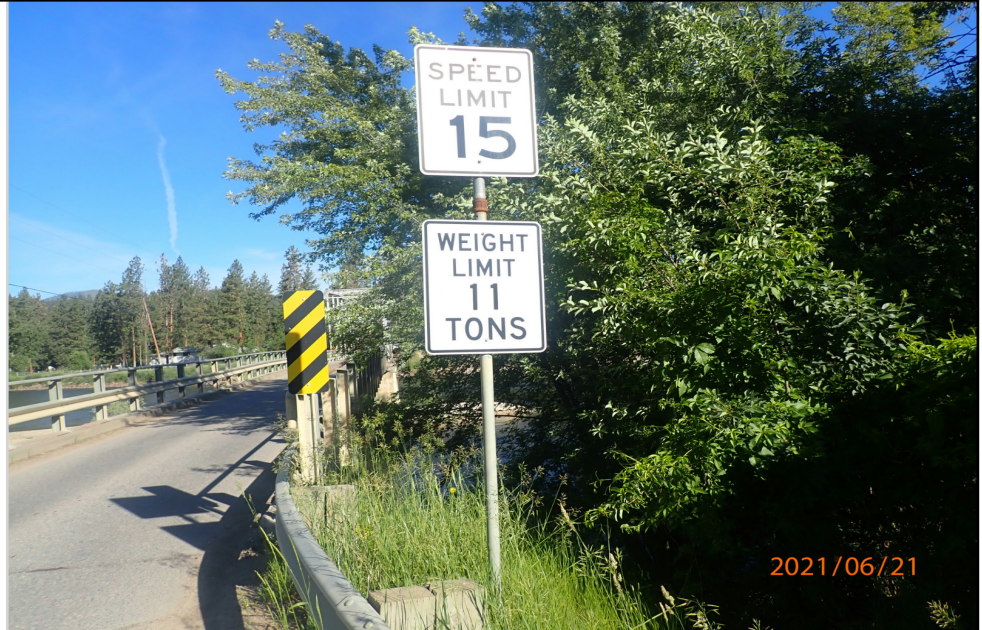
**Photo #:**East Load Posting,  
Looking W Location: ,  
Comments:

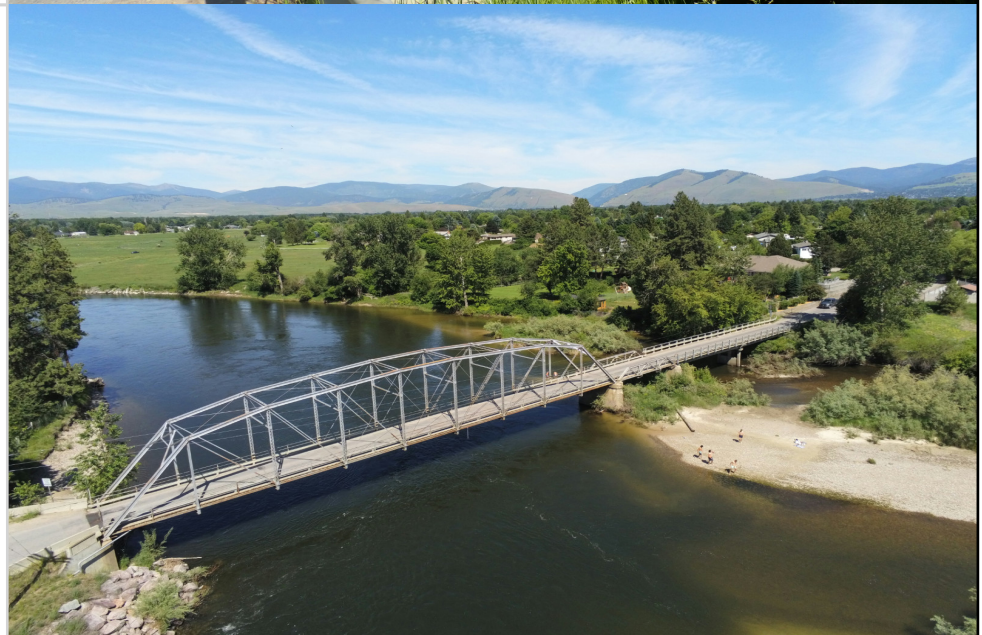
**Photo #:**Elevation, Looking NE  
Location: , Comments:

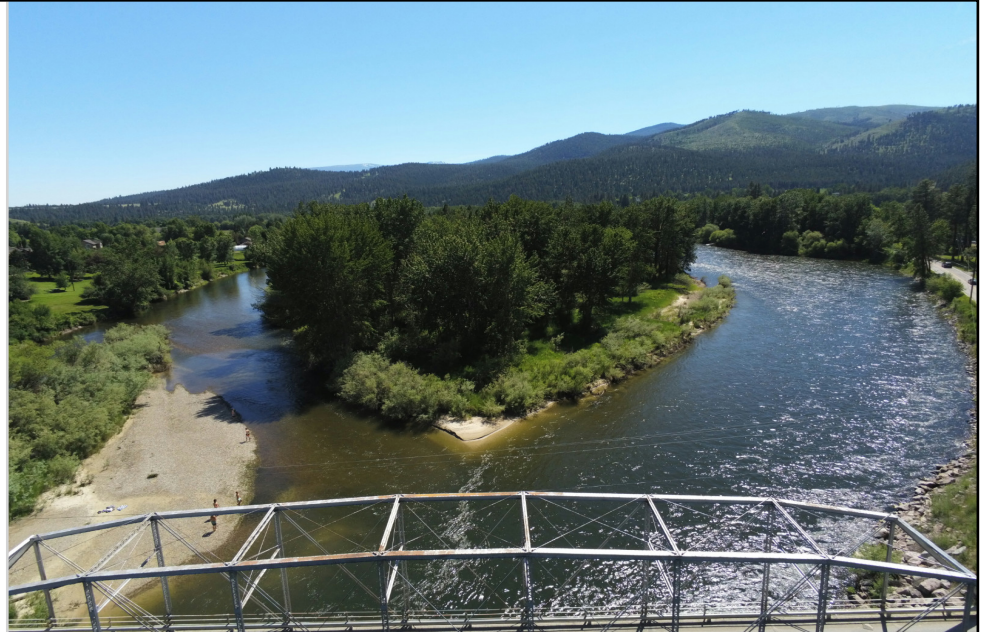
**Photo #:**Upstream Channel,  
**Looking S Location:** ,  
**Comments:**

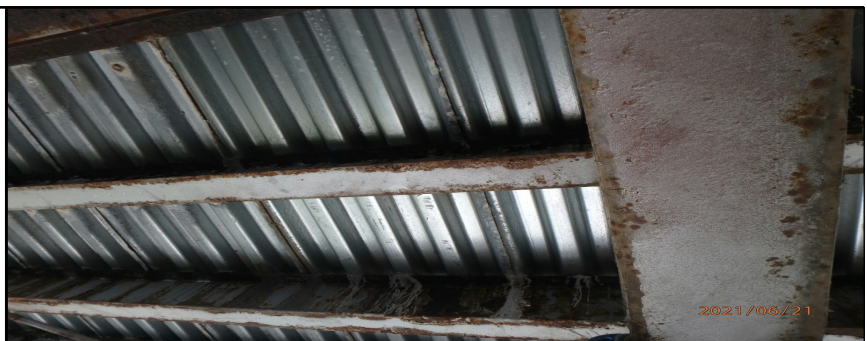
Approximately 1 percent of the corrugated stay-in-place forms had welding burn through with minor surface corrosion and negligible section loss. Condition State 2 : 1  
The corrugated deck exhibited an area of longitudinal and transverse cracking above Stringer 3 at FB3' with 90-100% section loss and multiple holes in an area measuring 18 in. long by 12 in. wide and associated cracking in the corrugated forms in the area surrounding the holes measuring 30 in. long by 24 in. wide. (6 SF)  
The corrugated deck exhibited an area of longitudinal and transverse cracking above Stringer 6 at FB2' with a hole measuring 2 in. in diameter and associated cracking in the corrugated forms extending 1 ft. to the east and west of the hole. (2 SF) Condition State 4 : .28  
Approximately 5 percent of the corrugated stay-in-place forms had welding burn through allowing debris to fall through the formwork. Condition State 3 : 1

Photo #:Span 1 Corrugated Deck Repair at FB3', Looking SE

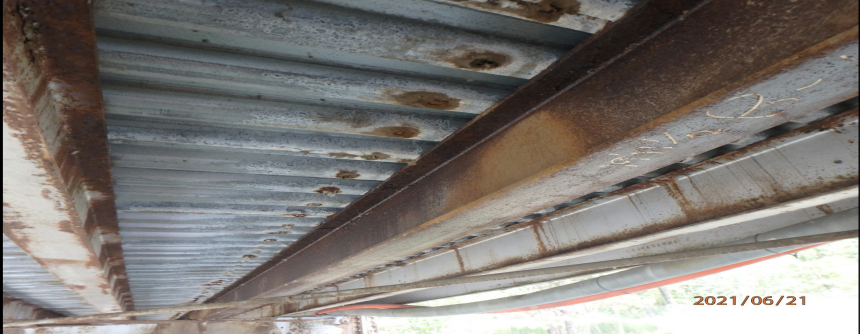
Approximately 5 percent of the corrugated stay-in-place forms had welding burn through allowing debris to fall through the formwork. See photo in Main Span 1 Deck defect for typical view of burn through areas. Condition State 3 : 1

Span 2: There were areas of surface corrosion on the underside of the deck, concentrated at the welding burn through holes. (Overlaps with CS3 Damage defect.)  
Span 1: There were areas of surface corrosion on the underside of the deck, concentrated at the welding burn through holes. (Overlaps with CS3 Damage defect.)  
Span 2: Approximately 5% of the underside of the corrugated metal deck exhibited welding burn holes.  
Span 1: Previously noted areas of cracking and through holes in the corrugated deck located at Floor Beam 2' and Floor Beam 3' have been patched.  
Span 1: Approximately 5 percent of the underside of the corrugated metal deck exhibited welding burn holes. See Span 2 - Pony Truss - CS3 Damage defect for typical photo.

Element #	Parent Element	Name	Unit	Quantity	%CS 1	%CS 2	%CS 3	%CS 4
<p>Photo #:Span 2 Typical Perforations in Corrugated Deck, Looking E</p> <p>Location:</p> <p>Comments:</p> <p>Element:30 - Steel Corrugated or Orthotropic Deck (SF)</p>

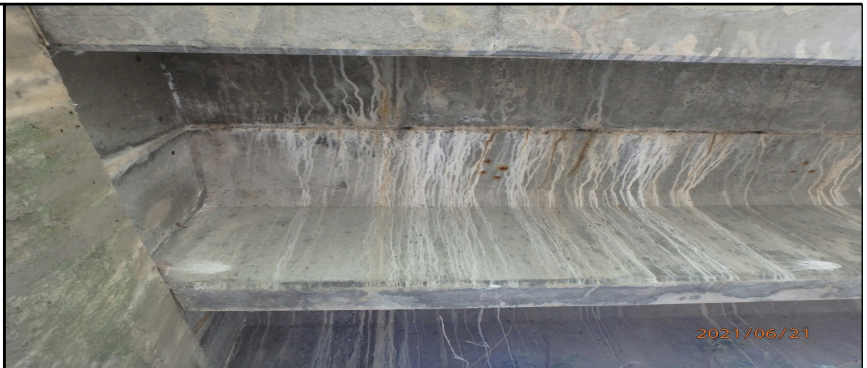
The tee beams in Spans 3 and 4 exhibited light efflorescence seeping through the construction joints. Condition State 2 : 10.22

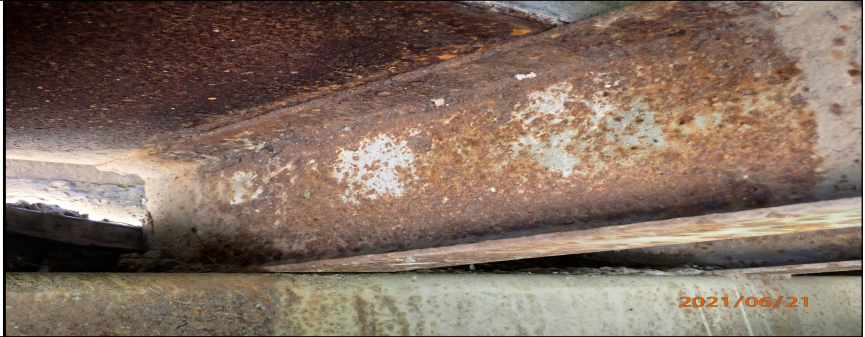
CS3/CS4 Stringers 2 and 5 over Bent 2 and Stringers 2, 5, 7, and 8 over Bent 3 had heavy corrosion with areas of through corrosion. See 2019 FC Inspection Report for table of measurements. (CS3 - 8 LF, CS4 - 6 LF) Condition State 3 : 2.55  
The unpainted stringer had minor to moderate corrosion with negligible section loss. Condition State 2 : 100  
The stringers had failed paint along their entire length with minor surface corrosion and negligible section loss.  
Condition State 2 : 94.59  
The stringer bearing tube at Bent 3 had a broken anchor rod at the south end. Condition State 3 : .32  
Stringers 4, 5, and 7 had gaps between the bottom flange and the stringer bearing tube at Bent 3. When vehicles drove over the bridge, the bearing tube was observed typically moving up to 1/4 in. and up to 1/2 in. at the south end. Condition State 3 : .64  
CS3/CS4 Stringers 2 and 5 over Bent 2 and Stringers 2, 5, 7, and 8 over Bent 3 had heavy corrosion with areas of through corrosion. See 2019 FC Inspection Report for table of measurements. (CS3 - 8 LF, CS4 - 6 LF) Condition State 4 : 1.91

Photo #:Span 2 Stringer 3 at Bent 3  
Corrosion, Looking SE

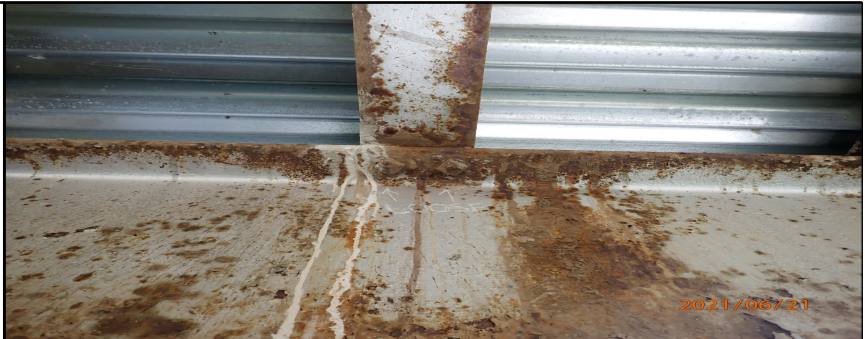
Span 1: (2) of 2 loose bolts at Floor Beam 3' to Stringer 1 and Floor Beam 3 to Stringer 6 connections. (2 LF CS3)  
 Span 1: There was a 1/4 in. gap at Stringer 5 between its bottom flange and the Abutment 1 beam seat, and the stringer deflected under live load. See video of movement uploaded to Inspection Documents. (1 LF CS3)  
 Span 1: Stringers 4, 5, and 6 over Abutment 1 exhibited delamination up to 1/8 in. thick on the webs and flanges extending from the west end for up to 1/2 the span length. (30 LF CS3)  
 Span 1: The stringers had failed paint along their entire length with minor surface corrosion.  
 Span 1: Stringers 2 and 7 at Abutment 1 exhibited heavy corrosion in the webs with through holes at the bearing locations. See 2021 Fracture Critical Inspection Report, Table 3, for specific locations and extents. (4 LF CS4)  
 10-19-2021: after phone conversation with County about concerns at bent 1 in the stringer section loss, data updated: stingers 2, 4 (new) and 7 have 100% section loss for between 8-12 inches from the end of the stringer aol, between 4-6 inches of solid stringer rest on the cap ahead of the section loss. will increase cs 4 in for defect 1000-element 113. New total quantity 6lf, no other stinger section loss was seen durring data update inspection Kurt Maart mdt.

Photo #:Span 1 Floorbeam 3 Stringer 6  
Loose Bolts, Looking W

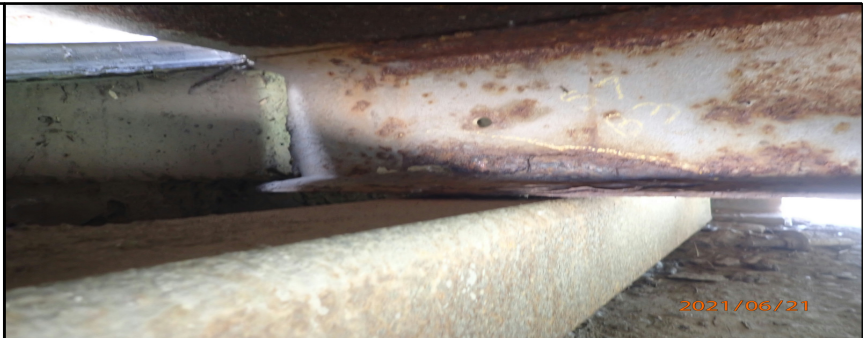
Photo #:Span 2 Stringer 7 at Bent 3  
Section Loss, Looking SE

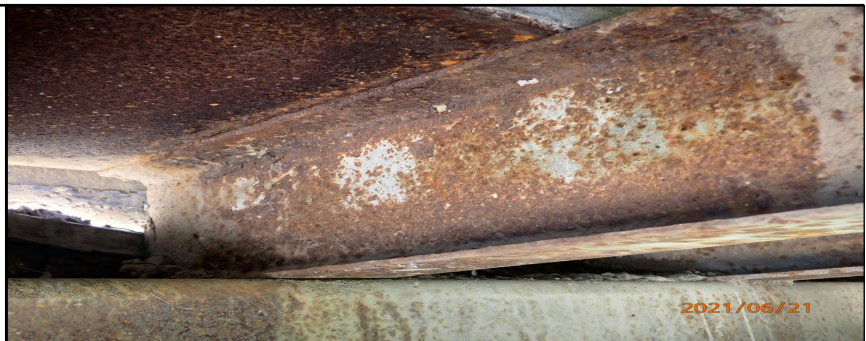
Photo #:Span 2 Stringer 3 at Bent 3 Corrosion, Looking SE

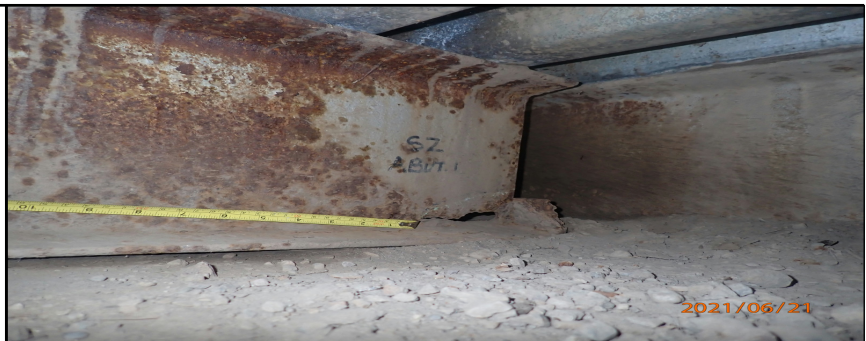
Photo #:Span 1 Stringer 2 at Abutment 1 Corrosion, Looking SW (2)

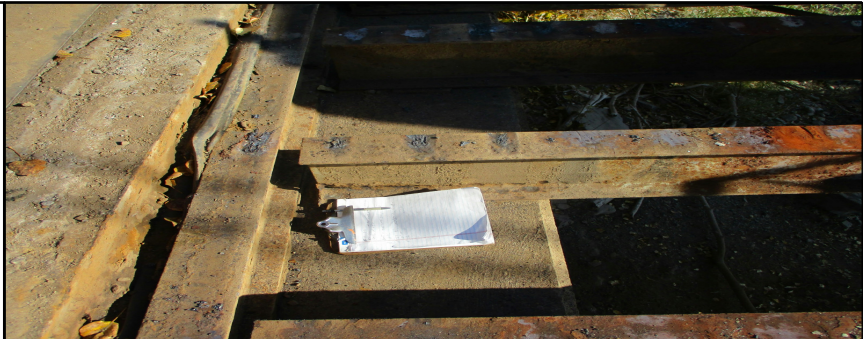
Location: Bent 1 stringer #4

Comments: 100% section loss from end of  
dstringer to 4-6 inches of the cap face.

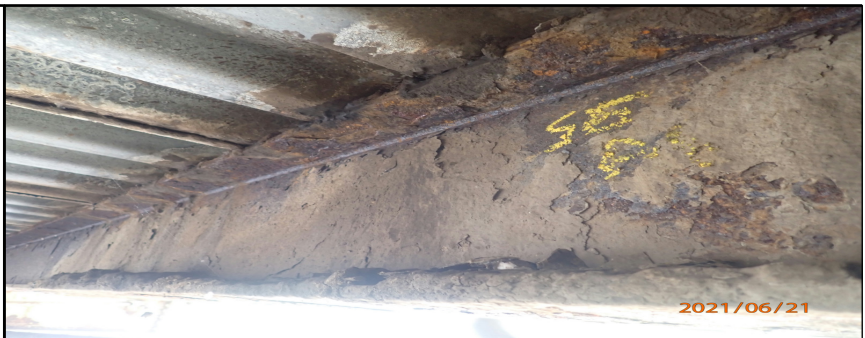
Photo #:Span 1 Stringer 6 at Abutment 1  
Corrosion, Looking SE

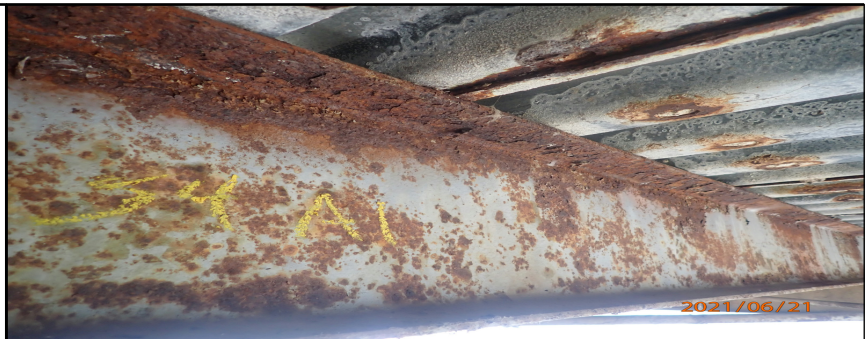
Photo #:Span 1 Stringer 4 at Abutment 1  
Corrosion, Looking NE

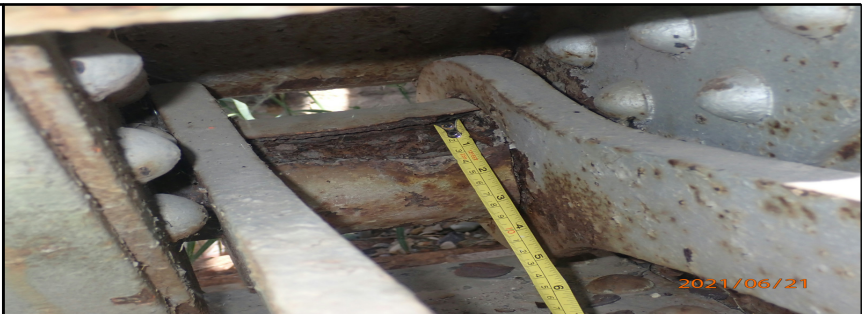
Photo #:Span 1 Pin L0S Pack Rust, Looking W

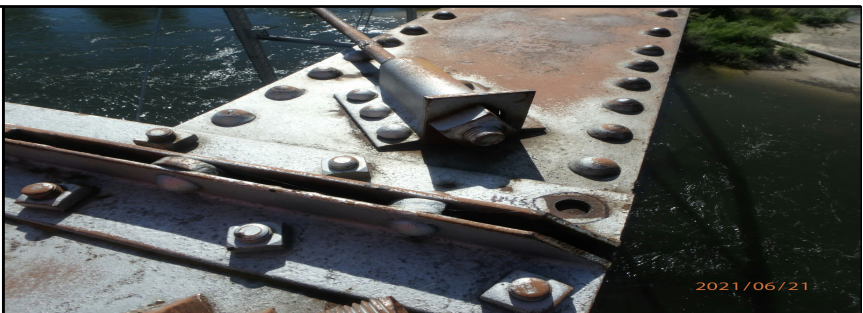
Photo #:Span 1 U4S Sheared bolt at Upper Sway Brace Connection, Looking E

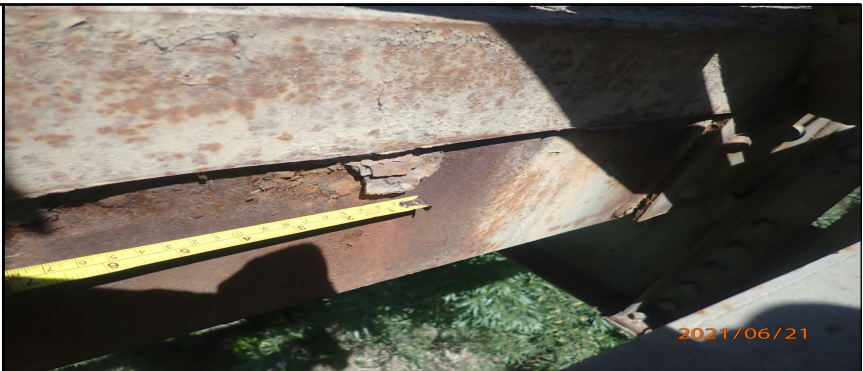
Photo #:Span 2 Lower Chord Typical  
Delamination on Inboard Channel,  
Looking NE

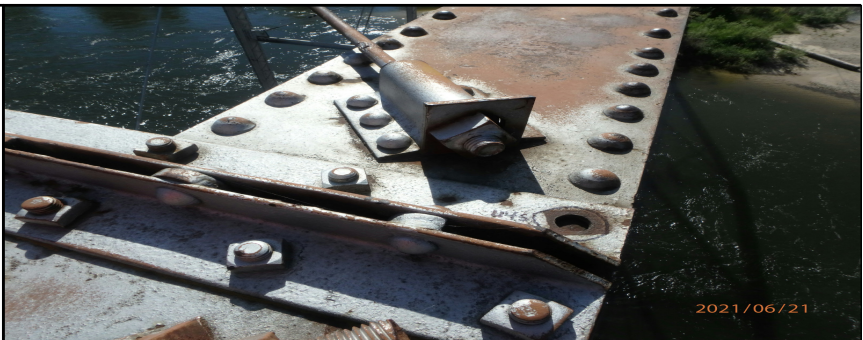
Photo #:Span 1 U4S Sheared bolt at  
Upper Sway Brace Connection, Looking E

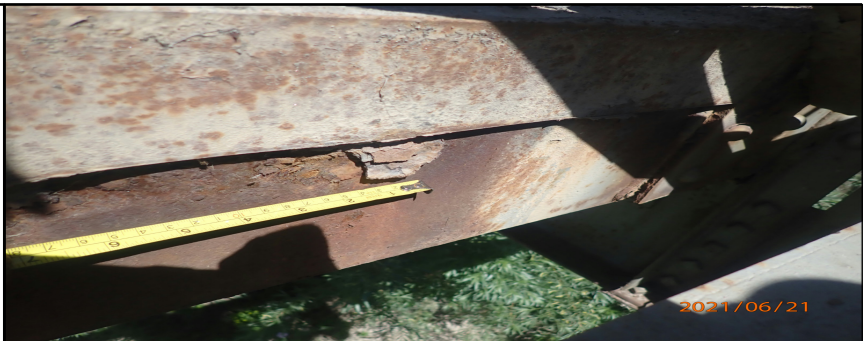
Photo #:Span 2 Lower Chord Typical Delamination on Inboard Channel, Looking NE

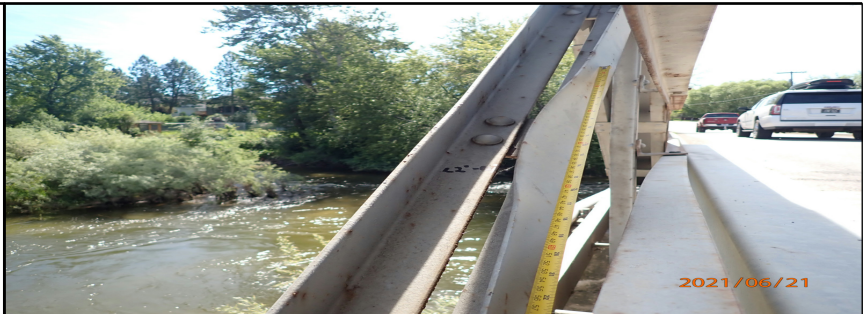
Photo #:Span 2 L2'U1'N Impact Damage, Looking E

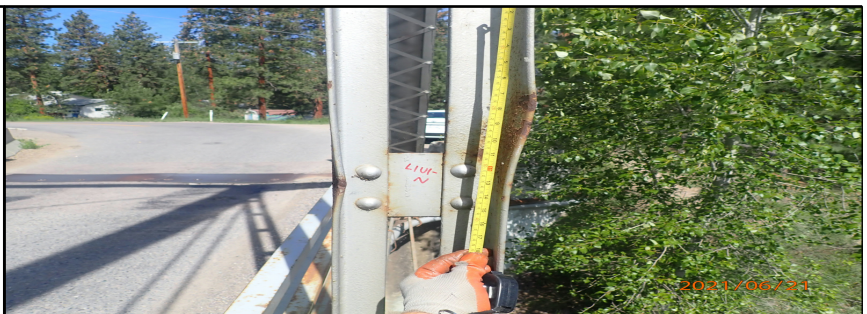
Photo #:Span 1 Vertical L1U1N Damage, Looking W

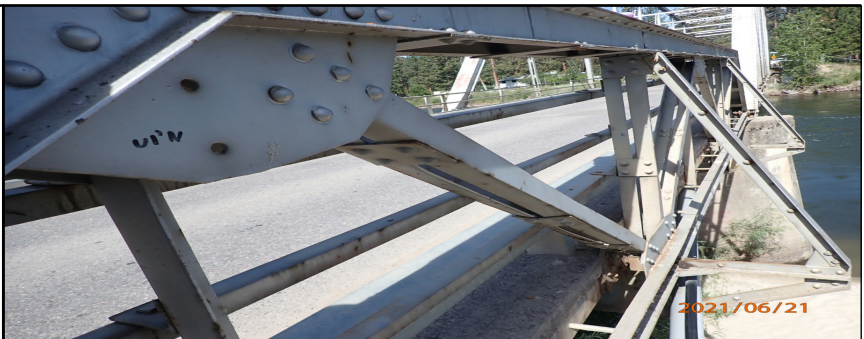
Photo #:Span 2 U1'N Misdrilled Holes, Looking SW

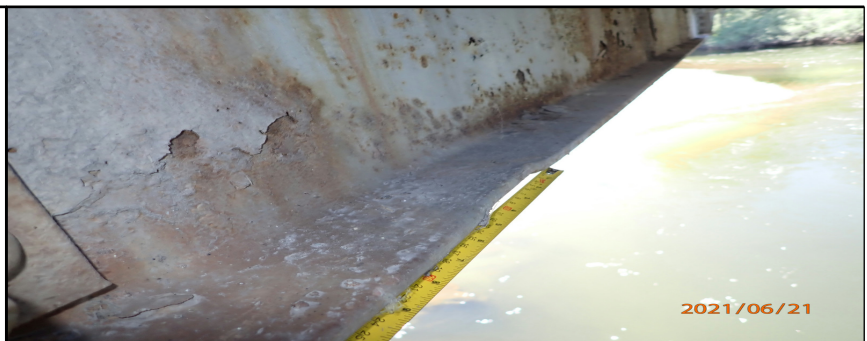
The bottom west flange of Floor Beam 1' on Span 1 had bent upwards 1/2 in. over a 6 in. length approximately 16 in. from the north end. Condition State 2 : .62

Photo #:Span 1 Floorbeam 1' Damage, Looking S

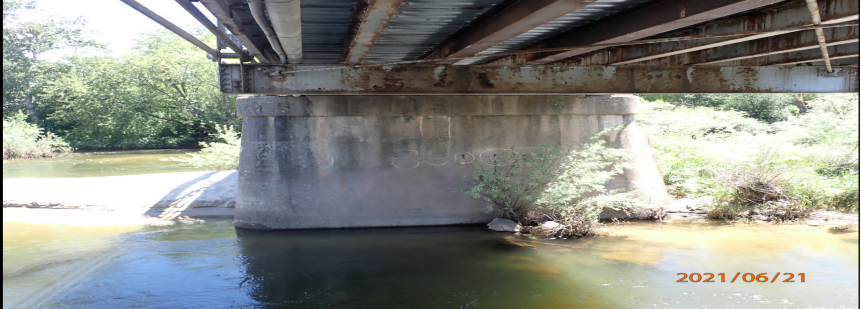
Bent 2: The entire surface of the pier wall had hairline temperature and shrinkage cracks.  
The west elevation of Bent 2 had seven areas of delaminations up to 60 in. wide by 12 in. high, edges had minor spalling up to 1 in. deep.  
The east elevation of Bent 2 had five areas of delaminations up to 15 in. wide by 30 in. wide, edges had minor spalling up to 1 in. deep.

Element #	Parent Element	Name	Unit	Quantity	%CS 1	%CS 2	%CS 3	%CS 4
<p>Photo #:Bent 2 West Face, Looking E</p> <p>Location:</p> <p>Comments:</p> <p>Element:210 - Reinforced Concrete Pier Wall (LF) Bent 3</p>

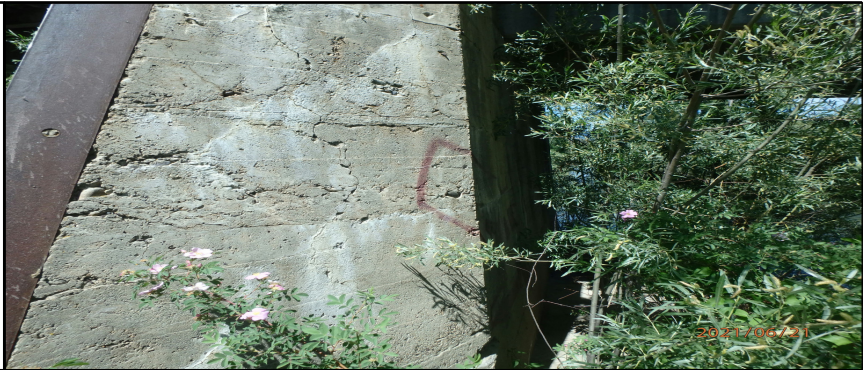
Bent 3 had a 12 in. wide by 10 in. high area of delamination on the top, southeast corner of the bent.  
Bent 3 had random hairline map cracking throughout and a 5 ft. long horizontal crack up to 1/16 in. wide located near the bottom, northeast corner.  
Bent 3: The noses of the pier exhibited light efflorescence.

Photo #:Bent 3 Cracking with Efflorescence on Upstream Nose, Looking N

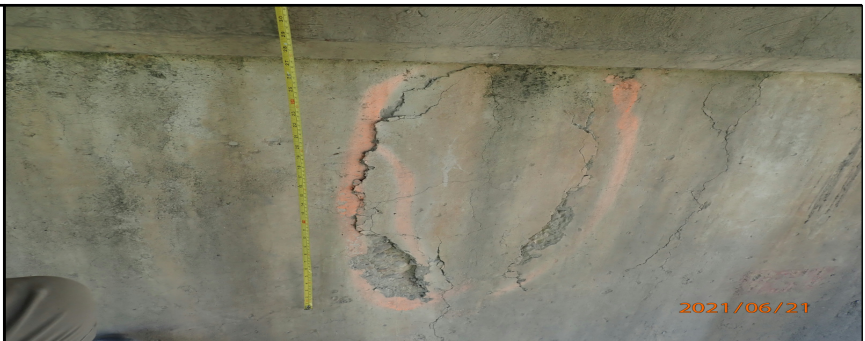
Photo #:Bent 2 East Face Delamination at Top of Pier Wall, Looking W

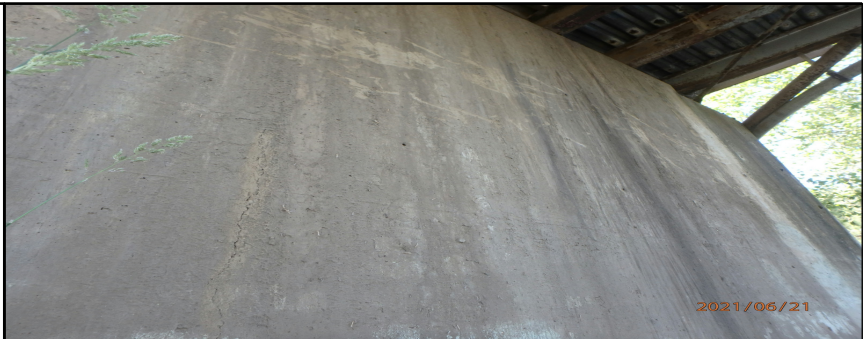
Abutment 1 had one full height, vertical crack up to 1/8 in. wide at the midpoint. Condition State 2 : 1.52

Photo #: Abutment 1 Vertical Crack Near Midpoint, Looking W

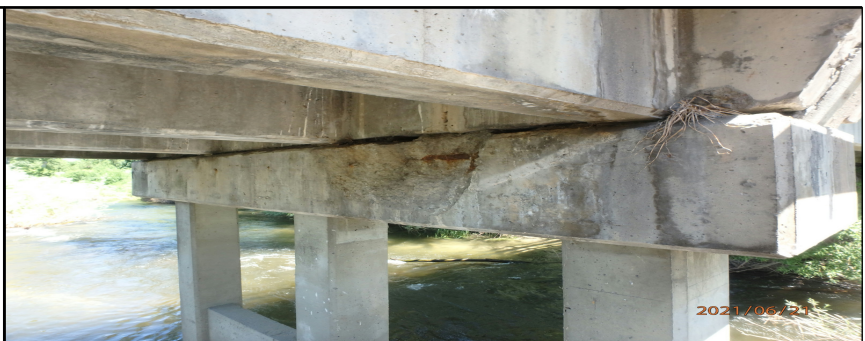
The west face of the Bent 4 cap had a 3 ft wide by 2 ft high by 3.5 in. deep spall with exposed reinforcing steel. (3 LF CS3)

The exposed reinforcing steel in the spalls on the Bent 4 cap had corrosion with up to 5% section loss. See photos in CS3 Spall defect. (2 LF CS3 qty overlaps with CS3 Spall Defect)

Photo #:Bent 4 Spall on West Face of Cap, Looking NE

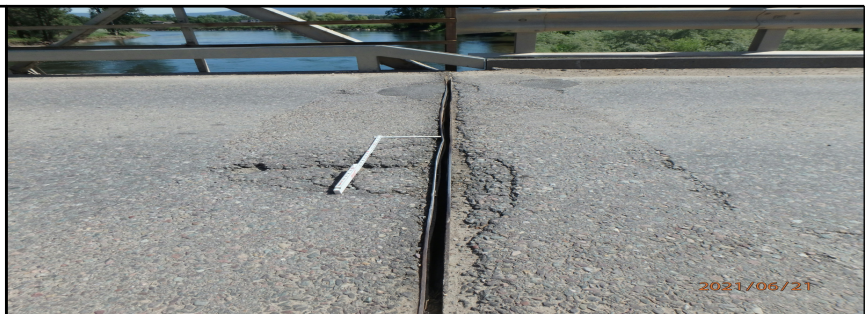
The joint had separated from the Span 2 deck up to 3/4 in. over a 4 ft. length.  
The joint had a 1/2 in. bend over a 6 in. length in the south wheel path. Condition State 3 : 31.25  
The rubber seal had failed over 90 percent of its length. Condition State 3 : 90

The rubber seal had failed over 90 percent of its length.  
The joint had separated from the Span 2 deck up to 3/4 in. over a 4 ft. length. The joint had a 1/2 in. bend over a 6 in. length in the south wheel path. The joint was moving under live load See CS3 Seal Damage defect for photos and see video of Movement in Inspection Documents.  
Compression joint located at Bent 3.

Photo #:Bent 3 Compression Joint Failed Seal and Distortion, Looking N

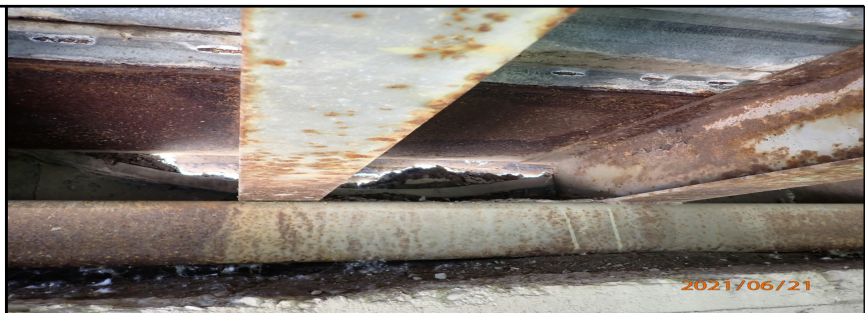
Photo #:Bent 3 Failed Joint, Looking E

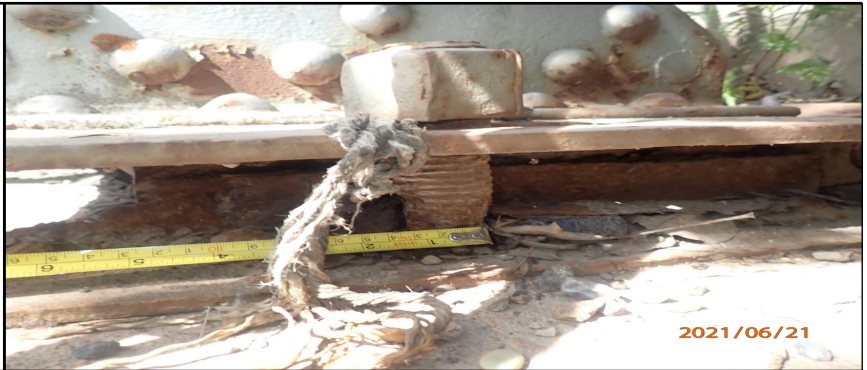
Photo #:Span 1 North Moveable Bearing at Abutment 1 Anchor Rod Section Loss, Looking S

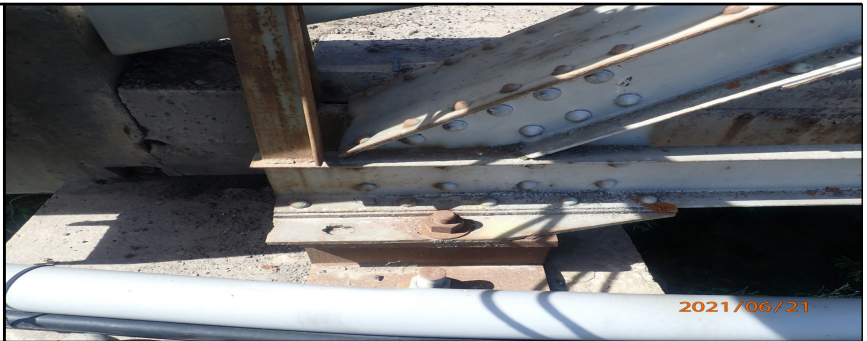
Photo #:Span 2 North Moveable Bearing at Bent 3, Looking S

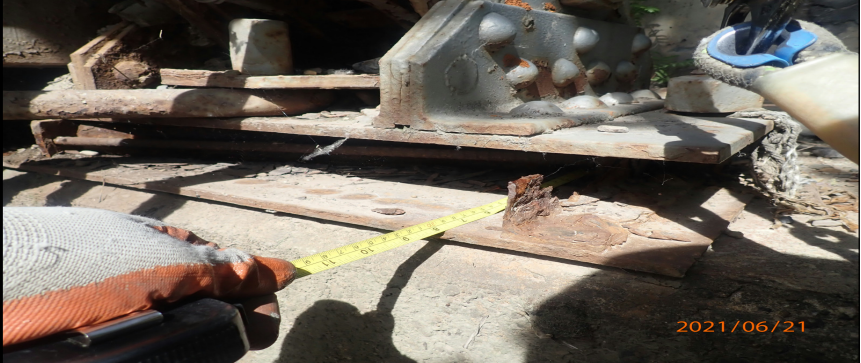
Element #	Parent Element	Name	Unit	Quantity	%CS 1	%CS 2	%CS 3	%CS 4
<p>Photo #:Span 1 North Moveable Bearing at Abutment 1 Rollers Walked Out, Looking SW</p> <p>Location:</p> <p>Comments:</p> <p>Element:311 - Movable Bearing (roller, sliding, etc.) (EA)</p>

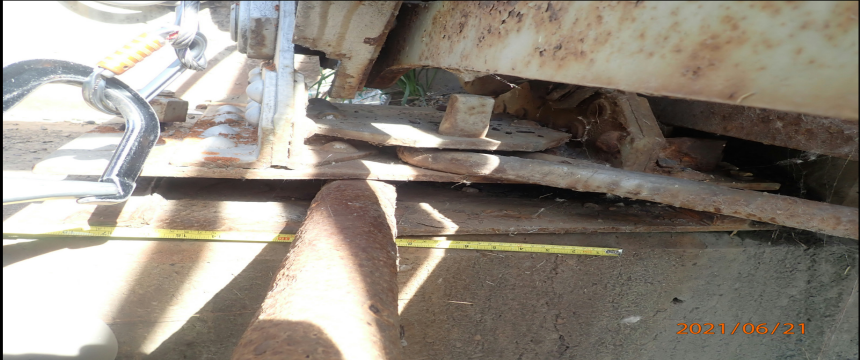
<p>Photo #:Span 1 South Moveable Bearing at Abutment 1 Rollers Walked Out, Looking W</p> <p>Location:</p> <p>Comments:</p> <p>Element:311 - Movable Bearing (roller, sliding, etc.) (EA)</p>

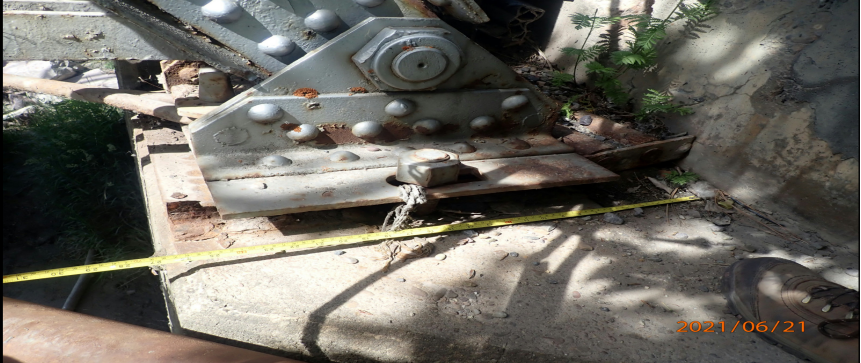
Element #	Parent Element	Name	Unit	Quantity	%CS 1	%CS 2	%CS 3	%CS 4
<p>Photo #:Span 1 North Moveable Bearing at Abutment 1 Rollers Walked Out, Looking S</p> <p>Location:</p> <p>Comments:</p> <p>Element:311 - Movable Bearing (roller, sliding, etc.) (EA)</p>

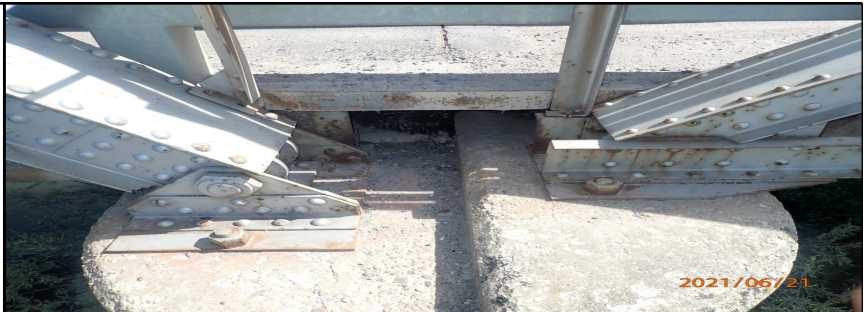
Photo #:Spans 1 and 2 South Fixed Bearings at Bent 2, Looking N

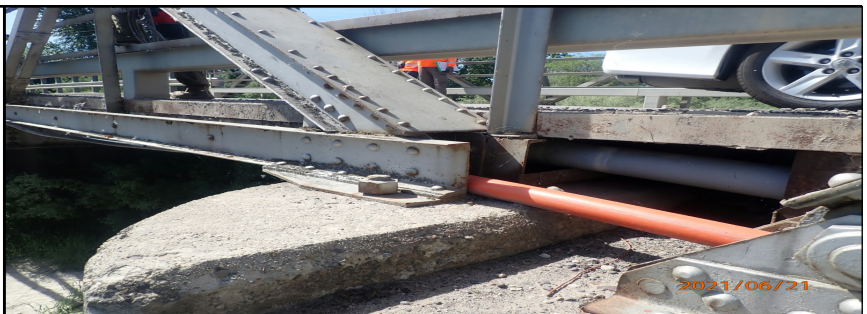
Photo #:Span 2 Northwest Fixed Bearing, Looking SE

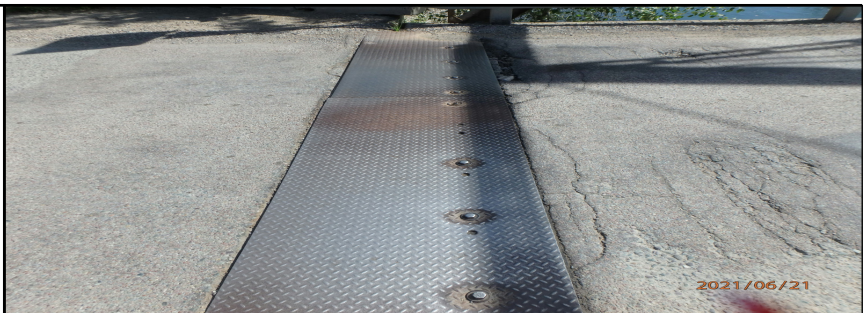
Photo #:Span 1 Wearing Surface Spall at West Joint, Looking N

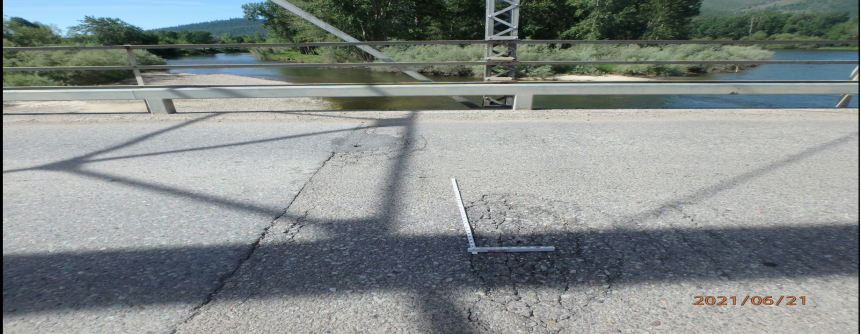
Element #	Parent Element	Name	Unit	Quantity	%CS 1	%CS 2	%CS 3	%CS 4
Photo #:Span 1 Wearing Surface Cold Patch with Map Cracking at FB2', Looking S  Location:  Comments:  Element:510 - Wearing Surfaces (SF)
