MONTANA DEPARTMENT OF TRANSPORTATION STREAM MITIGATION MONITORING REPORT

*Sweathouse Creek
Ravalli County, Montana*

*Year Project Completed: 2011
Monitoring Report #4: December, 2016*

MDT Project Number: NH 7-1(114)59
Control Number: CN 2015004

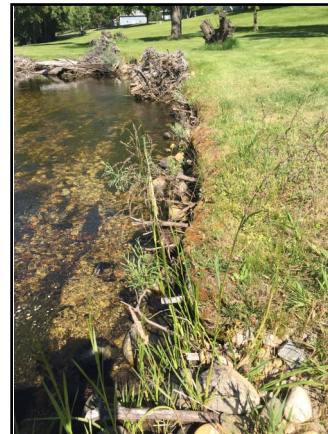
Photo Point 2 —2016

Description: View of un-keyed coir log on south bank
Compass: 90 (East)

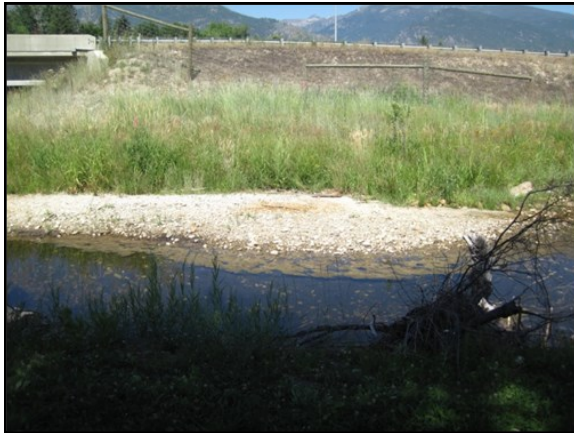
Photo Point 4.2—2013

Description: View of north bank and point bar development. **Compass:** 315 (Northwest)

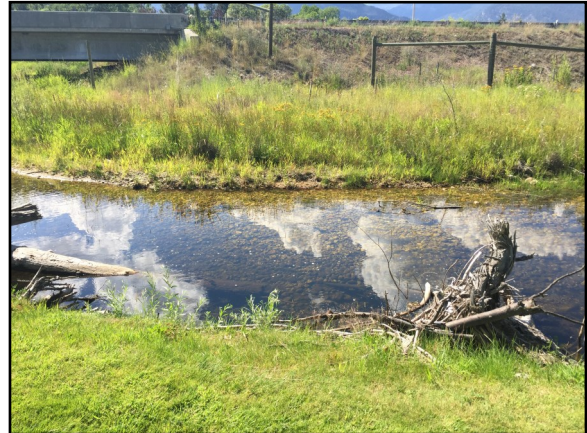
Photo Point 4.2—2016

Description: View of north bank and point bar development. **Compass:** 315 (Northwest)

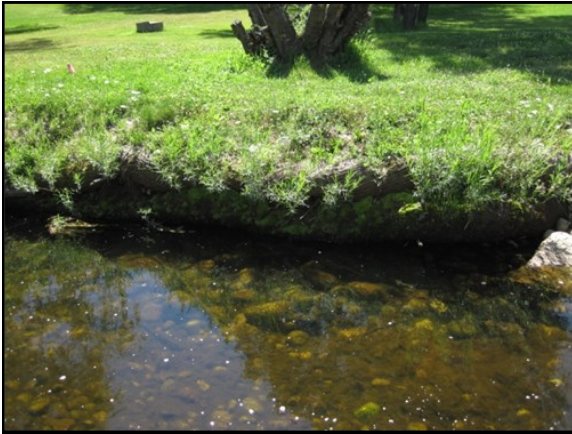
Additional Photo 4 - 2013

An erosion inventory conducted along both stream banks revealed no new erosion in 2016. In 2014, erosion was noted along a short segment of the right (south) bank where one of the coir logs separated from the bank and washed downstream. Monitoring of the site during the past two years has indicated no further bank erosion at this location (see Additional Photos 4 and 5 in Appendix C).

Description: Eroding Bank EBR1 prior to bank collapse **Compass:** 90 (East)

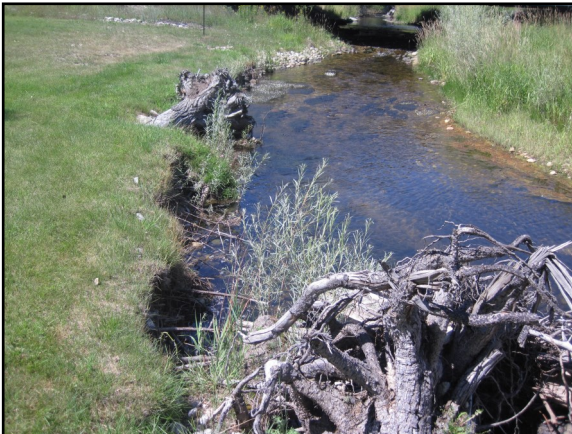
Additional Photo 5: Eroding Bank EBR1 - 2015

Description: Looking upstream toward Highway 93 bridge from south bank.
