MONTANA DEPARTMENT OF TRANSPORTATION STREAM MITIGATION MONITORING REPORT

*Mill Creek
Ravalli County, Montana*

*Project Constructed: 2011
Monitoring Report #5: December, 2017*

MDT Project Number: NH7-(114)59
Control Number: 2015004

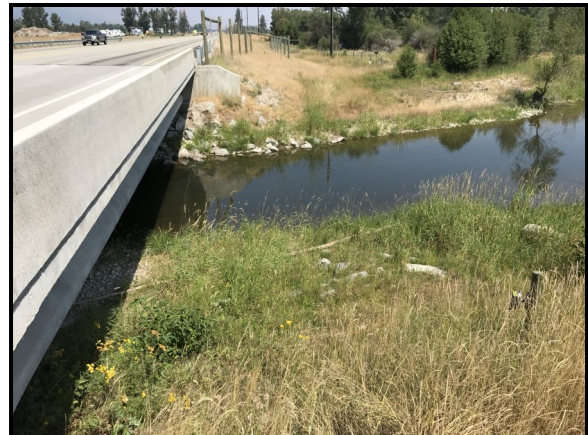
Photo Point 1.1: View east (downstream) of Hwy 93 Bridge. **Compass:** 45 (Northeast)

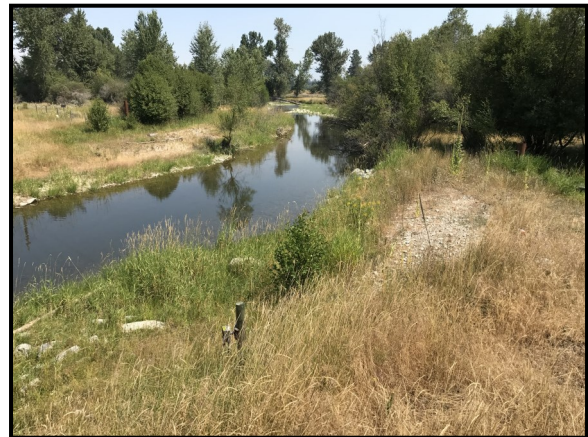
Photo Point 1.2: View from southeast corner of bridge looking downstream. **Compass:** 45 (Northeast)

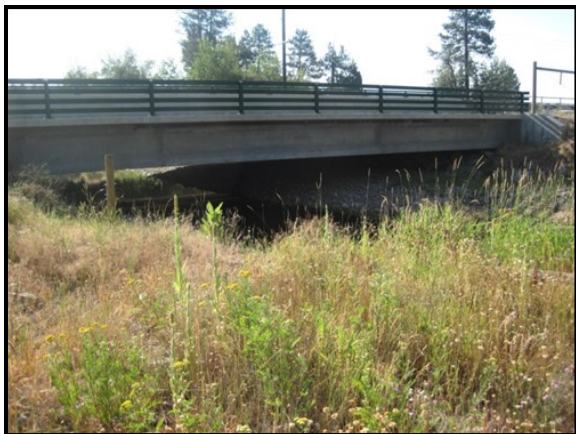
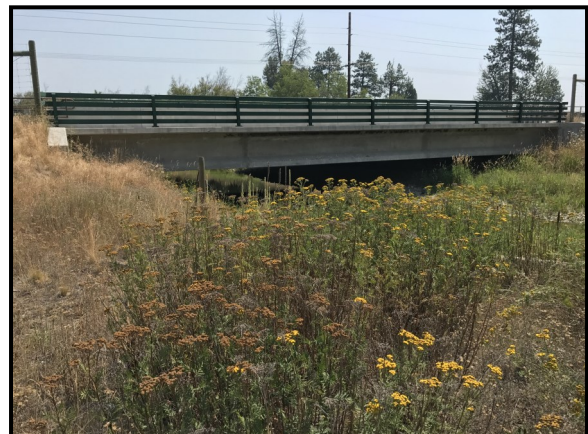
Photo Point 2.1: View across channel from west side of bridge. **Compass:** 113 (East-Southeast)

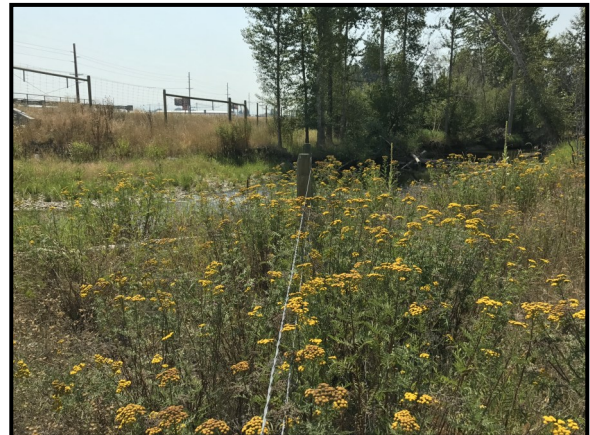
Photo Point 2.2: View from west side of bridge looking across stream channel. **Compass:** 225 (Southwest)

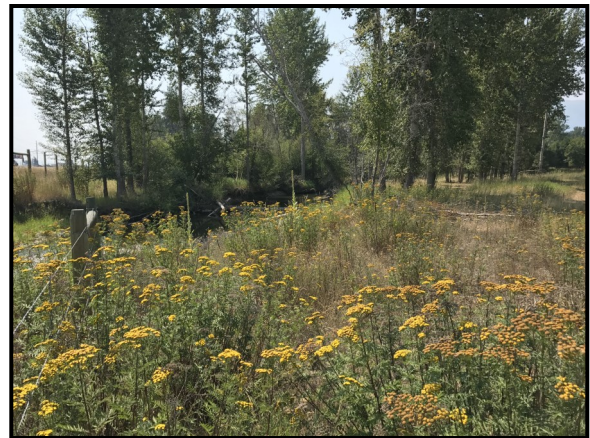
Photo Point 2.3: View from Photo Point 2 looking upstream. **Compass:** 248 (West-Southwest)

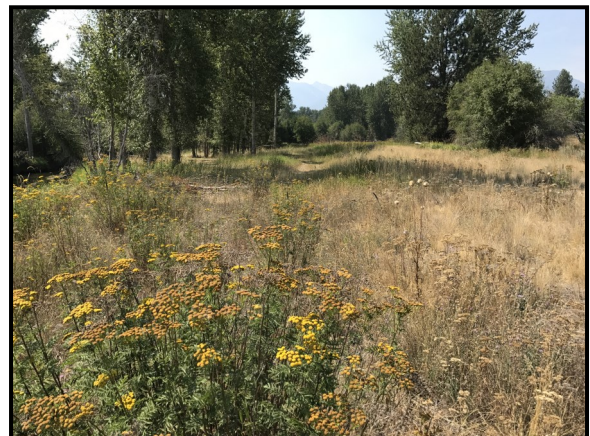
Photo Point 2.4: View of deactivated channel alignment **Compass:** 270 (West)

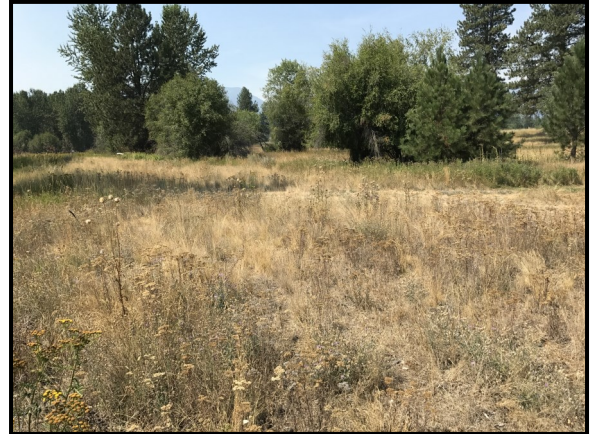
Photo Point 2.5: View of deactivated channel alignment. **Compass:** 248 (West-Southwest)

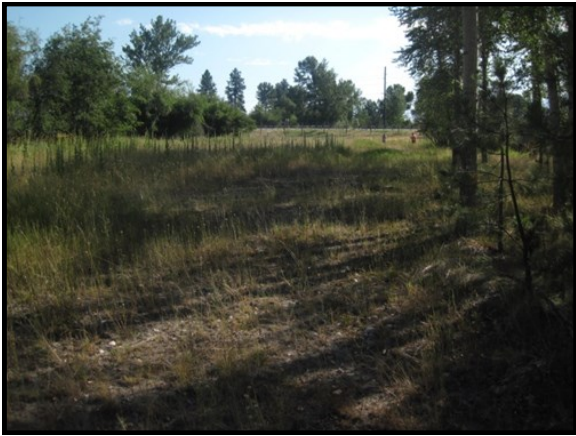
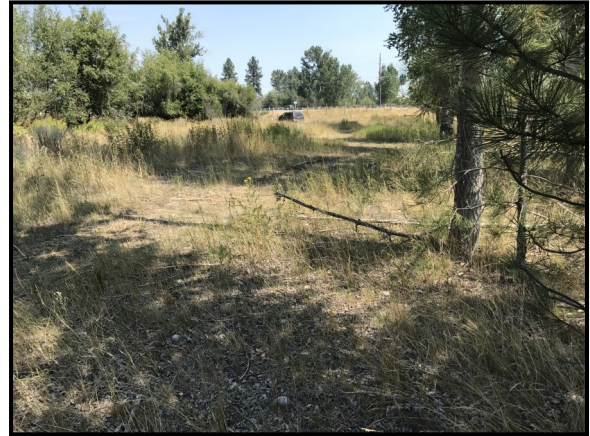
Photo Point 3.1: View of deactivated channel segment from Photo point 3. **Compass:** 68 (East-Northeast)

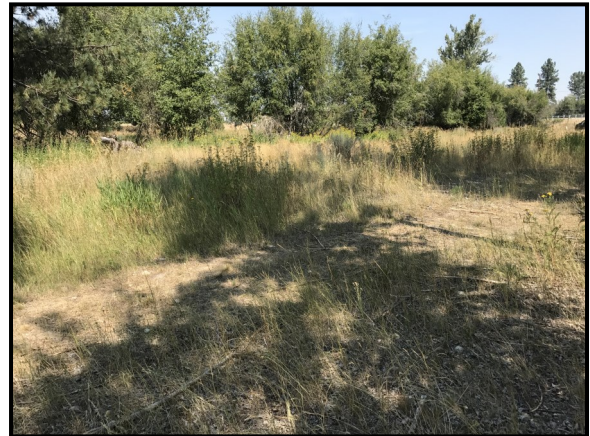
Photo Point 3.2: View of deactivated channel plug. **Compass:** 45 (East)

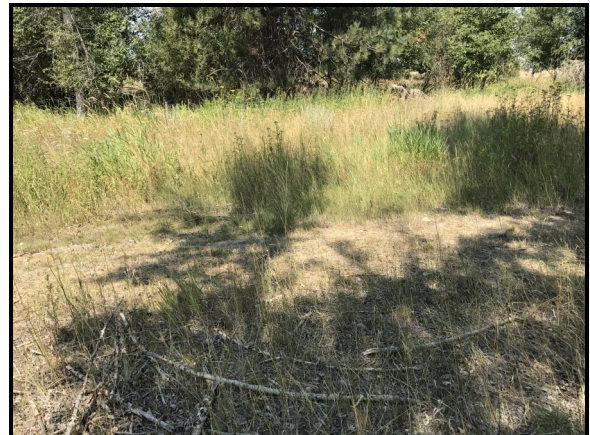
Photo Point 3.3: View of deactivated channel plug from Photo Point 3. **Compass:** 0 (North)

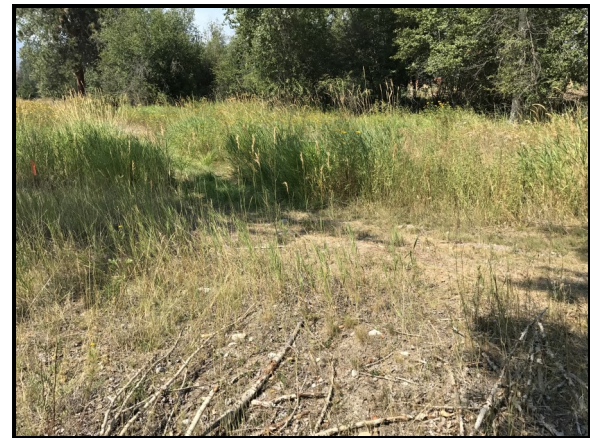
Photo Point 3.4: View of deactivated channel plug from Photo Point 3. **Compass:** 315 (Northwest)

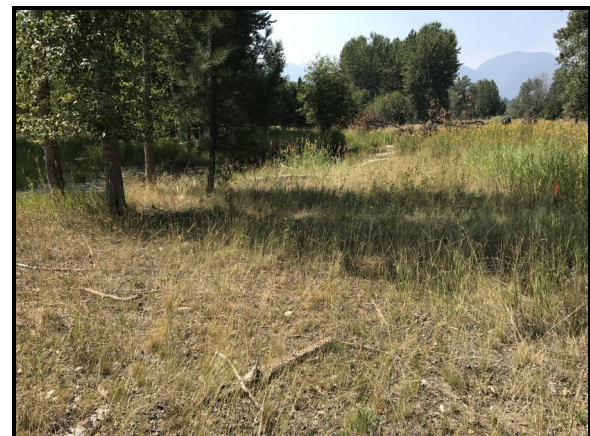
Photo Point 3.5: View of upstream extent of deactivated channel segment **Compass:** 270 (West)

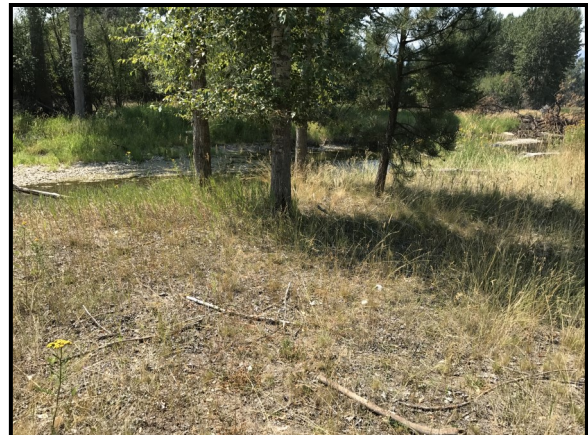
Photo Point 3.6: View of north bank (foreground) and woody debris in the channel. **Compass:** 248 (WSW)

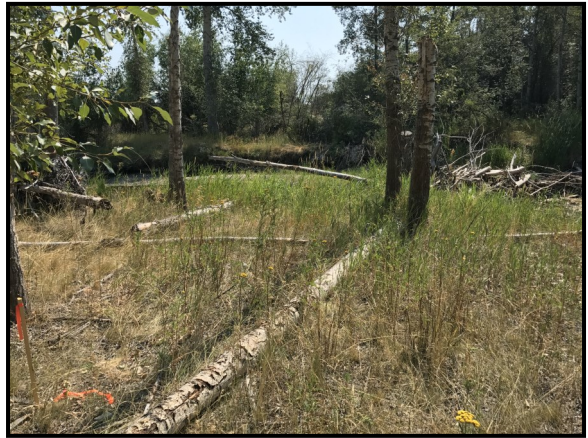
Photo Point 3.7: View of north bank (foreground) and woody debris in the channel. **Compass:** 180 (South)

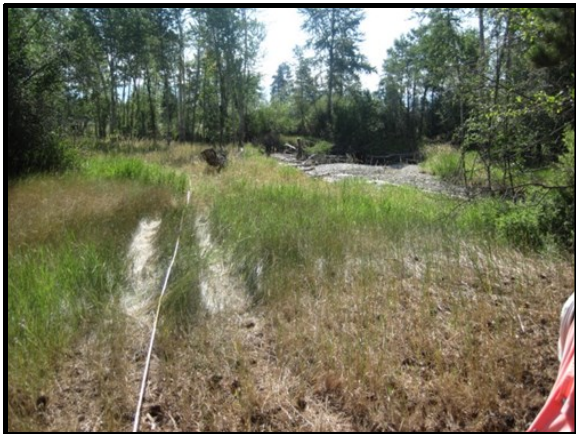
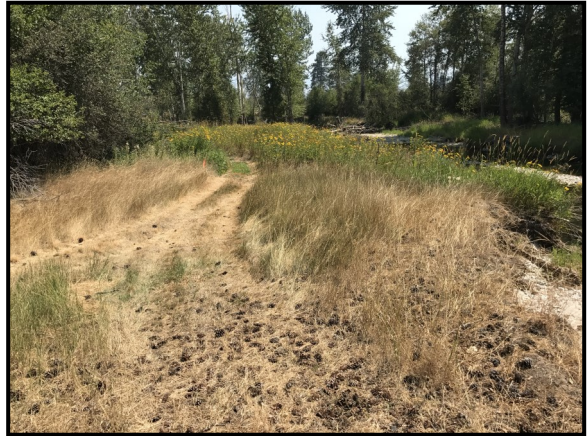
Photo Point 3.8: View looking across deactivated channel segment. **Compass:** 90 (East)

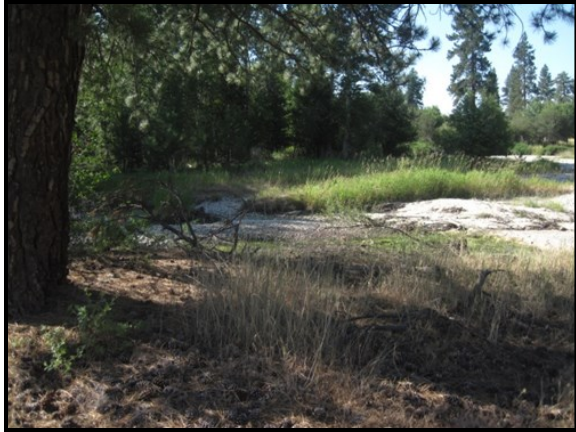
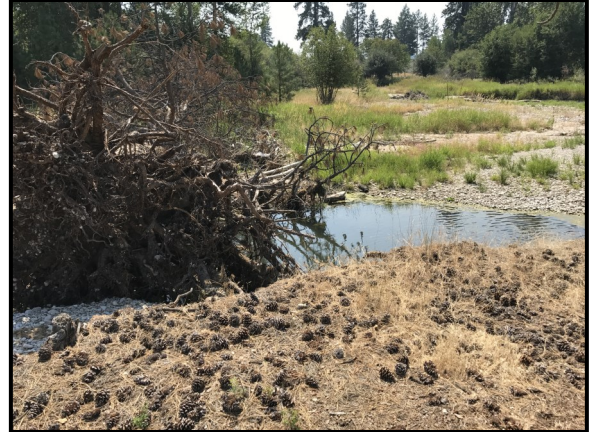
Photo Point 4.2: View across stream channel toward south bank. **Compass:** 180 (South)
Note: toppled Ponderosa pine tree obscures view on left side of photo

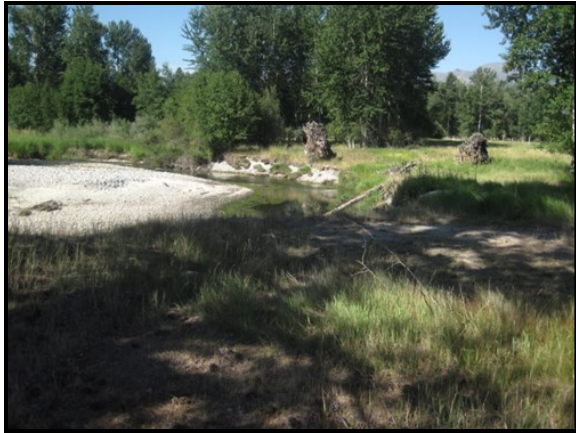
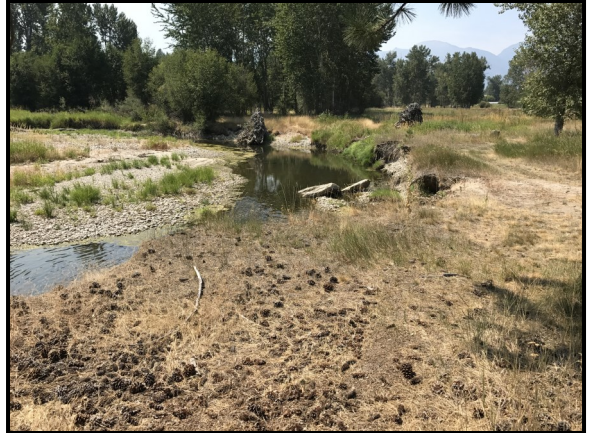
Photo Point 4.3: View of point bar formation from Photo Point 4. **Compass:** 225 (Southwest)

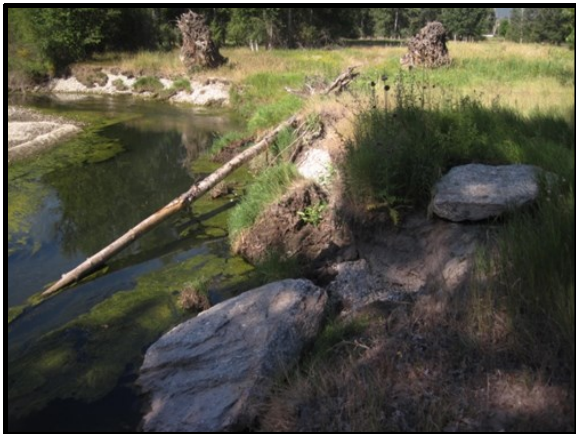
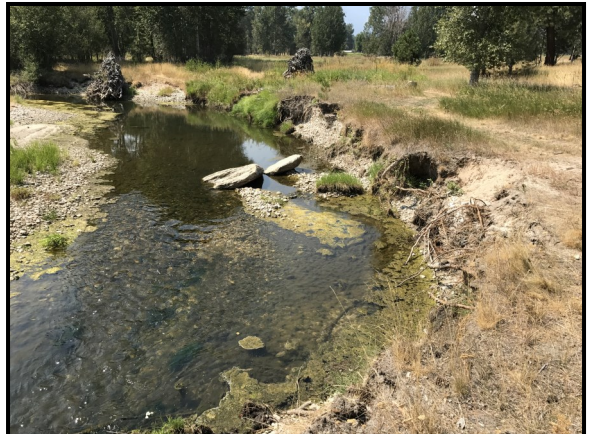
Photo Point 4.4: View of boulders, logs, and root wads placed on bank. **Compass:** 248 (West-Southwest)

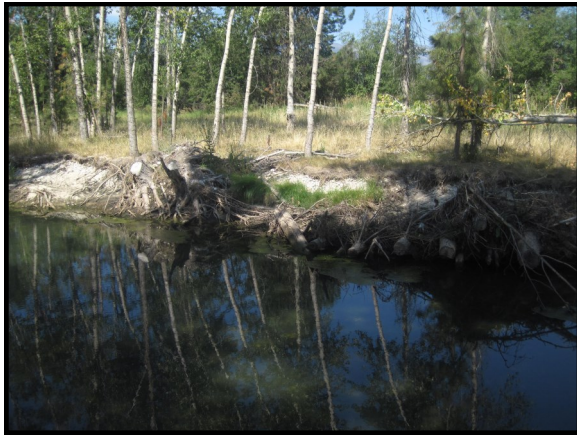
Lateral erosion at bank EBL4 appears to have continued over the past two years, as evidenced by the adjacent root balls detaching from the bank (see Additional Photo 5 in Appendix C). The bank has retreated approximately 6-8 feet since 2013, although the eroding bank length of 64 feet has not increased. Bank instability at this location was potentially caused by removal of the trees for use in log revetment construction, or from natural channel adjustments following construction. The dominant vegetation along the bank includes reed canary grass and smooth brome, the former of which offers dense roots capable of withstanding erosion more effectively than most species. Erosion severity along this bank is considered low, as it does not jeopardize any infrastructure elements or the newly installed bridge downstream. As a result of the erosion occurring likely as a result of natural channel adjustments, no corrective actions are warranted at this location.

Additional Photo 5: Eroding streambank EBL4

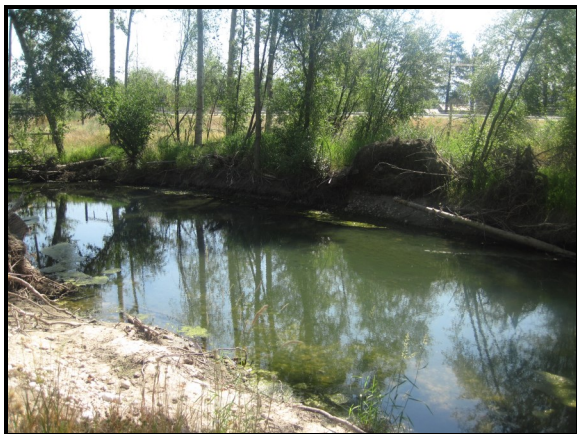
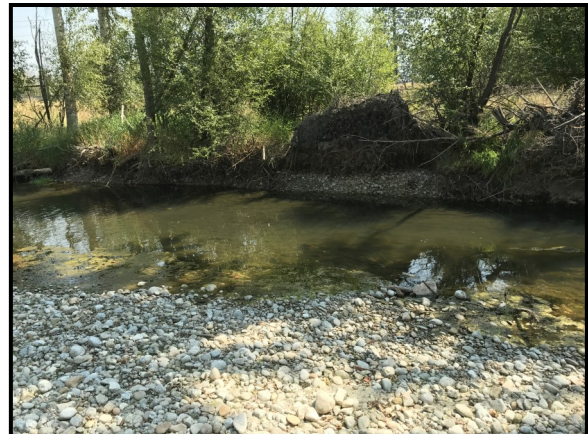
Eroding bank EBR1 occurs directly across the channel from EBL4. Previous monitoring efforts documented fallen trees both into the channel and away from the channel along this bank, although it appears no additional erosion has occurred along the bank since 2014 (See Additional Photo 6 in Appendix C). Based on the lack of continued bank erosion along EBR1 as noted in the past four years, it has been removed from the list of actively eroding banks and no longer appears on Figure 3 in Appendix A.

Additional Photo 6: Eroding streambank EBR1

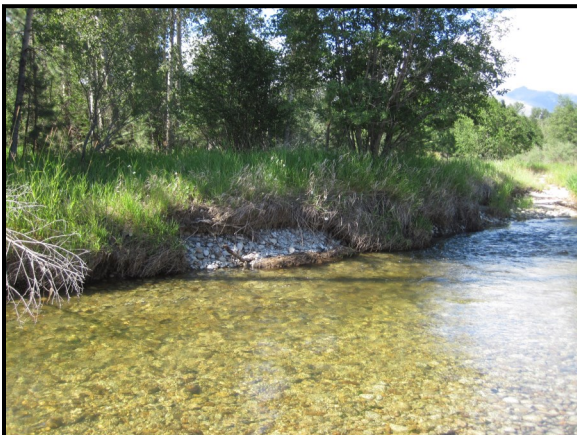
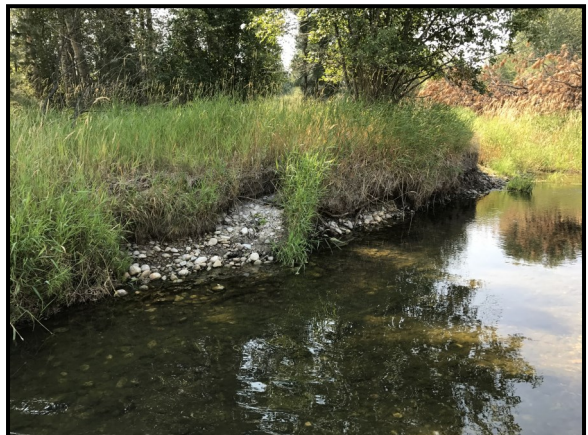
Erosion at EBR2 was originally noted in 2014 along 65 feet of the channel across from the head of the deactivated stream channel. Erosion at this location was tied to channel adjustments and scour along the outside of a meander. No additional erosion along this bank segment has been noted over the past three years (see Additional Photo 7 in Appendix C), and as such, it has been removed from the list of actively eroding banks.

Additional Photo 7: Eroding streambank EBR2
