Montana Department of Transportation Stream Mitigation Monitoring Report

FOY'S BEND FISHERIES CONSERVATION AREA

Monitoring Year: 2020

Monitoring Conducted By: Confluence Consulting Inc.

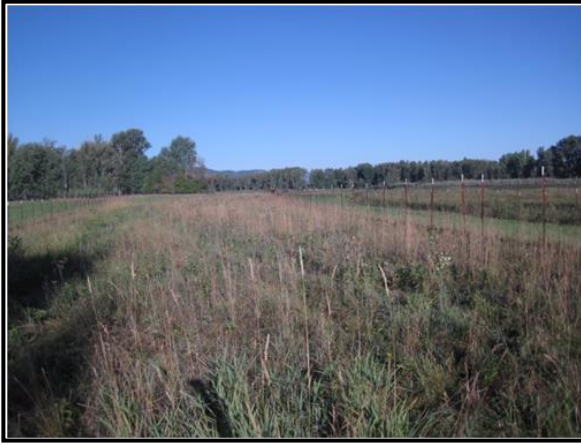
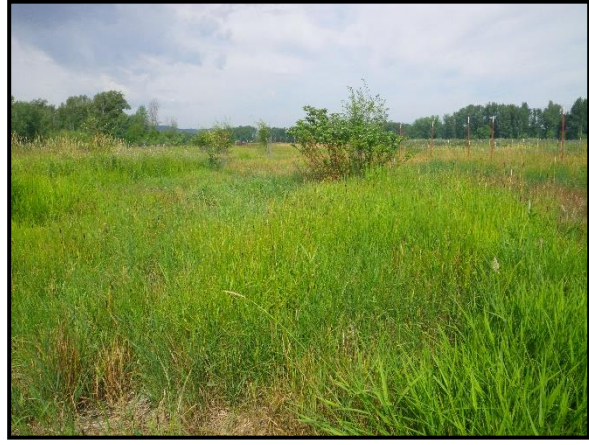
Photo 1: Exclosure 4, looking northwest.

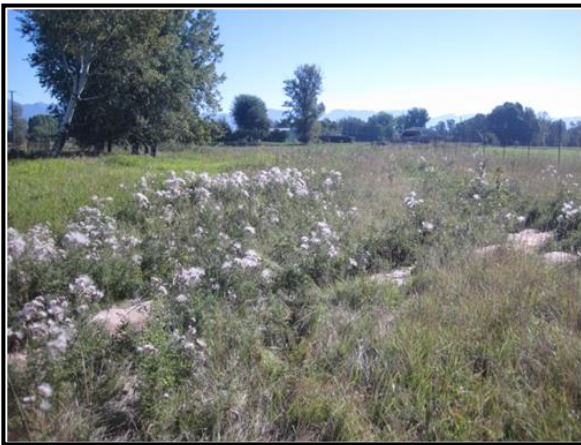
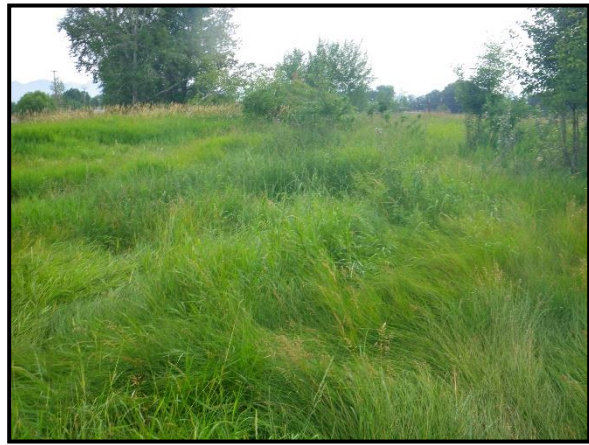
Photo 2: Exclosure 6, looking east.

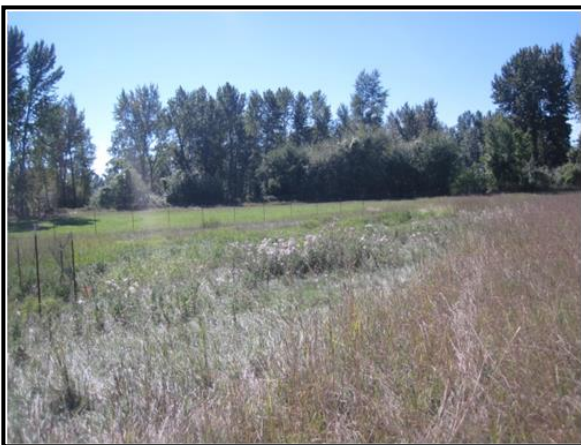
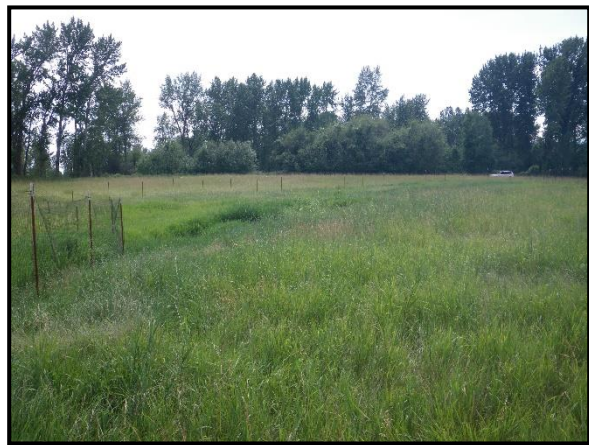
Photo 3.1: Exclosure 8 looking southeast.

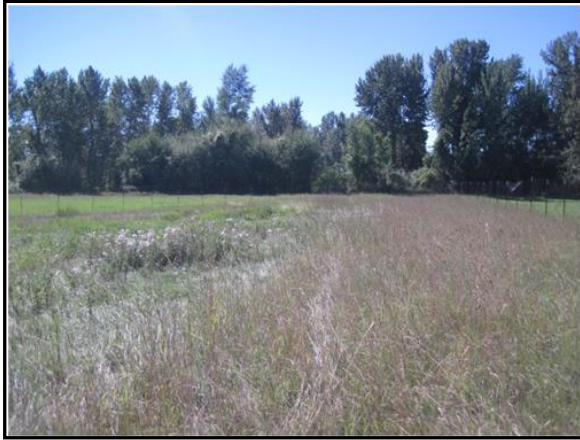
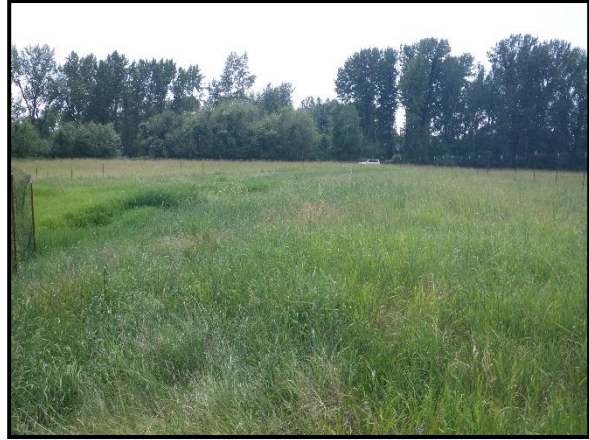
Photo 3.2: Exclosure 8 looking south-southeast.

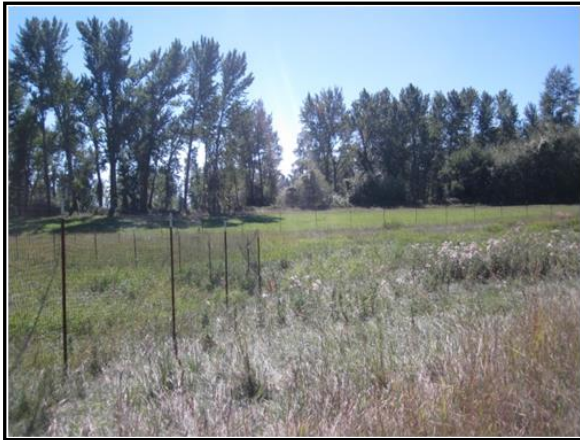
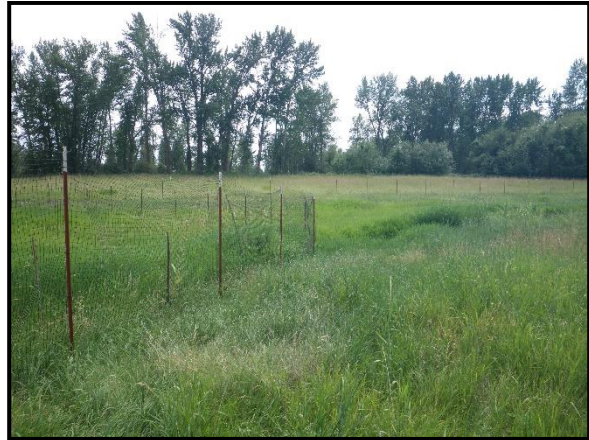
Photo 3.3: Exclosure 8, looking south-southwest.

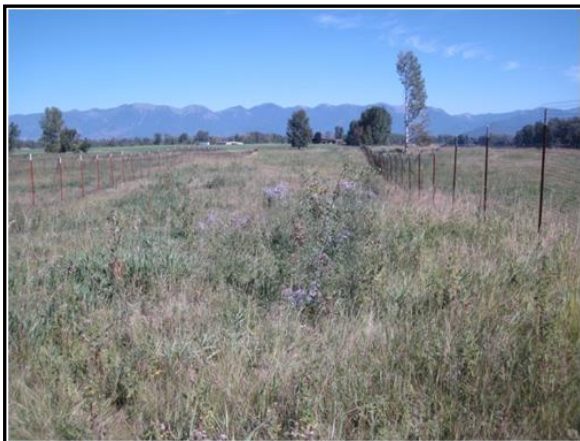
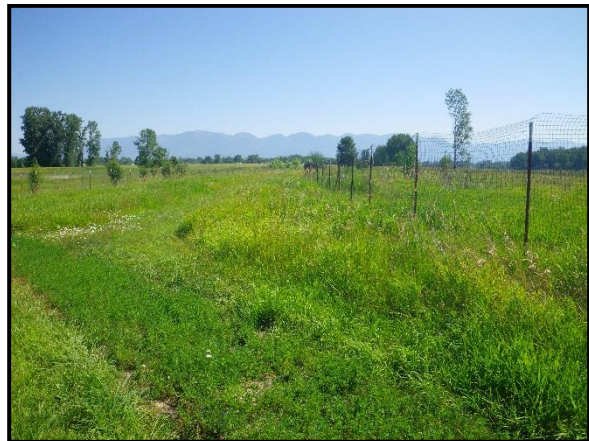
Photo 4: Exclosure 14, looking east.

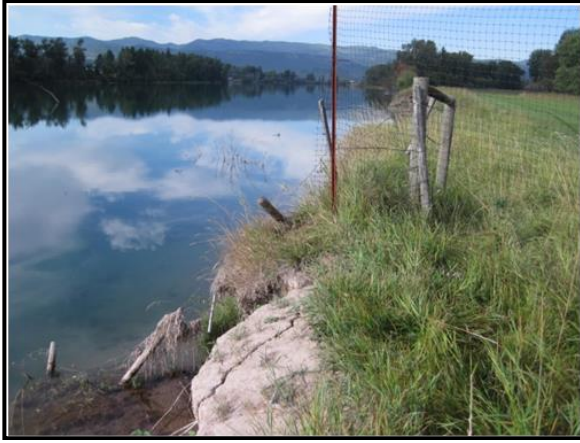
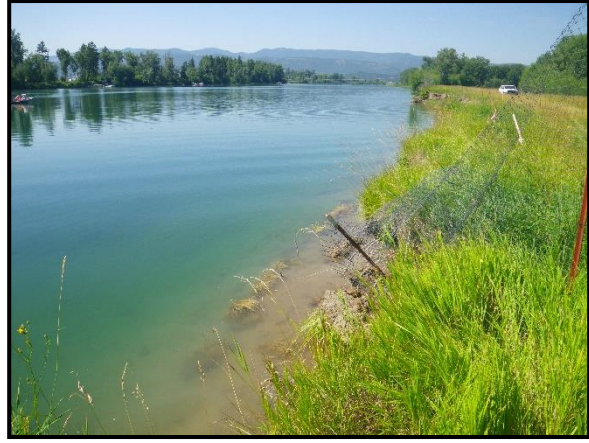
Photo 5.1: Upstream extent of restored stream bank looking upstream (west).

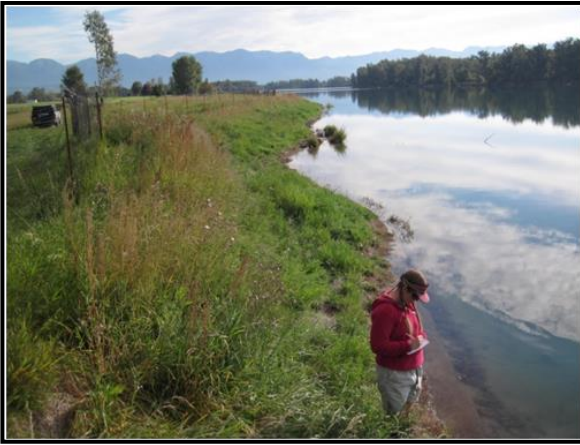
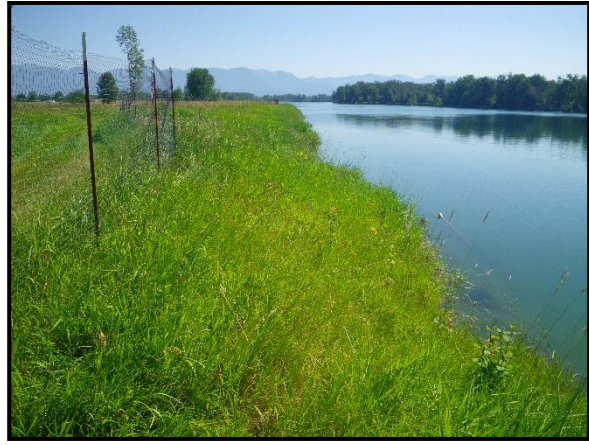
Photo 5.2: Upstream extent of restored stream bank looking downstream (northeast).

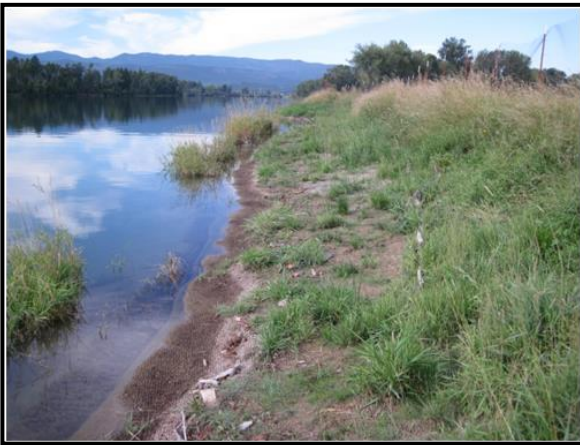
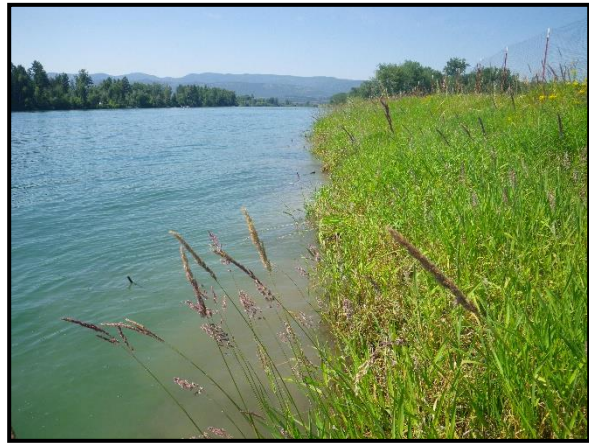
Photo 6.1: Middle of restored stream bank, looking upstream (west).

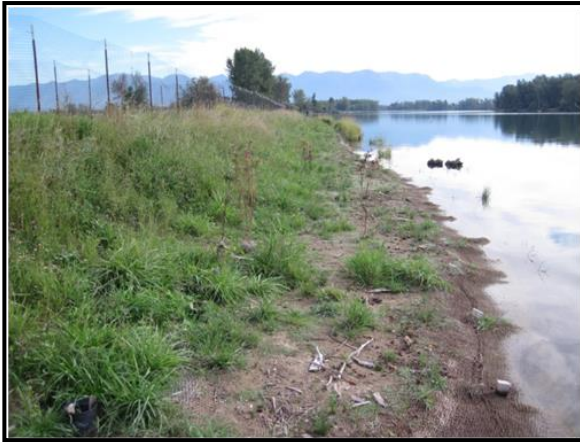
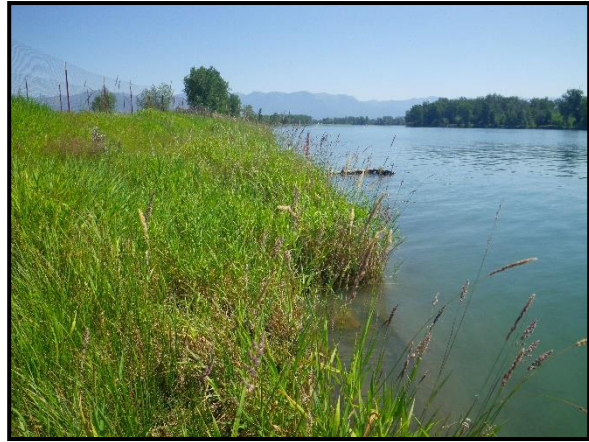
Photo 6.2: Middle of restored streambank looking downstream (northeast).

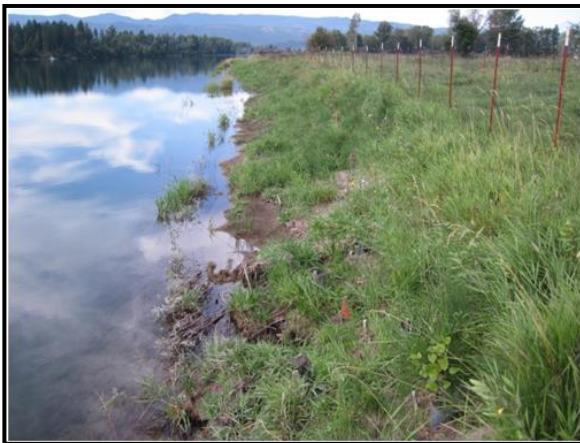
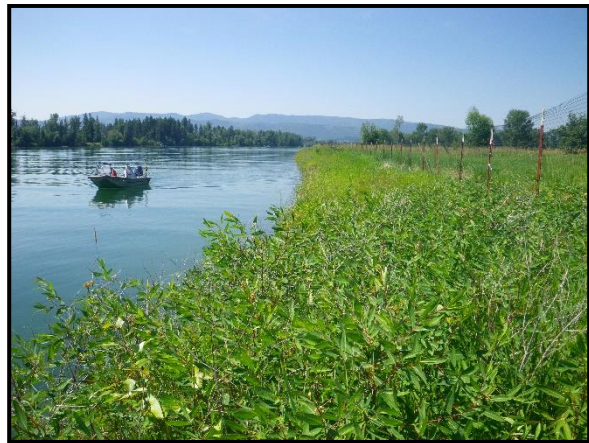
Photo 7: Downstream end of restored stream bank, looking upstream (west).

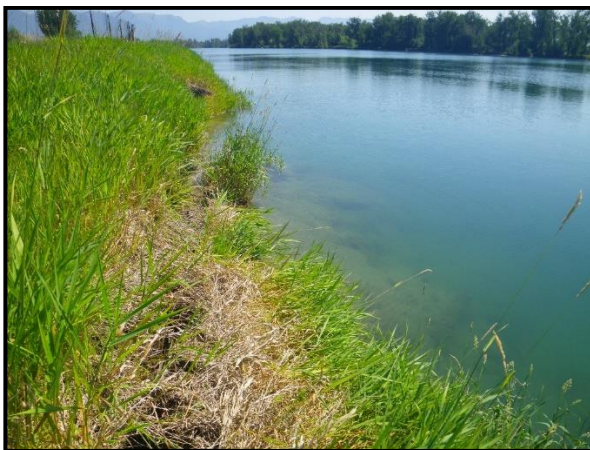
Reach 2 – Reach 2 is 135 feet long and is represented by Transects 3.5 through 4.5 (Figure 2). Although the re-sloped and revegetated upper portions of the reconstructed bank remain stable, severe bank erosion beneath the woody fascines was observed in Reach 2 between 2013 and 2017, and the fascines became detached from the bank. Due to the loss of bank protection from the fascines, the bank has eroded more rapidly over the past three years. The leading edge of the bank has retreated 1-2 feet over the past year, and between 9 and 11 feet since monitoring began in 2013 (Appendix G). The average retreat rate for Reach 2 is 1.2 feet/year over the monitoring period, which is considered “functional at risk” in the performance standards. Bank retreat is expected to continue in Reach 2 given the lack of bank protection beneath the treated area.

Additional Photo 1: Bank sloughing near Transect 3.5

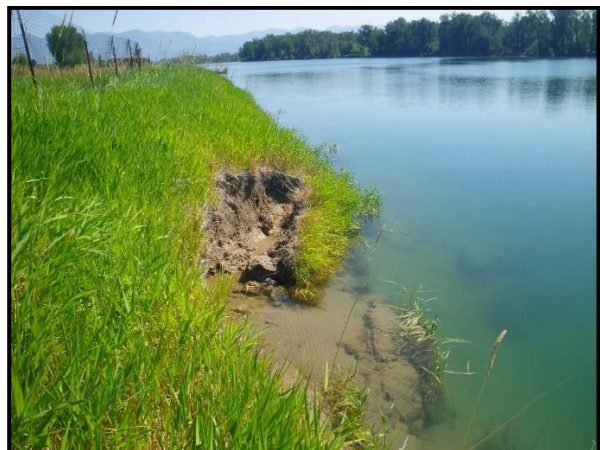
Additional Photo 2: Bank calving off behind coir soil lift at Transect 4.

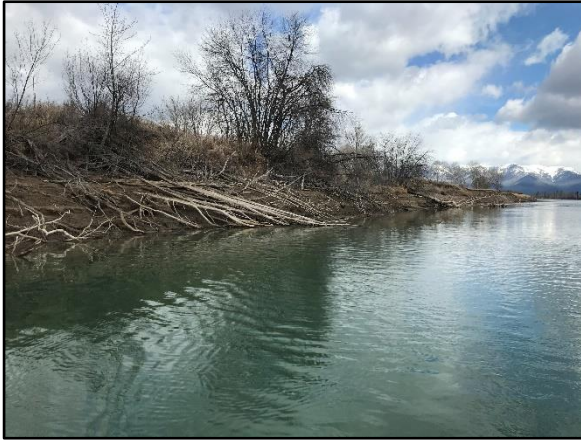
Erosion Upstream of Reconstructed Bank – Erosion has been monitored at three transects (-0.5, 0, 0.5) upstream of the treated bank since 2016, where approximately 775 feet of bank is actively eroding (Figures 2 and 5, Appendix G). This bank segment has often exhibited higher erosion rates as compared to transects downstream (Table 7). The majority of erosion observed in this reach is in the uppermost portion of the bank and extends downstream far enough to intercept the reconstructed bank where it has begun to influence the stability of Reach 1, and has captured a portion of the protective fencing installed around a revegetated area (see photo point 5.1 and survey photos 14 & 15, Appendix B). Over the survey timeframe, Transect -0.5 has exhibited the highest bank retreat rate when compared to all other transects surveyed. Between 2016 and 2020, Transect -0.5 retreated by 12.2 feet (3.1 feet/year). The bank is also retreating at Transects 0.0 and 0.5, although at a slower pace; 1.5-2 feet per year. The trend of rapid bank retreat the upstream reach continued in 2020, when the bank retreated 1-2 feet between April and July (Table 7). Since this reach is not treated or reconstructed portion of the mitigation project, it is not compared against the success criteria.

Additional Photo 3: Flathead River bank upstream of treatment reach.

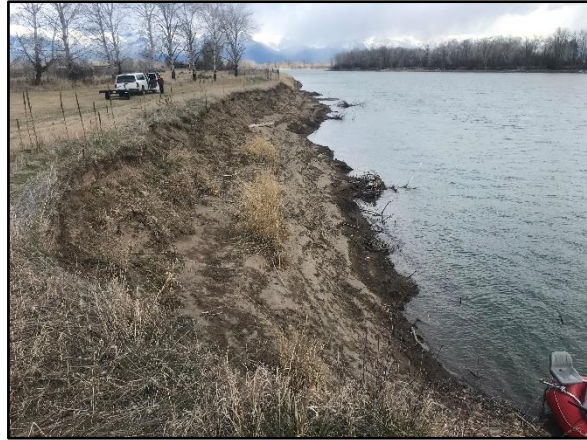
Additional Photo 4: Looking downstream from riprap outcrop above bank stabilization.

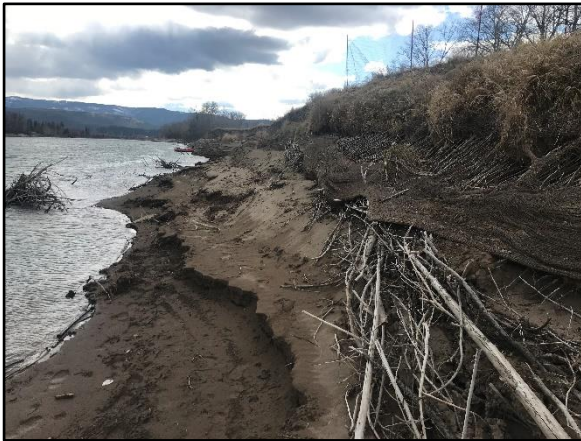
Additional Photo 5: Looking upstream at cross section 1.5 from bottom of bank.

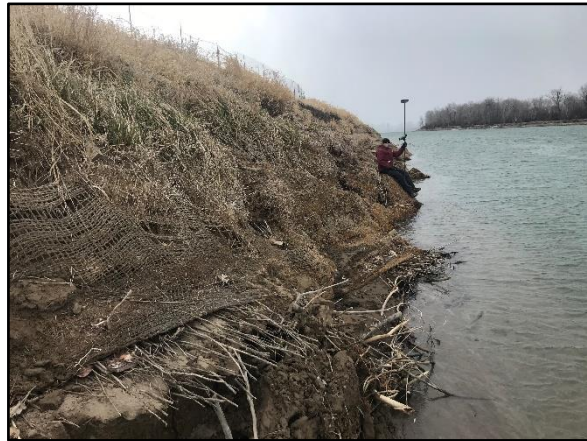
Additional Photo 6: Looking downstream at cross section 2.5 from bottom of bank.

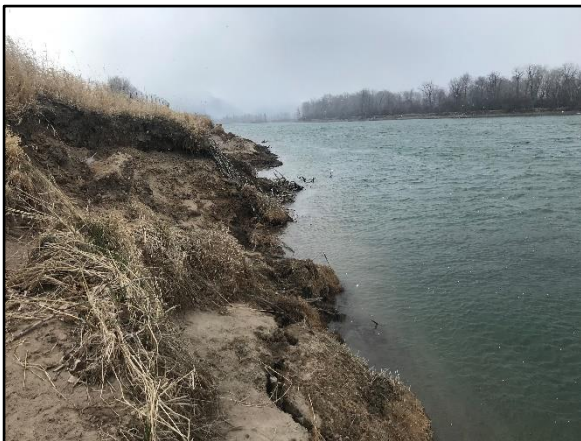
Additional Photo 7: Looking downstream at cross section 4.5 from bottom of bank.

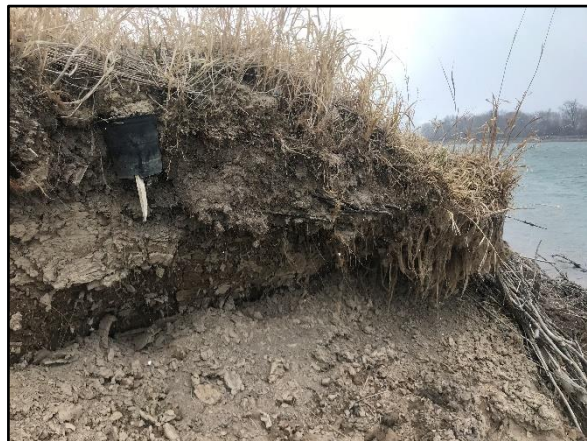
Additional Photo 8: Exposed planting in eroding bank.

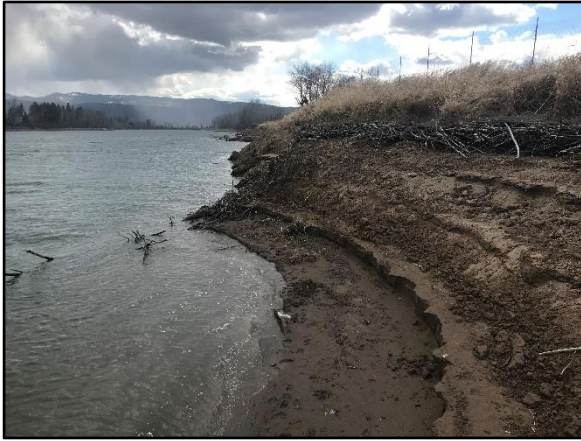
Additional Photo 9: Looking upstream at cross section 5.5 from bottom of bank.

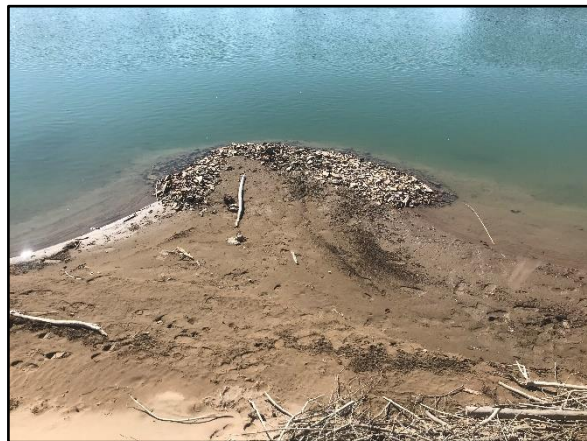
Additional Photo 11: Looking upstream at cross section 2.

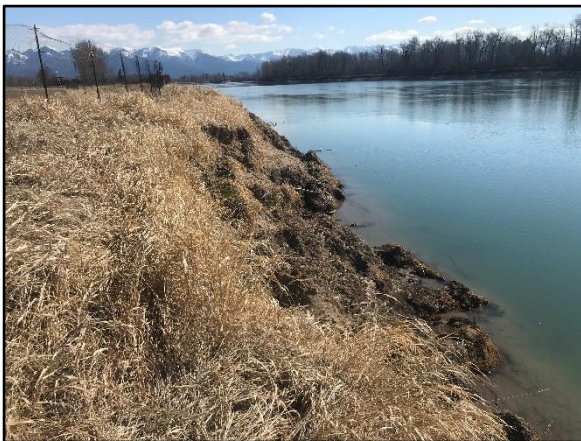
Additional Photo 12: Looking south at cross section -0.5.

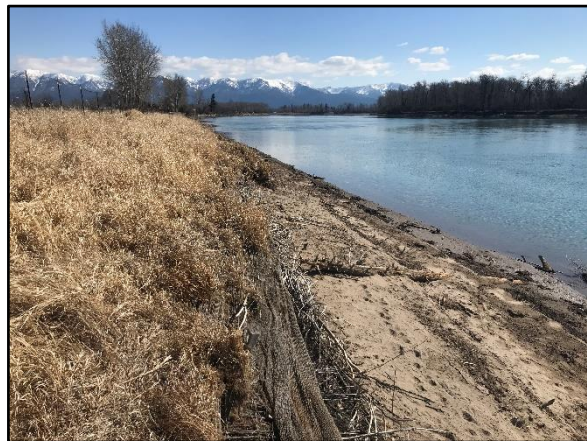
Additional Photo 13: Looking downstream at cross section 3.5.

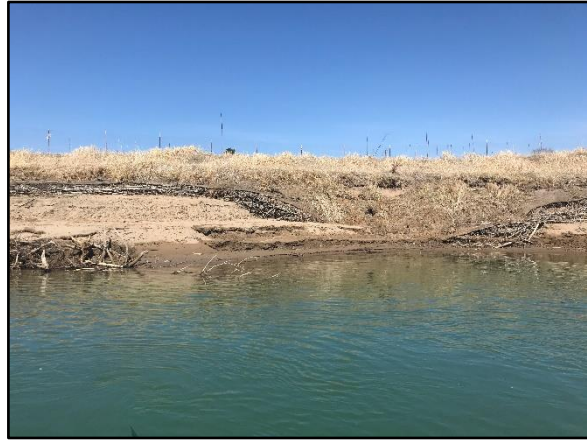
Additional Photo 15: Looking north at cross section 1.5.

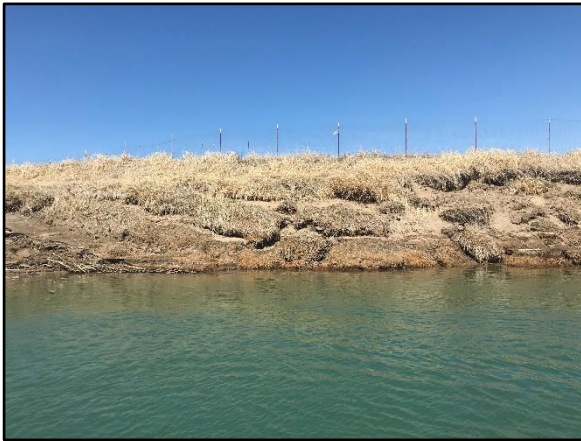
Additional Photo 16: Looking north at cross section 2.5.

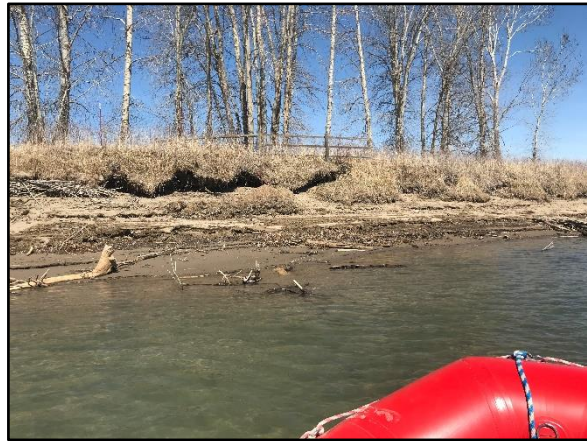
Additional Photo 17: Looking north at cross section 3.5.

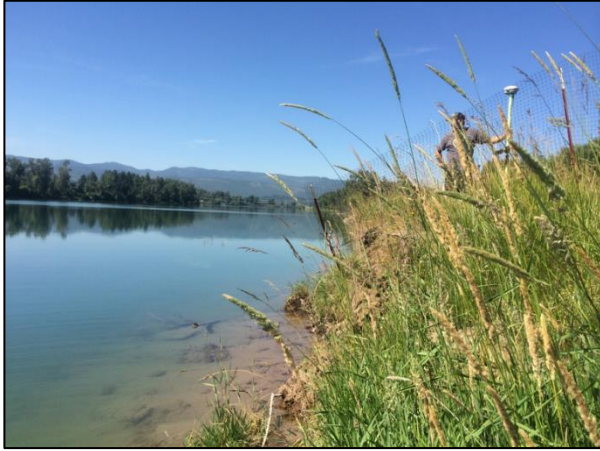
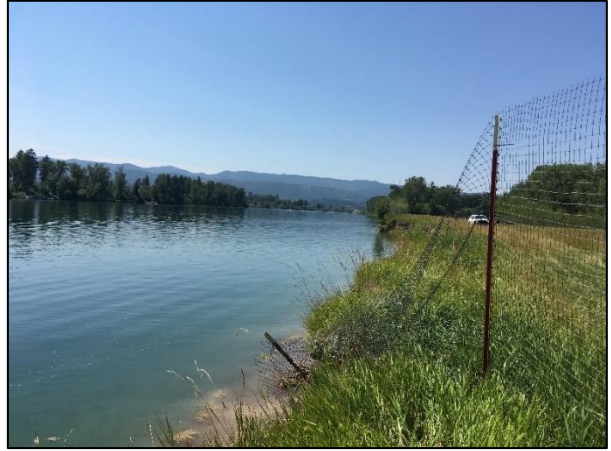
Survey Photo 10: T 1.0 Looking West

Reach 1 – Reach 1 spans the upstream 235 feet of reconstructed bank and contains five transects (Transects 1-3; Figure 2). Annual surveys of these transects indicate that upper portions of the reconstructed bank that were re-sloped and revegetated remain stable but that the lower portions of the bank have retreated by an average of 4.6 feet since 2013 (Table 7). The average annual retreat rate of lower bank is approximately 0.6 feet/year which is considered “functional” in the performance standards (less than 1 foot annually). However, the average retreat rate across the Reach 1 transects was 2.2 feet per year since 2019, which would be considered “Functional at Risk” in the performance criteria. Additionally, the area beneath the bank treatments has become vertical and is susceptible to undercutting and bank failure (Appendix G). Bank failures were observed at Transects 2.5 and 3, where the bank slumped and retreated by approximately three feet between April and July 2020 (Table 7; Appendix G). The bank has now retreated past the edge of the coir mat at these transects and remains quite steep between the low and high-water elevations. The increased bank retreat observed over the 2020 summer is primarily attributed to undercutting beneath the reconstructed portion of the bank, which has caused the fascines and coir soil lift to slump down in elevation by an average of 0.8 feet over the last year. Erosion is expected to continue along these transects at a relatively rapid pace now that the bank is no longer protected by the bank treatments.
